Palm Beach Isles, Singer Island  
Canal Crossing Structures Condition Report  
2nd Draft Report: November 25, 2015

**Palm Beach Isles, Singer Island Canal Crossing Structures Condition Report  
(2<sup>nd</sup> Draft)**

Simon A. Coleman, Ph.D., P.E.  
FL License No. 68929  
Alan Gerwig & Associates, Inc.  
12798, W Forest Hill Boulevard, Suite 201  
Wellington, FL 33414  
CA # 7969

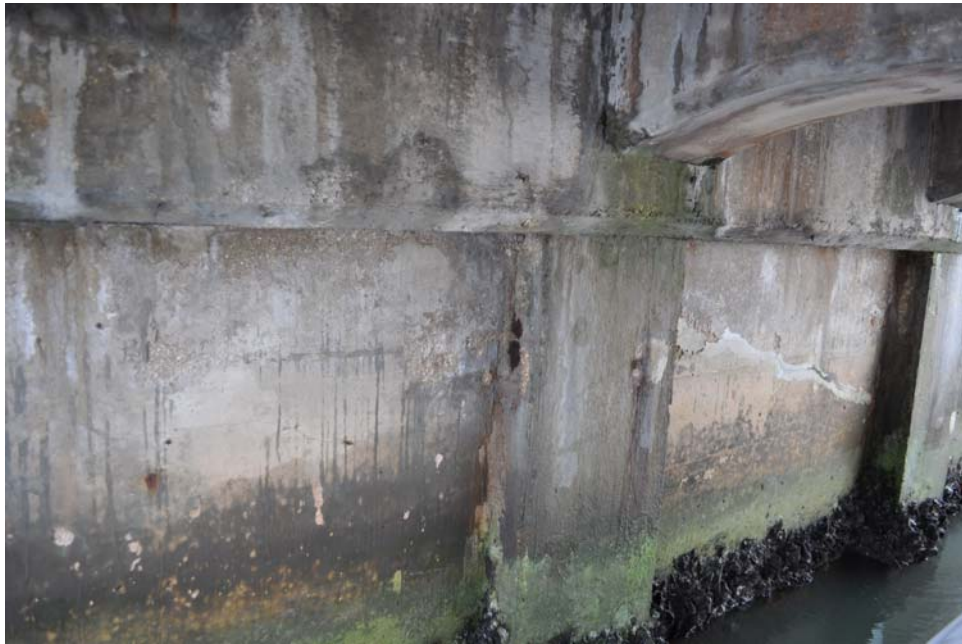
The sheet panels spanning between the piles show some horizontal cracks – see Figure 8, 9, 12 and 13. Some of the cracks have been filled at the time of previous repairs. Although the sheet panels are cracked, they are not showing signs of significant deterioration. The sheet panels are not part of the main support structure for the canal crossings as their role is primarily to retain the material under the roadway off the structures.

**Figure 8: Substructure Island Drive**

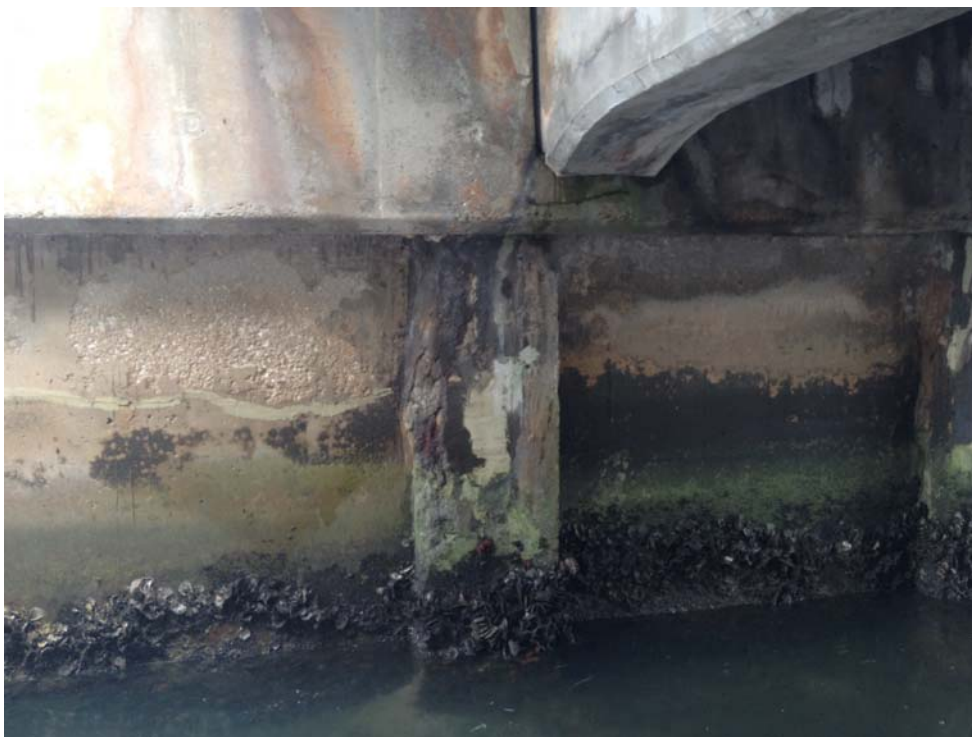
The piles supporting the structures contain some cracking as shown in Figure 12 and some general deterioration as shown in Figure 9, but no signs of major concrete spalls due to corrosion of the reinforcing steel. The cracks in the piles show signs of previous repairs – see Figures 10 and 12, where cracks have been sealed.

**Figure 9: Substructure Island Drive**

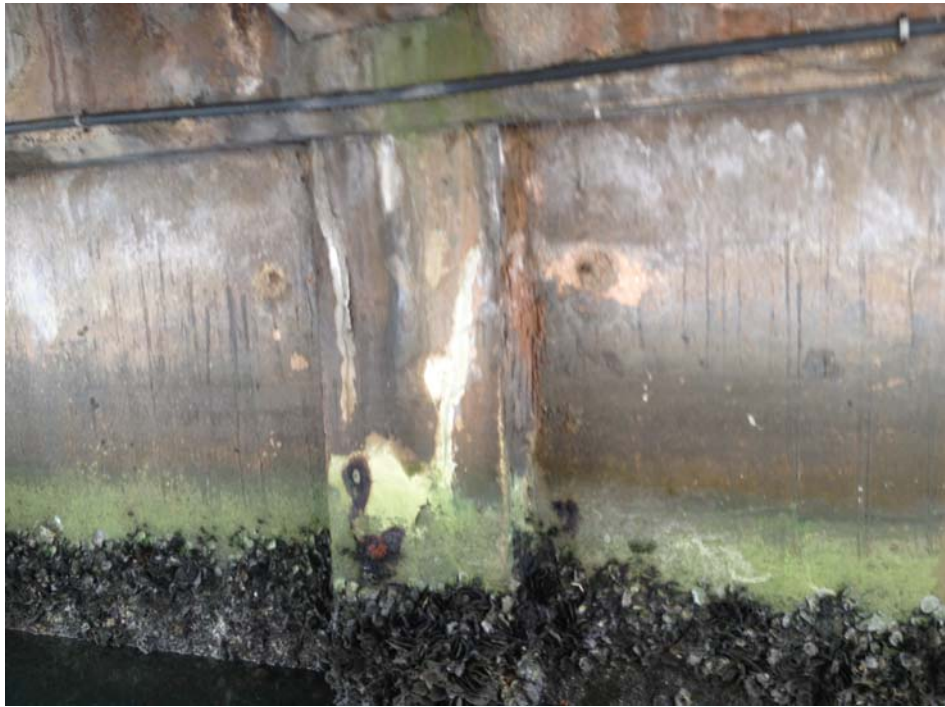
**Figure 10: Substructure Island Drive**

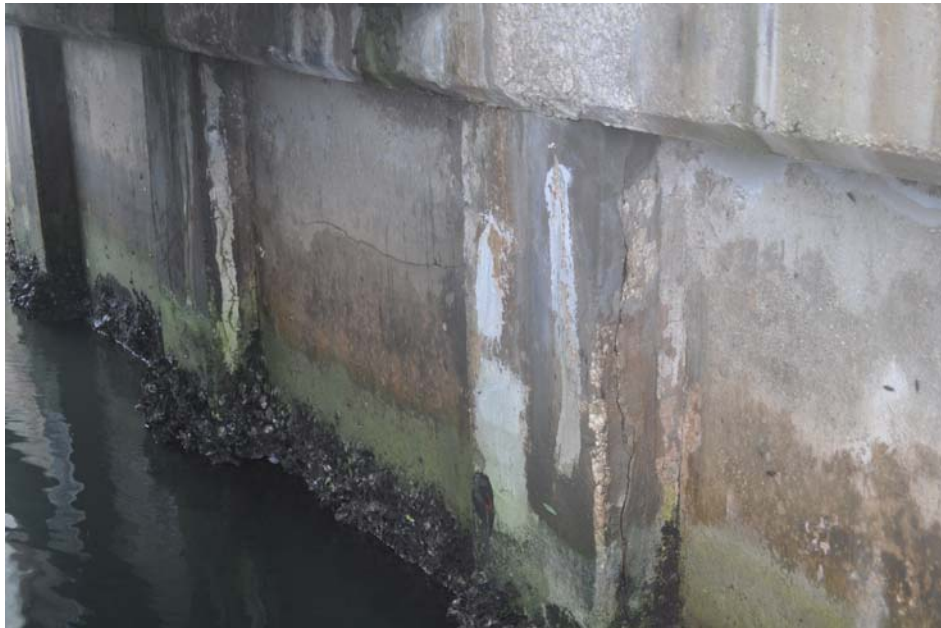
**Figure 12: Pile Cracking Island Drive Structure**

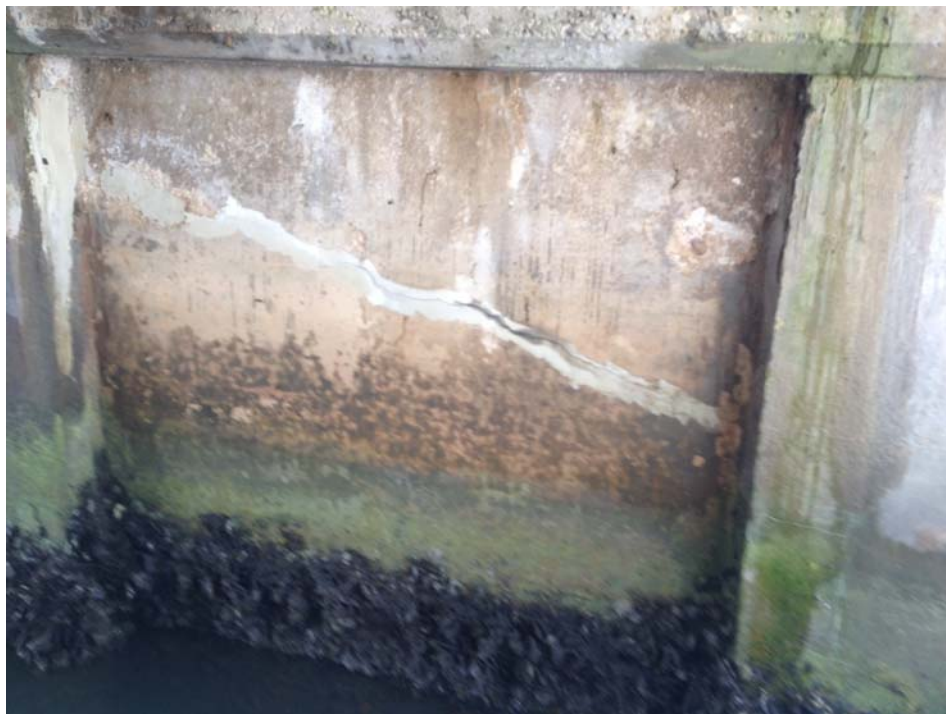
**Figure 13: Sheet Panel Cracking Island Drive Structure**

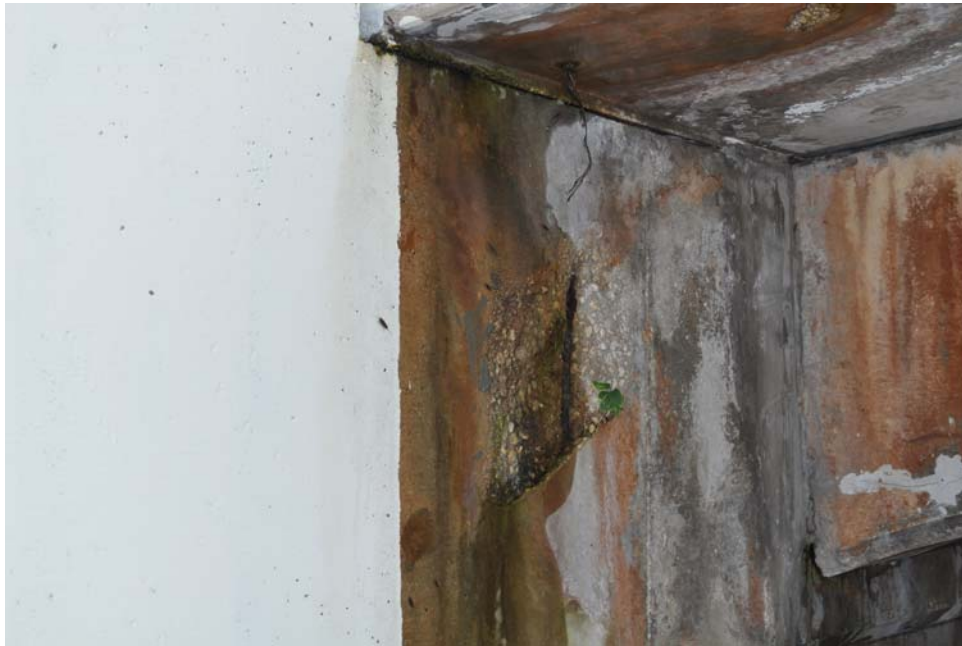
The concrete caps supporting the decks of the structures are in reasonable condition. Figure 14 shows a minor concrete spall exposing reinforcing steel. The reinforcing is corroded. However, it is possible that the concrete spall is due to an impact rather than a result of the steel corroding. Figure 15 shows some cracks that have been repaired on one of the caps. However, these cracks are not showing any signs of significant deterioration or likely concrete spalling.

**Figure 14: Cap Spall Island Drive Structure**

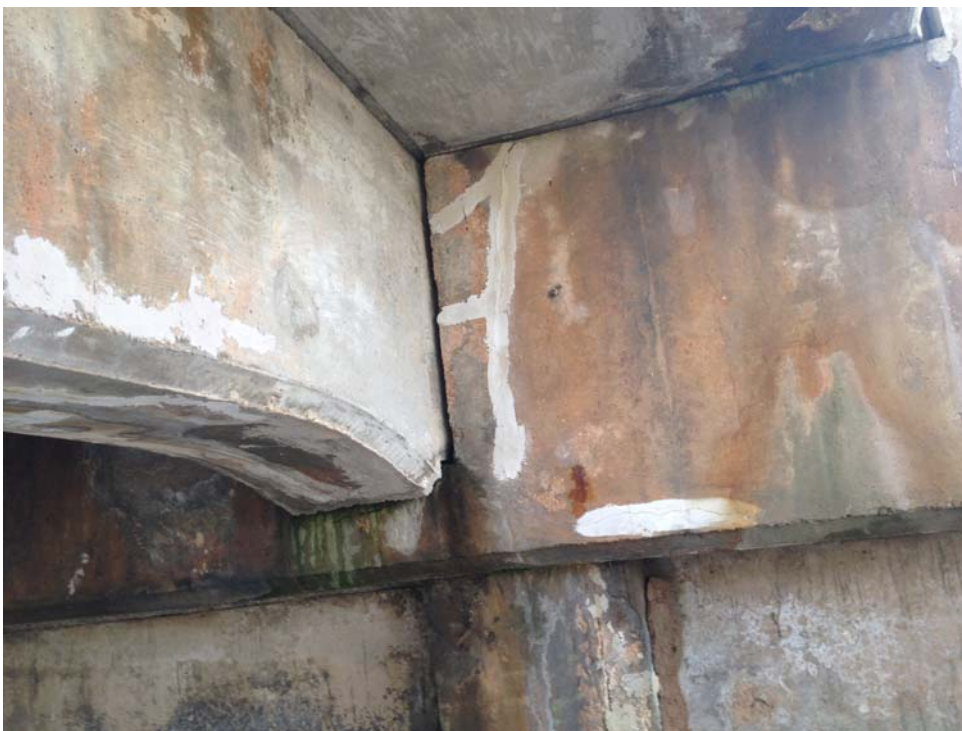
**Figure 15: Cap Cracks Island Drive Structure**

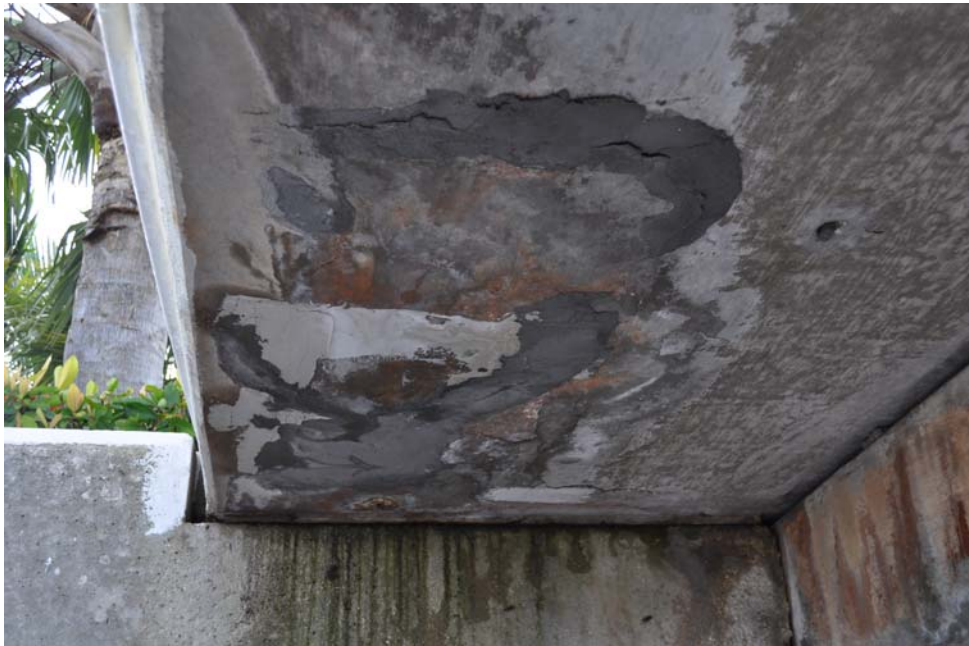
The underside of the deck slabs of the four structures are in good condition as these elements were replaced in the late 1990s. Other than some surface defects at what appears to be a previous repair of the slab under one of the planters as shown in Figure 16, the deck slabs are in good condition. Representative photographs of the underside of the slabs are shown in Figures 17 and 18, which show the surface of the concrete in good condition with no signs of deterioration.

**Figure 16: Slab Under Planter Island Drive Structure**

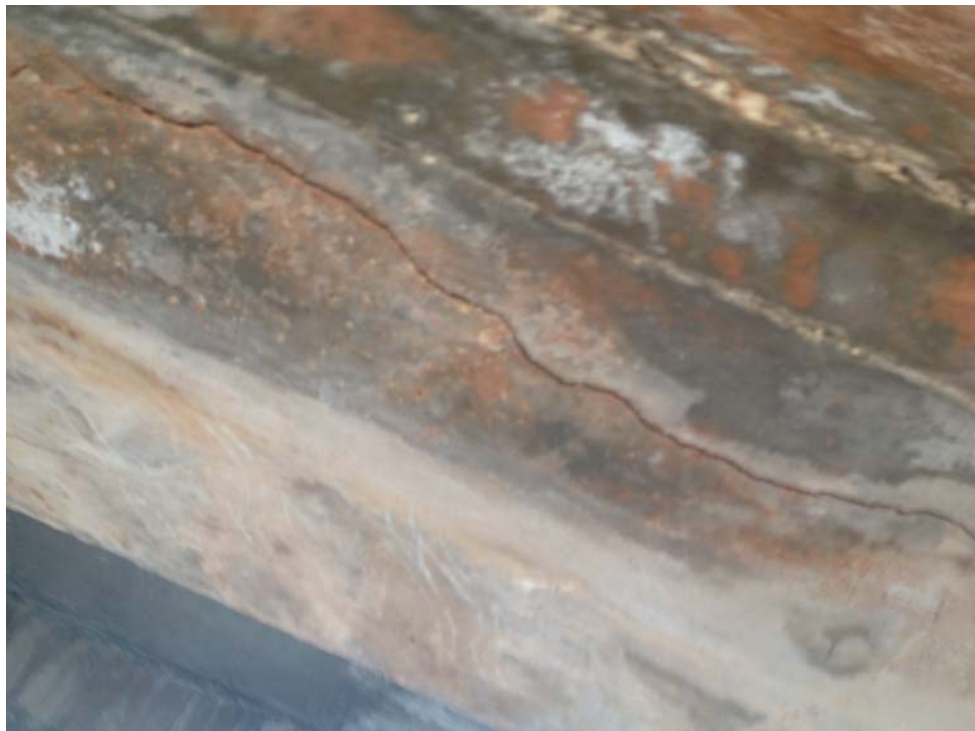
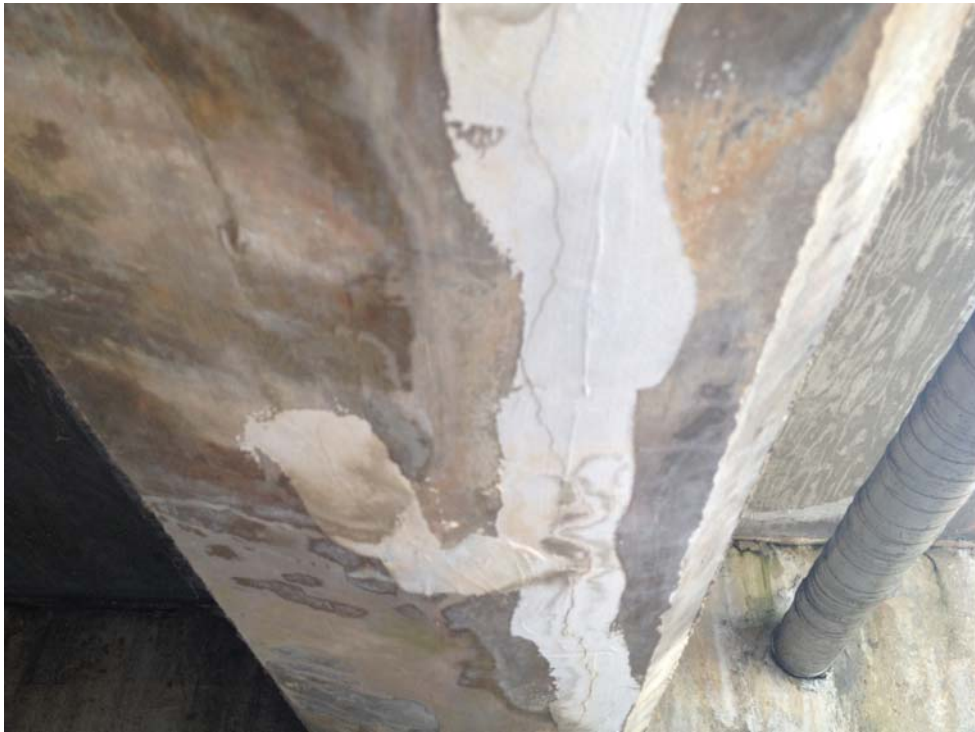
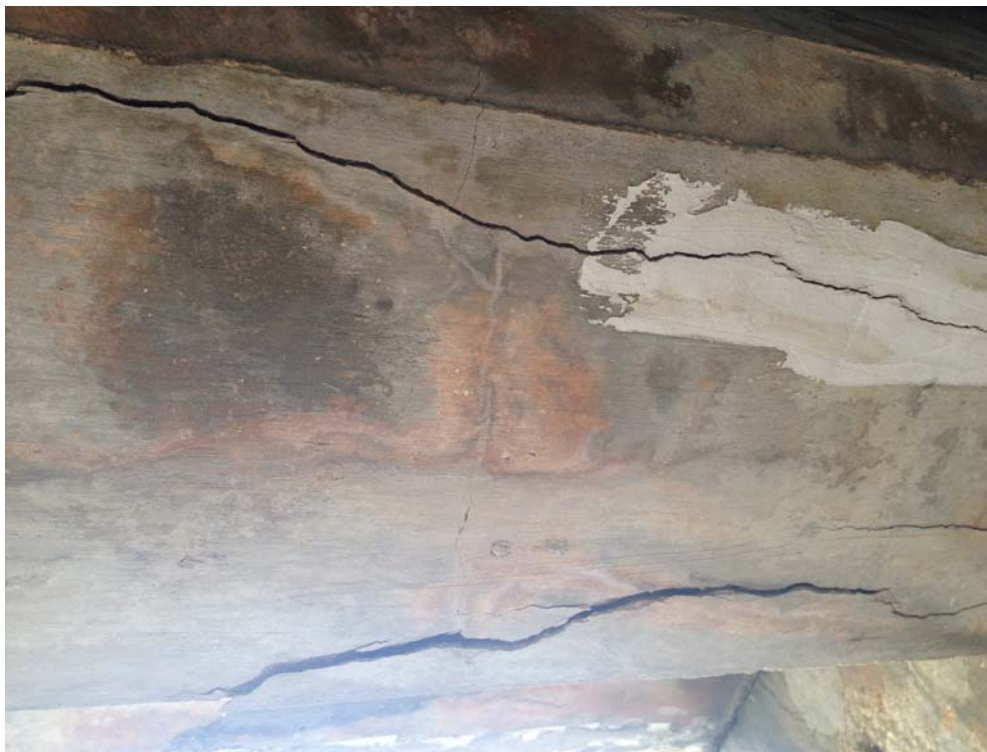
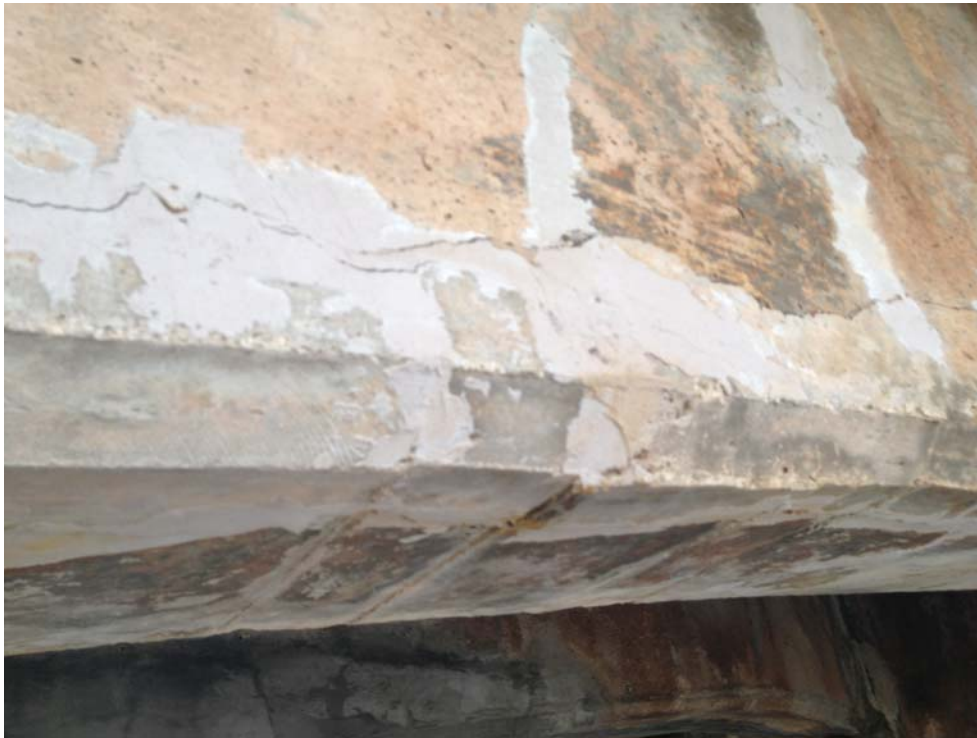
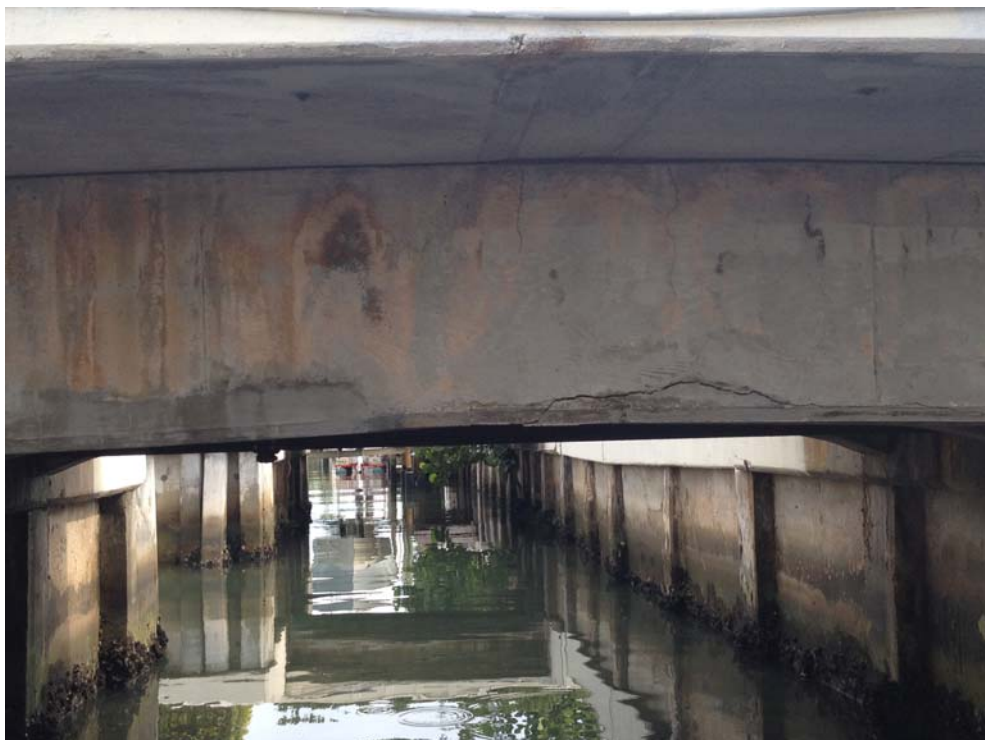
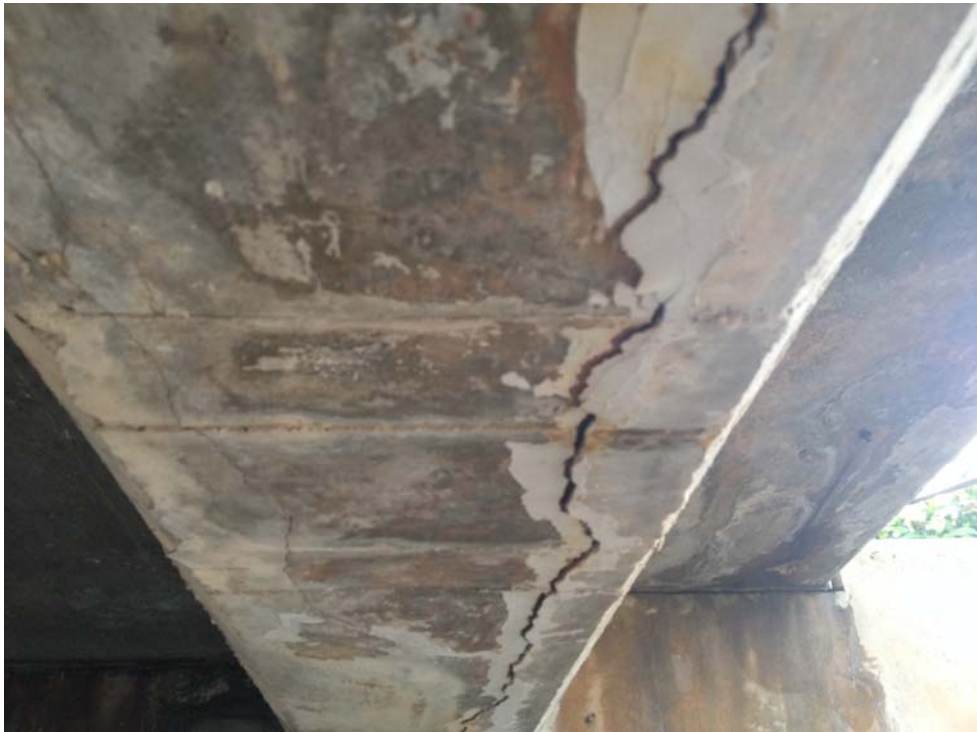
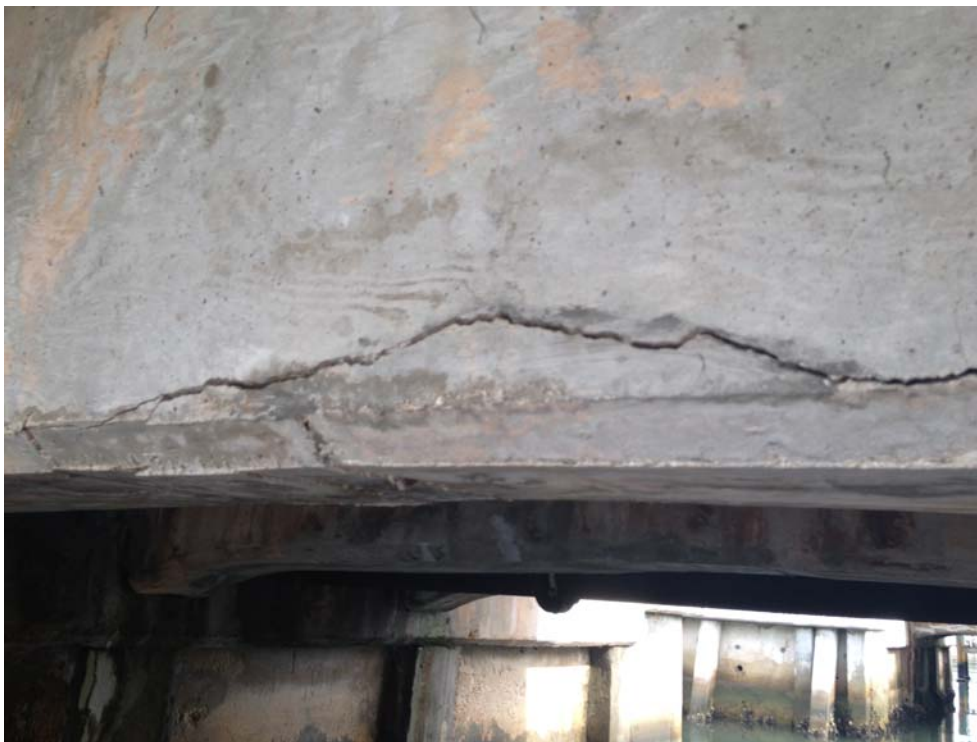
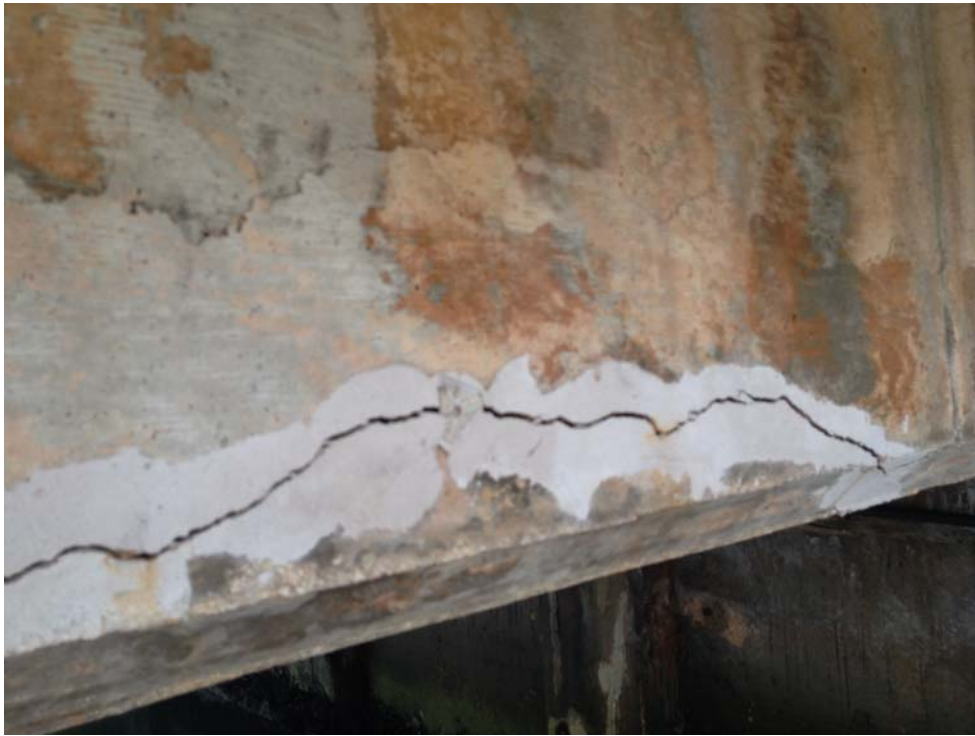
The condition of the beams of the decks is shown in Figures 19 to 31. Figures 19 to 26 show a range of cracks on the underside and lower sides of a selection of the beams. Some of the cracks appear to be at the site of previous repairs. Most of the cracks are fairly wide and it appears that it is only a matter of time before the concrete starts to spall, exposing the reinforcing steel.

**Figure 19: Beam Cracking Island Drive Structure**

It is recommended that the four structures and the bulkhead walls between the structures be replaced due to the significant deterioration detailed in this report. This represents the best value based on the life of the replacement structures.

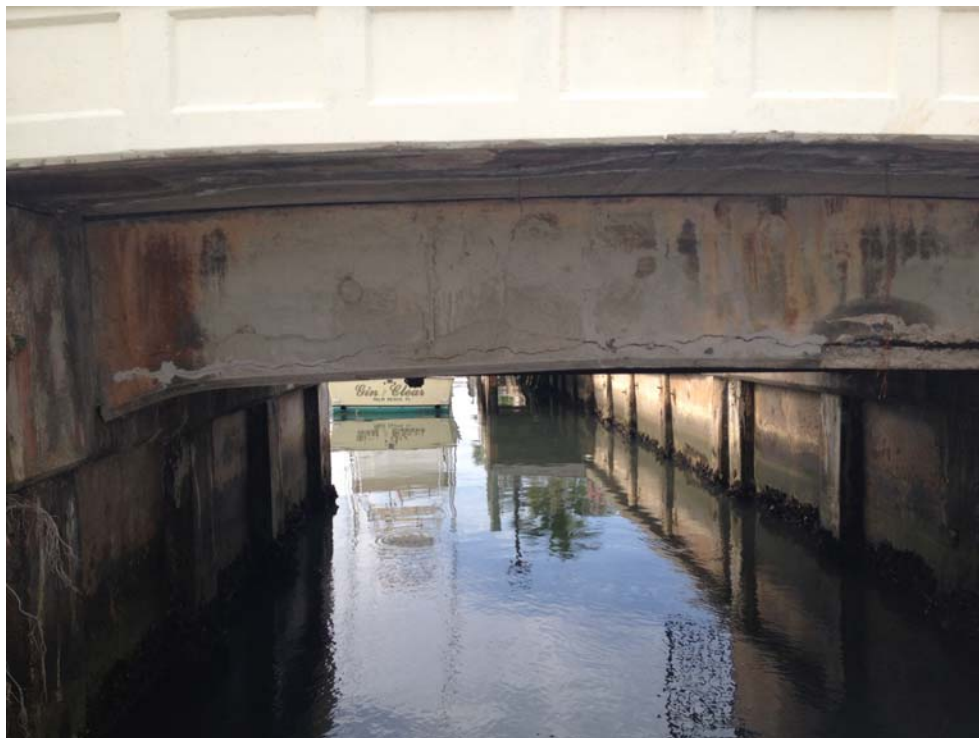
A case where a significant concrete spall has taken place is for one of the beams on the southwest structure shown in Figures 27 to 30. Figure 27 shows a large concrete spall and an exposed corroded reinforcing bar towards one end of the beam with a large crack continuing to the other end of the beam. Figure 28 and 29 show close-up views of the spall and Figure 30 shows the continuation of the cracking to the other side of the beam. It appears from the surface that the exposed reinforcing bar has already undergone significant corrosion and some loss of section. It is only a matter of time before more of the concrete spalls off, resulting in further corrosion of the underlying steel.

**Figure 27: Concrete Spall & Beam Cracking Island Drive Structure**

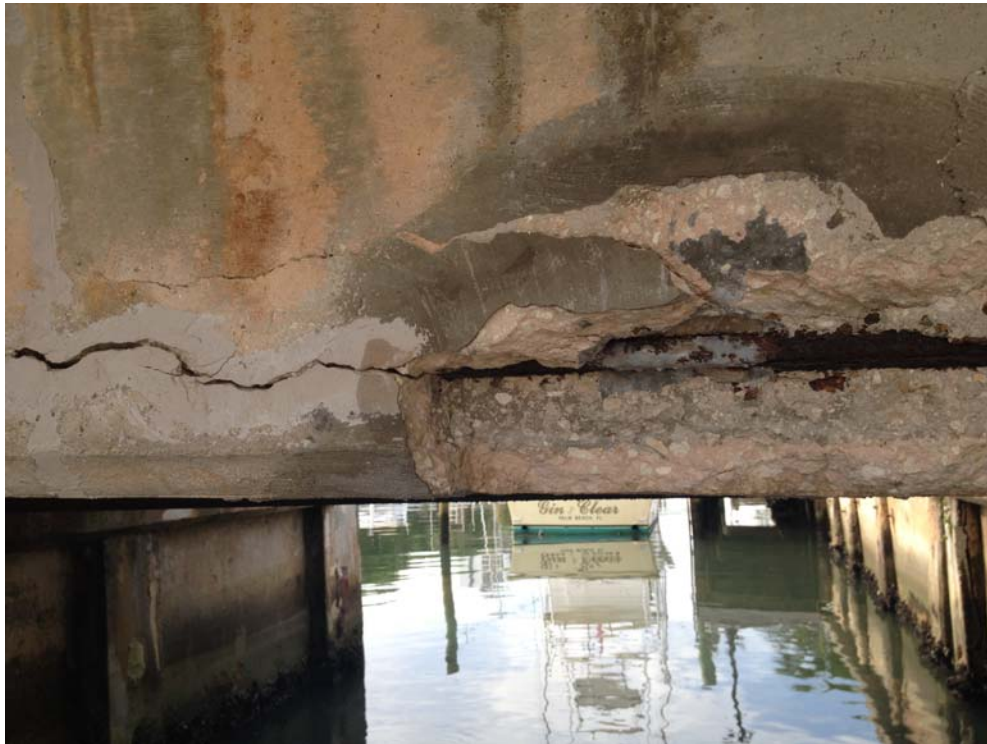
**Figure 28: Concrete Spall & Reinforcing Corrosion Island Drive Structure**

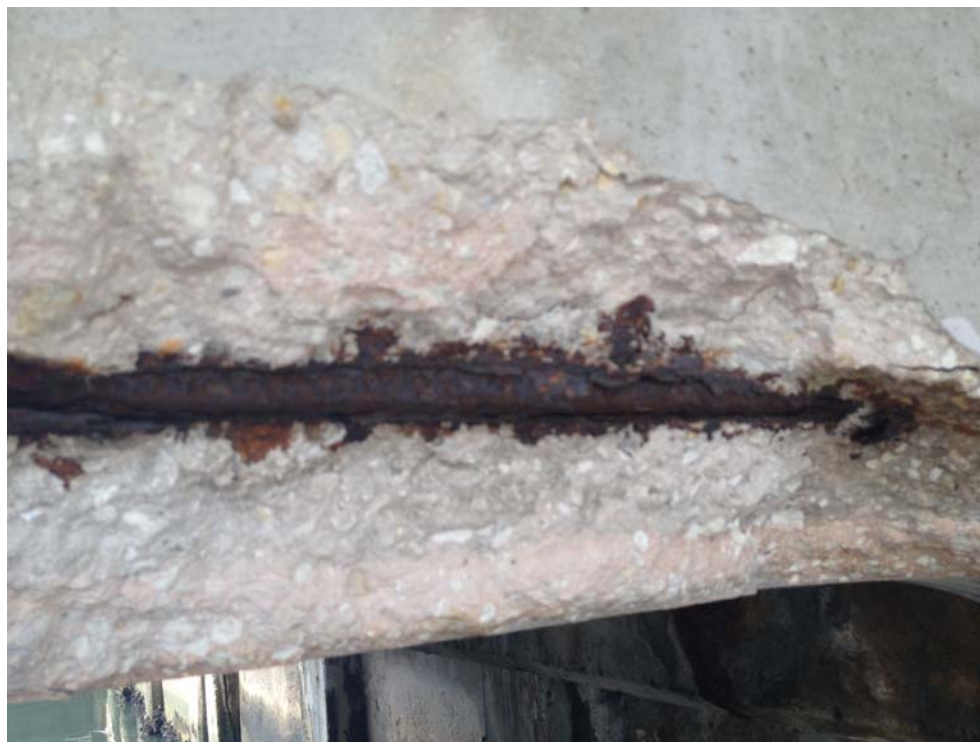
**Figure 29: Reinforcing Corrosion Island Drive Structure**

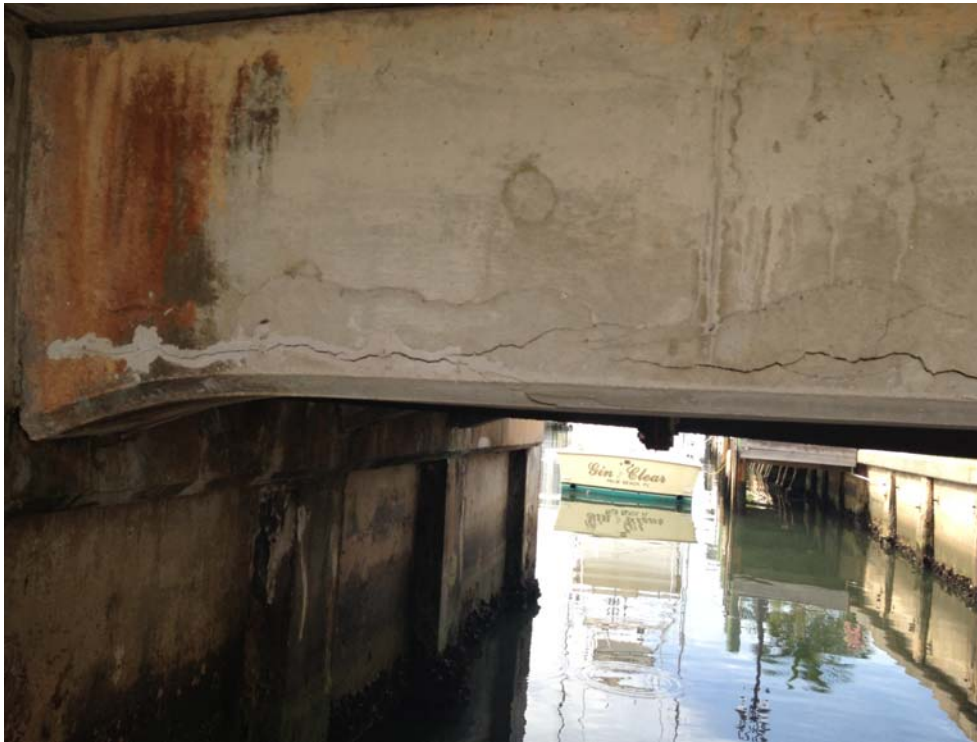
**Figure 30: Beam Cracking Island Drive Structure**

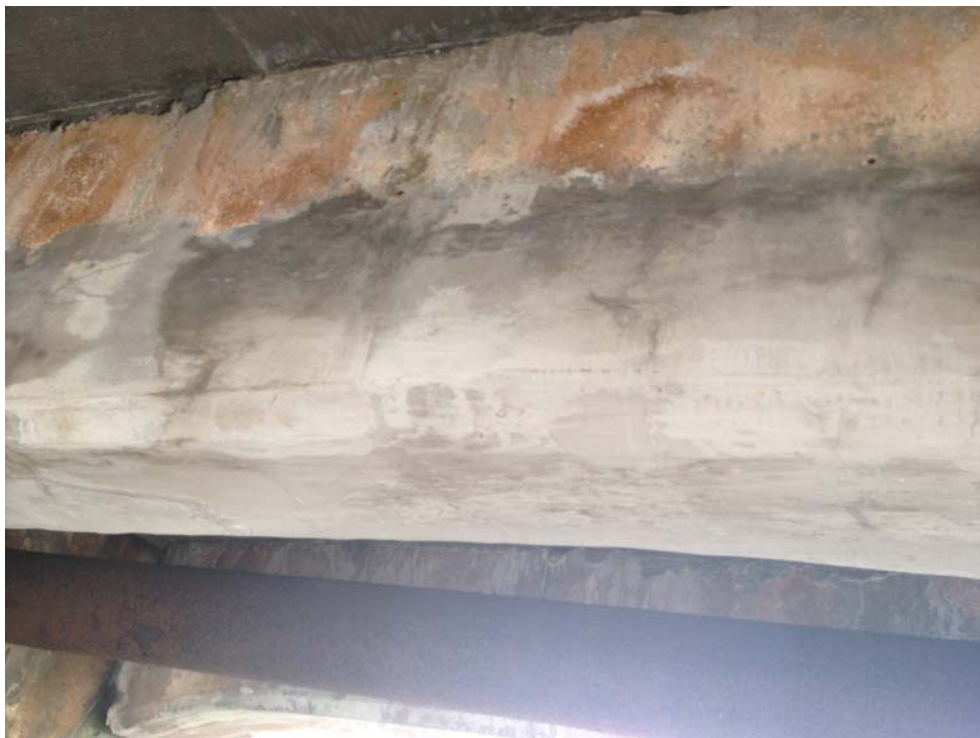
Figure 31 shows a beam that has been repaired. Even though the newer concrete is not showing signs of cracking, in many of these cases impact tests with a hammer indicate that the newer concrete is delaminated and not properly bonded to the original concrete.

**Figure 31: Beam Repair Island Drive Structure**

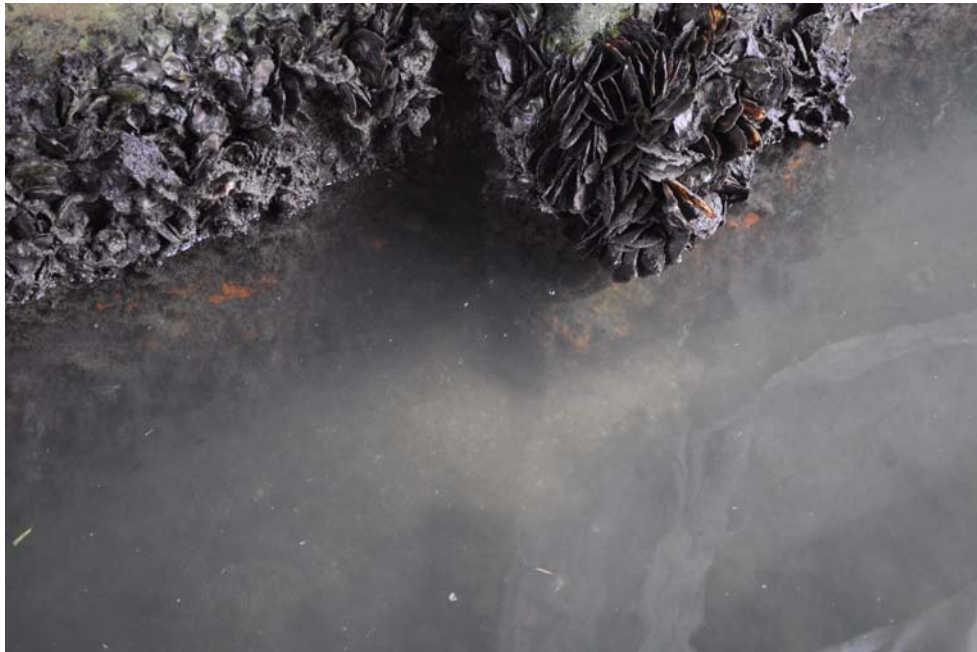
A number of the piles for the structures have a light colored sand at the bottom of the pile that is a different color to the material at the bed of the channel. This is a sign that some of the joints in the sheet panels behind the piles are leaking material from behind the panels. This shown in Figure 32, where a light tan color ring of sand can be seen around the bottom of the pile.

**Figure 32: Retained Material Leak Island Drive Structure**

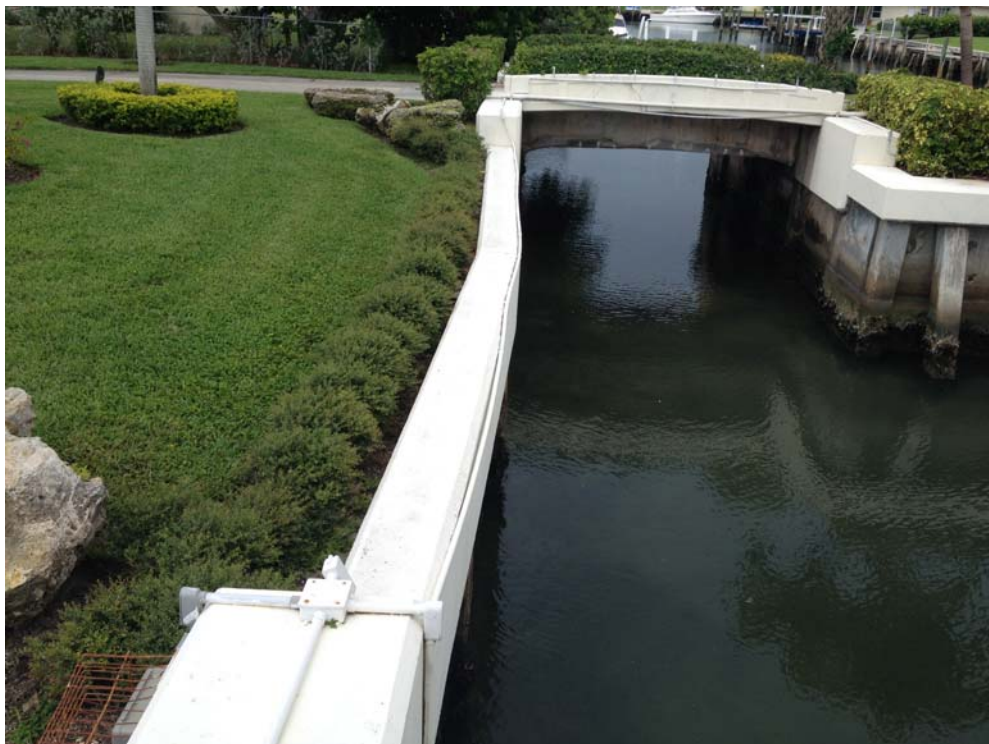
On each side of the canal the bulkhead walls between the structures have deflected significantly in the middle. This is shown in Figure 33. This deflection, which could be due to a tie-back failure or a lack of horizontal restraint, has resulted in significant cracking in the cap and the adjacent sheet panels. These cracks can be seen in Figure 34 to 36.

**Figure 33: Bulkhead Wall Deflection Island Drive Structures**

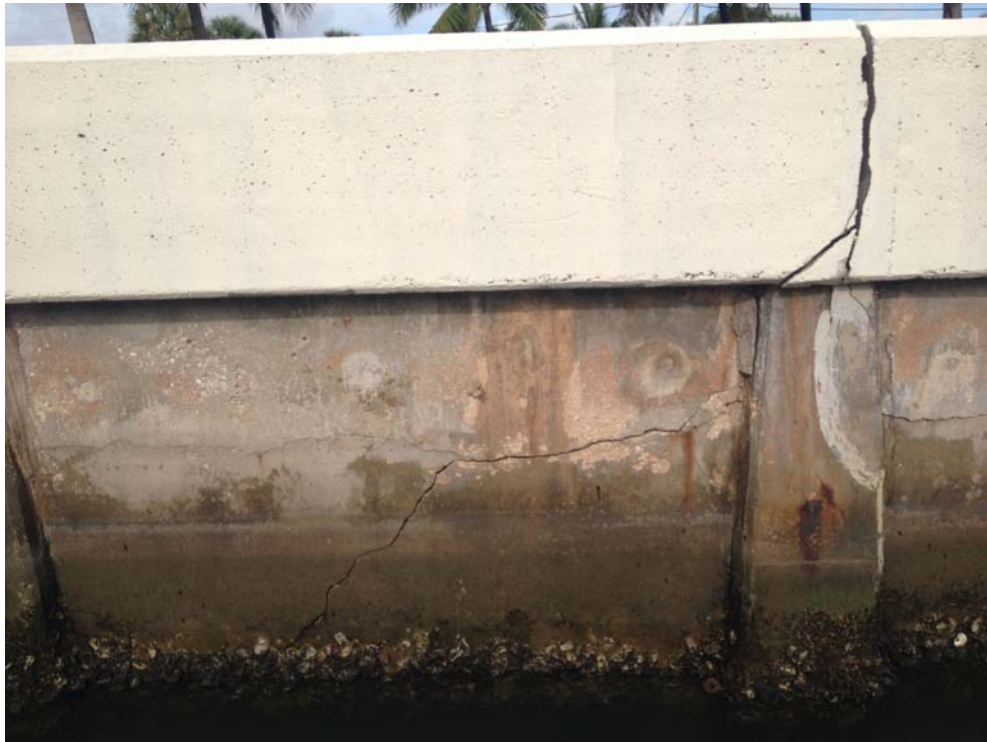
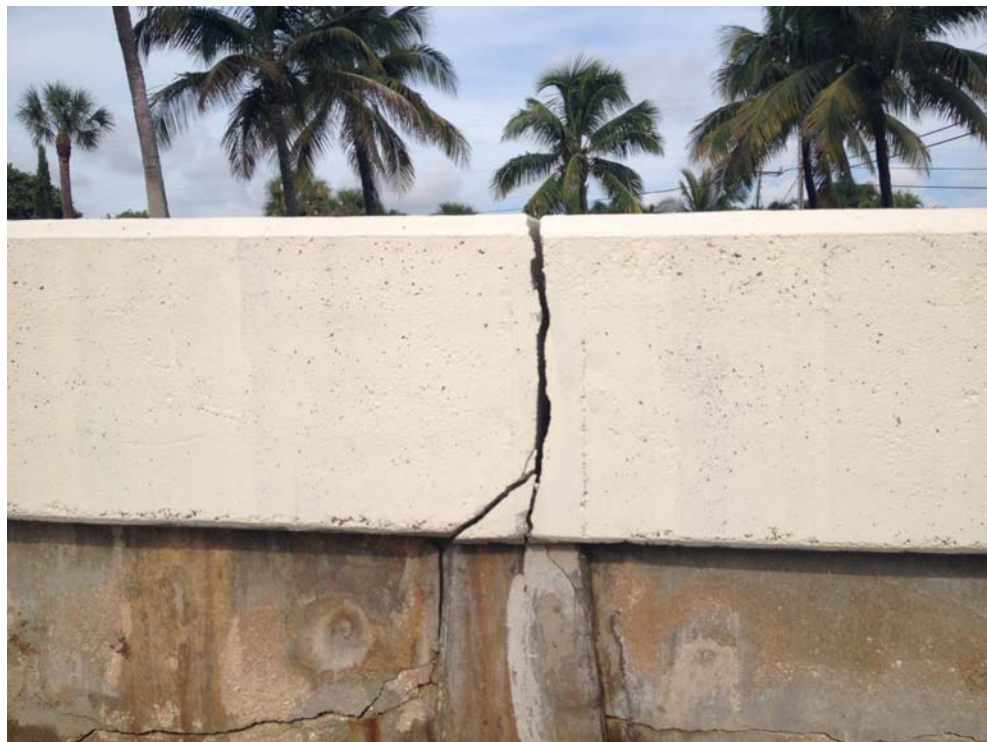
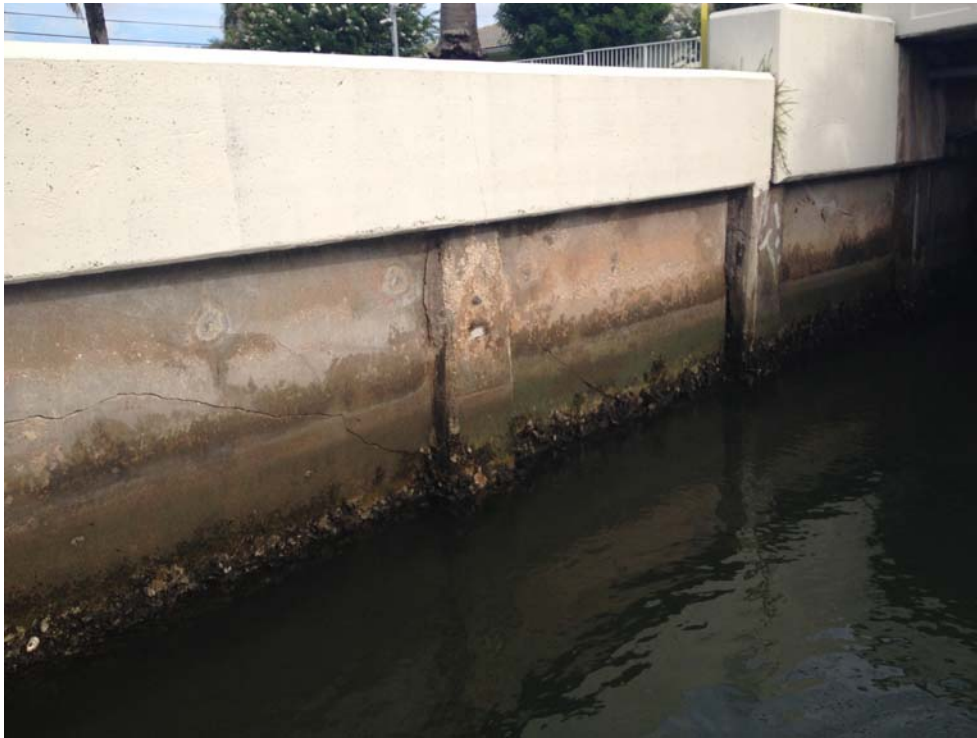
**Figure 34: Bulkhead Cap & Sheet Panel Cracking Island Drive Structures**

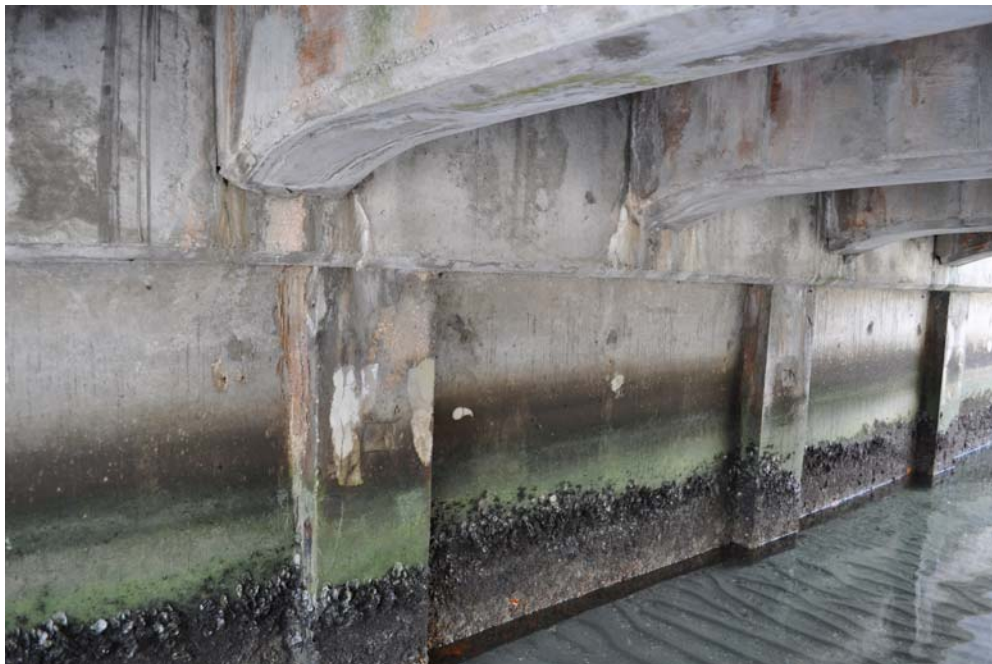
Figure 37 shows the substructure and beams of one of the two structures on Grand Bahama Lane. The substructure is in reasonable condition for the age of the structures. In addition, the beams are in reasonable condition.

**Figure 37: Substructure & Deck Beams Grand Bahama Lane Structure**

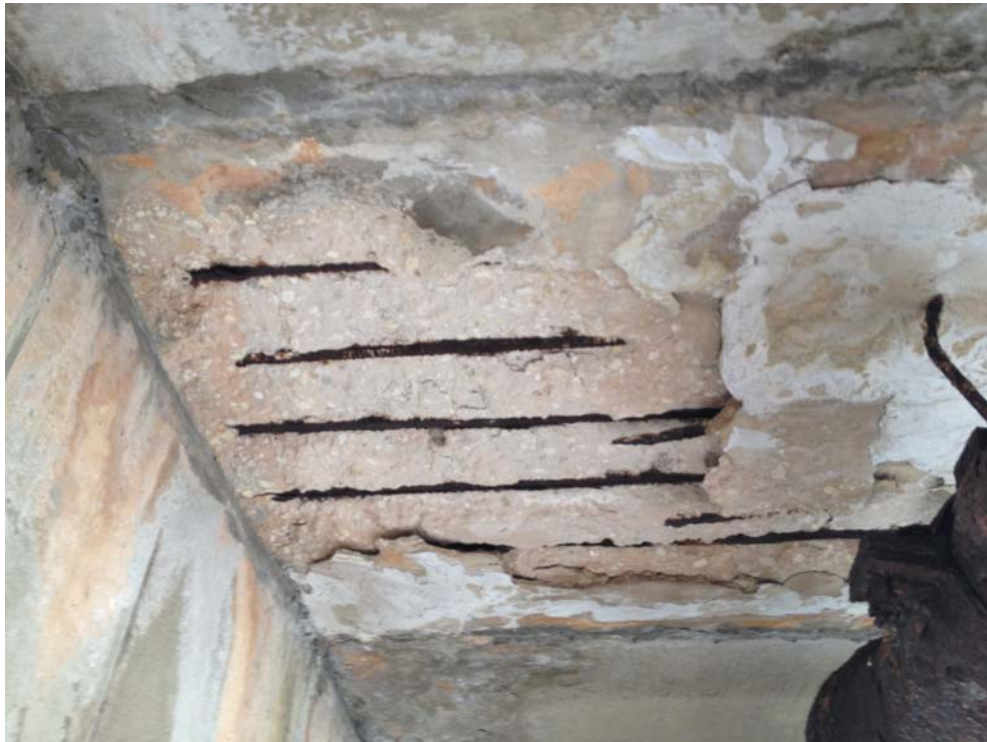
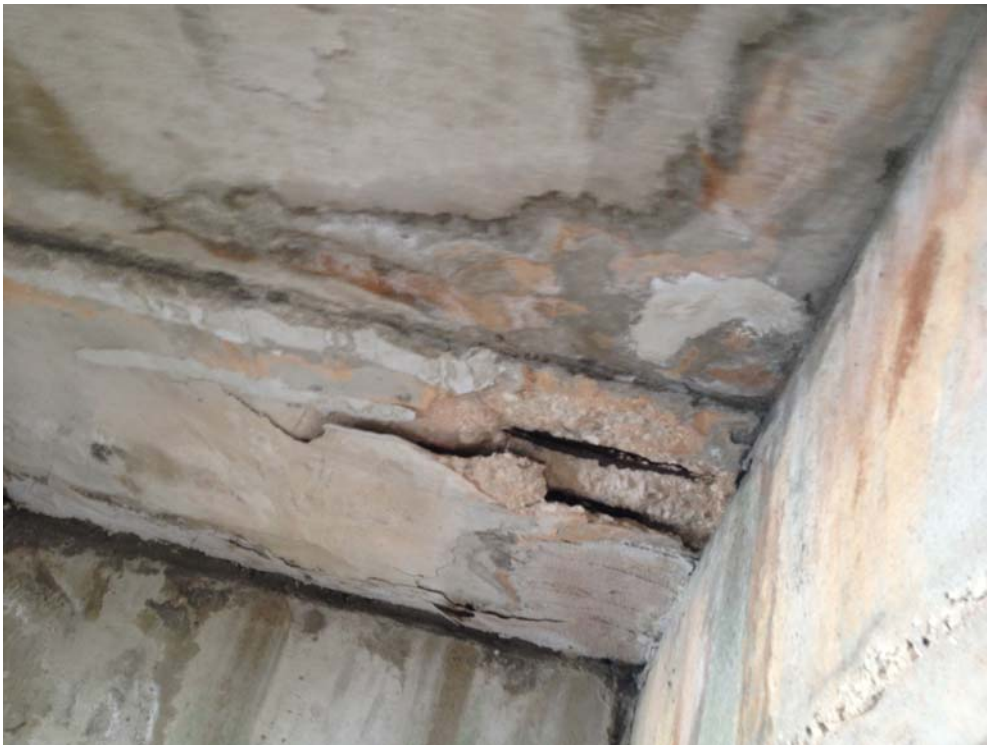
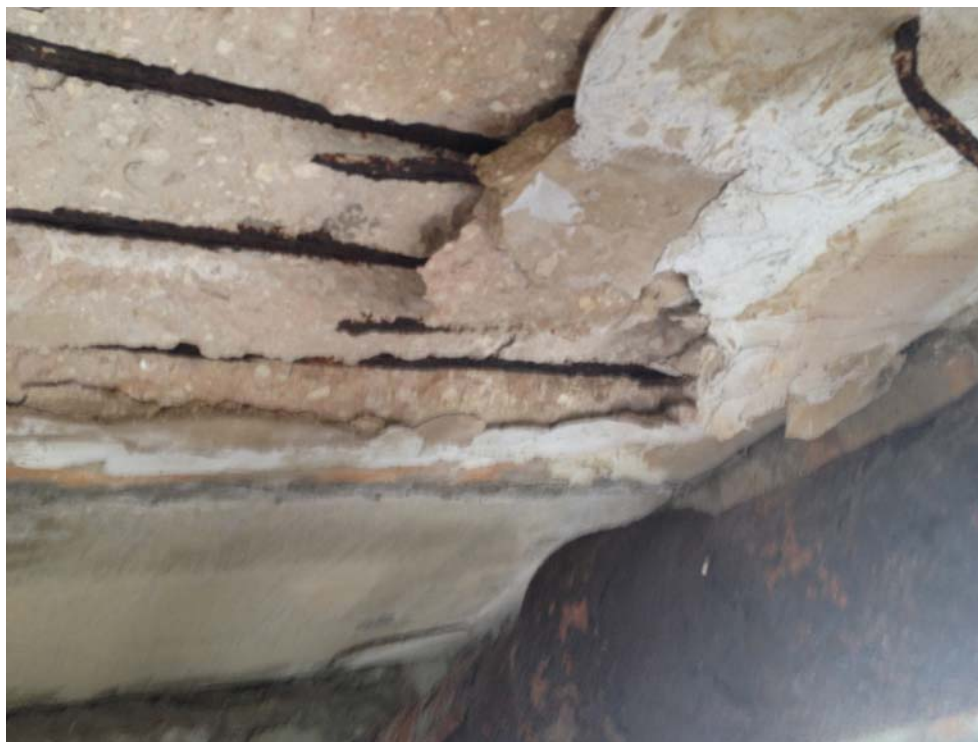
Figures 38 to 40 show the underside of the deck slab and show significant deterioration with multiple exposed reinforcing bars resulting from significant concrete spalls. The reinforcing bars are showing significant corrosion.

**Figure 38: Deck Spalling & Reinforcing Corrosion Grand Bahama Lane Structure**

It is recommended that the two structures be replaced due to the significant deterioration detailed in this report. This represents the best value based on the life of the replacement structures.
