Palm Beach Isles, Singer Island  
Canal Crossing Structures Condition Report  
2nd Draft Report: November 25, 2015

**Palm Beach Isles, Singer Island Canal Crossing Structures Condition Report  
(2<sup>nd</sup> Draft)**

Simon A. Coleman, Ph.D., P.E.  
FL License No. 68929  
Alan Gerwig & Associates, Inc.  
12798, W Forest Hill Boulevard, Suite 201  
Wellington, FL 33414  
CA # 7969

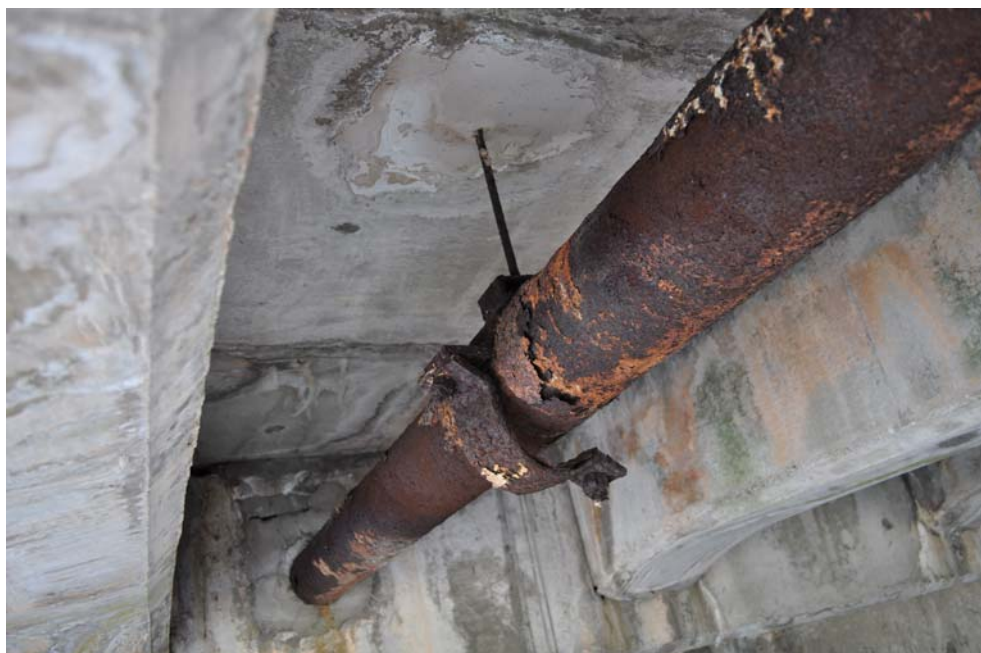
Figure 41 shows the water main suspended from the bottom of the deck of the structures. From Figure 41 it can be seen that the pipe support has corroded and is no longer supporting the pipe.

**Figure 41: Pipe & Pipe Support Corrosion Grand Bahama Lane Structure**

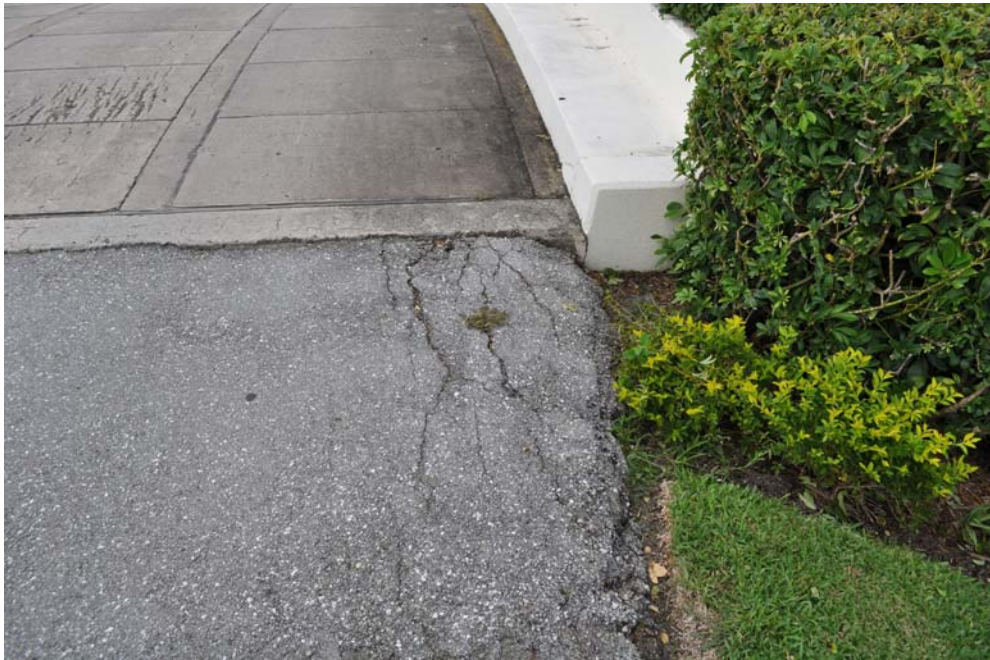
Figure 42 shows the corner of the east structure on Grand Bahama Lane. The asphalt cracking is a sign of settlement due to loss of subgrade materials through the joints between the sheet panels under the deck. In addition, the asphalt at this location appeared to be very thick indicating that additional asphalt had been placed on numerous occasions due to the loss of material.

**Figure 42: Asphalt Settlement Grand Bahama Lane Structure**
