PLUMBING AND FIRE PROTECTION

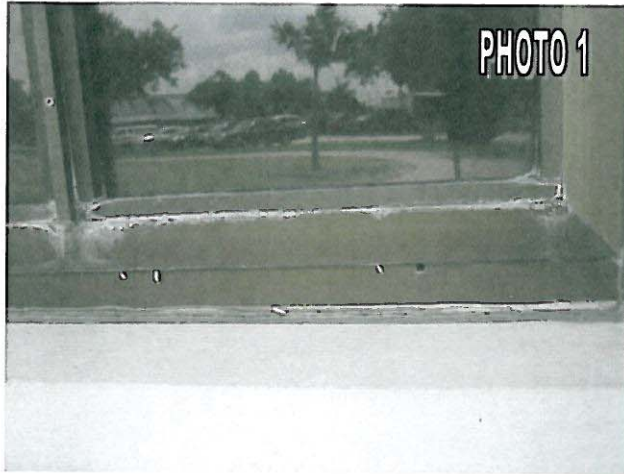
City Hall Exterior - Water stains and corrosion on window sill.

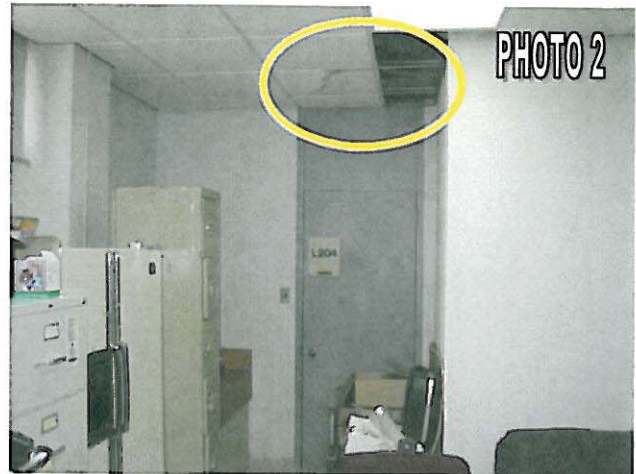
Library Staff Lounge - Stains on ceiling tiles and missing tiles.

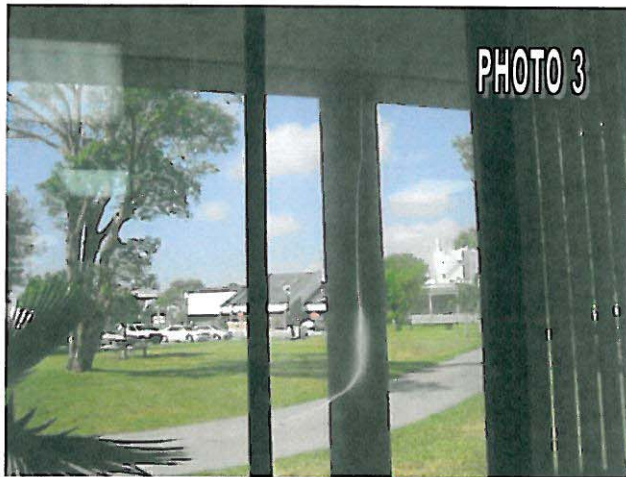
City Hall Room C115 - Crack in exterior window pane.

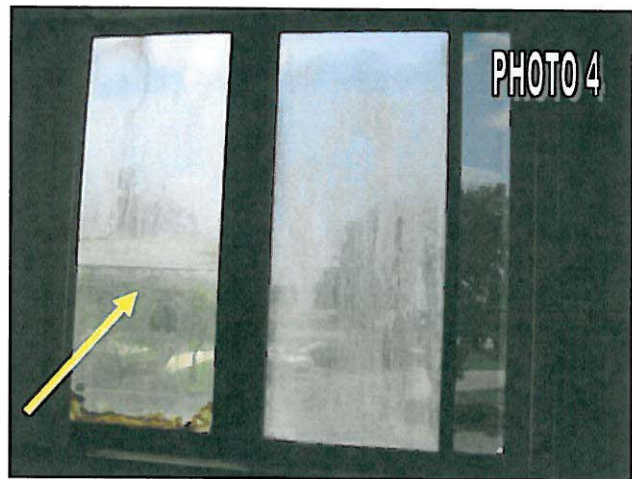
City Hall Room A31 - Crack in window and water trapped between panes of glass.

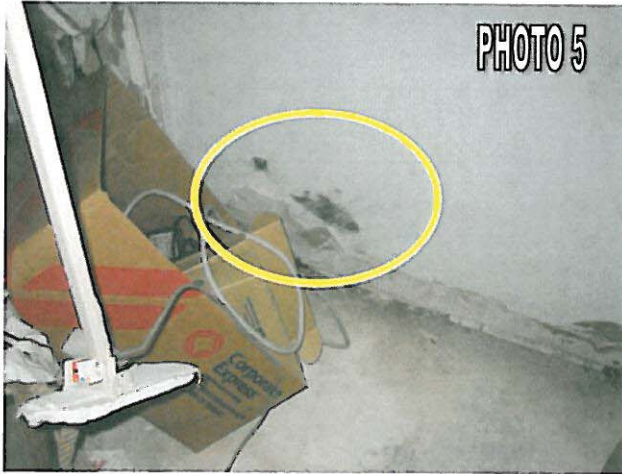
Police Department Room P244 – Suspect visible mold (SVM) on drywall in southeast corner.

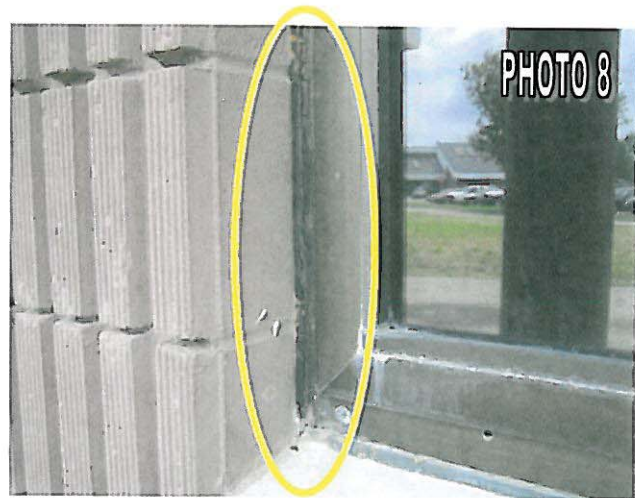
City Hall Exterior – Crack in caulk around window.
