LEAD TESTING CONSULTANTS

October 16, 2018

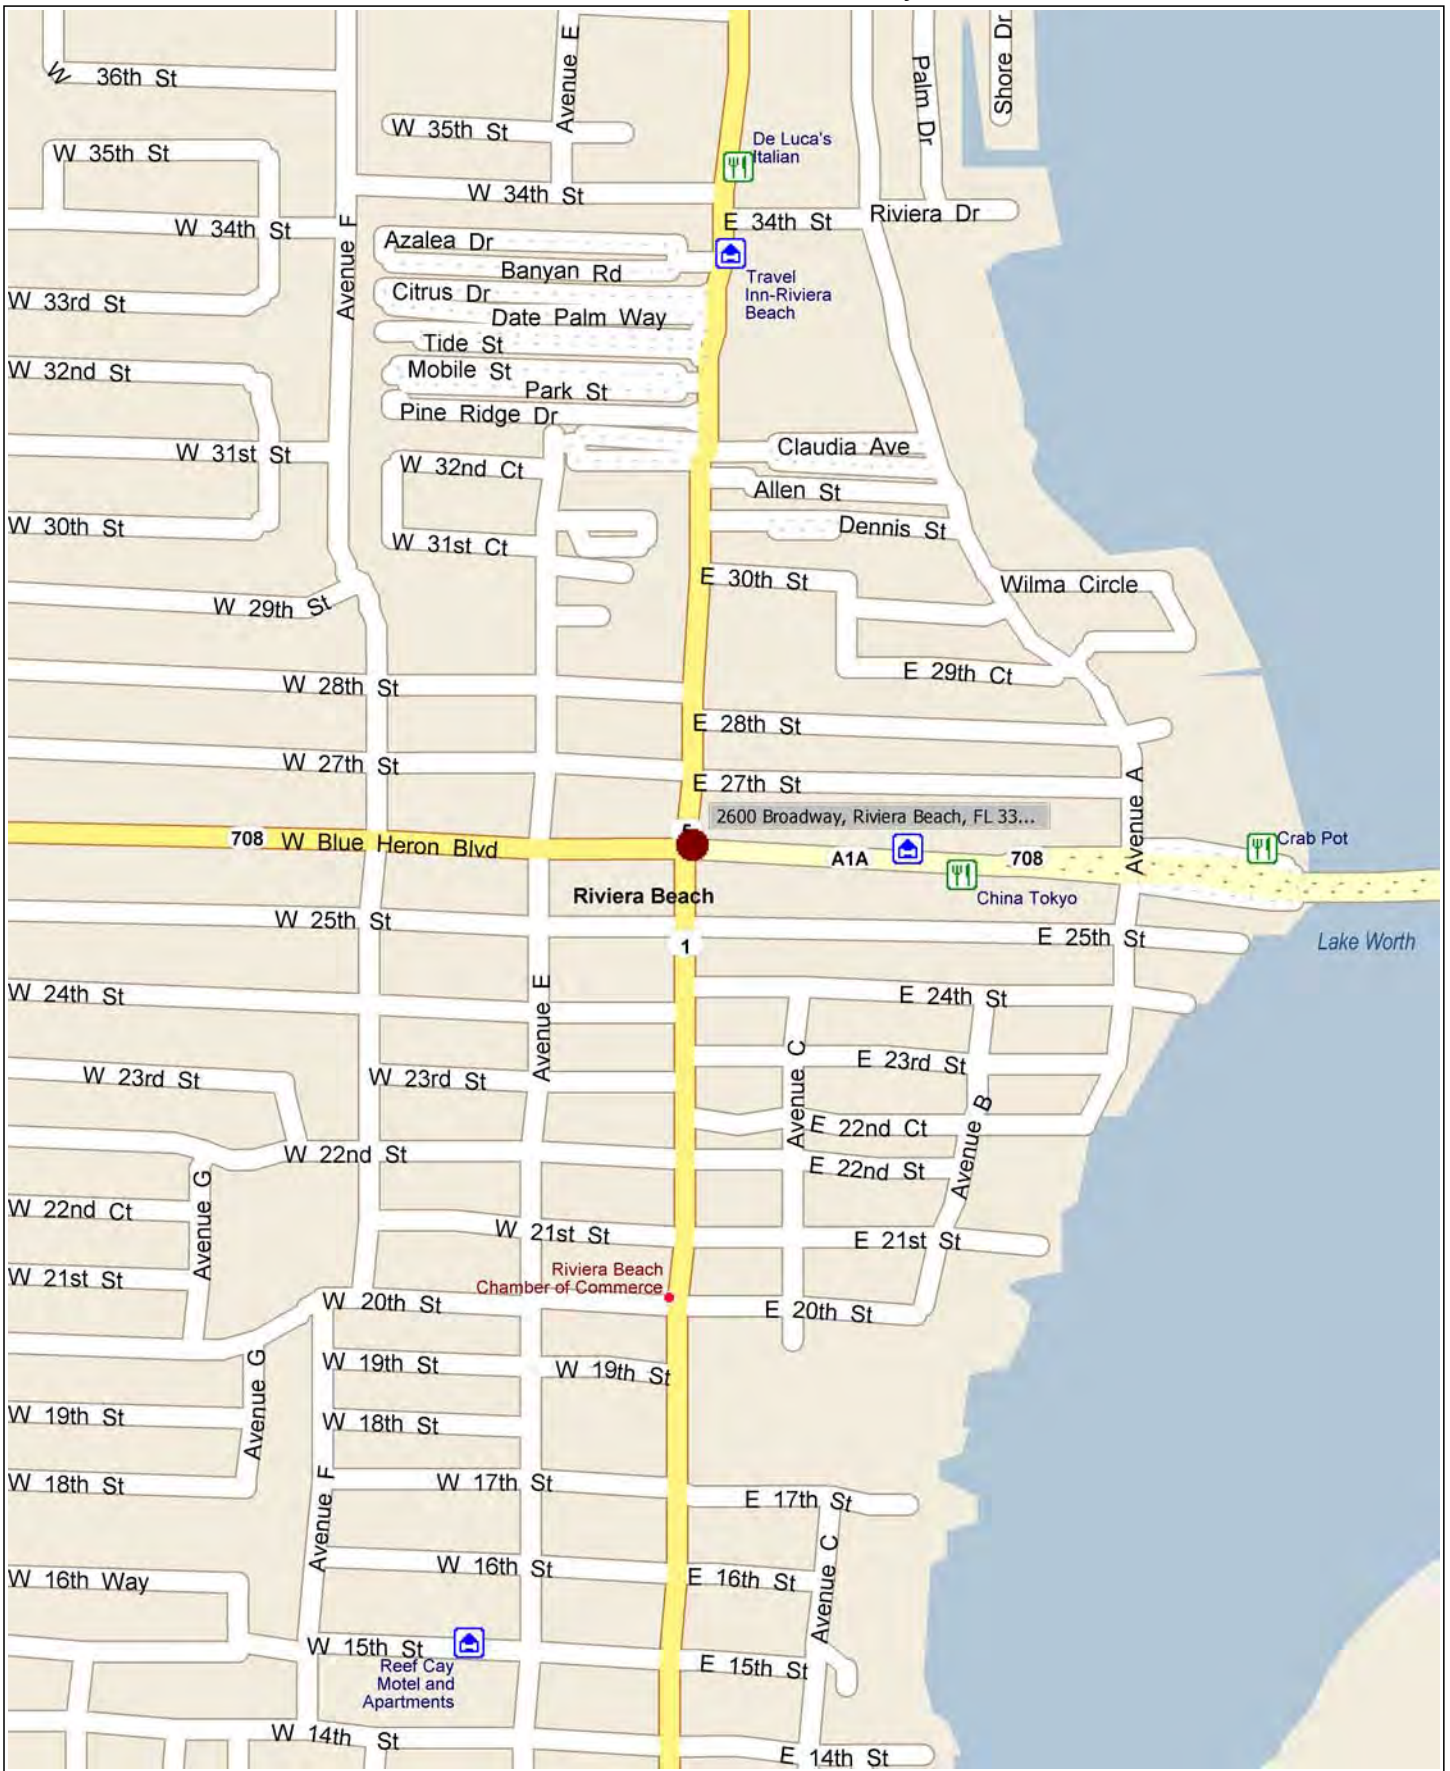
Blue Heron & Broadway

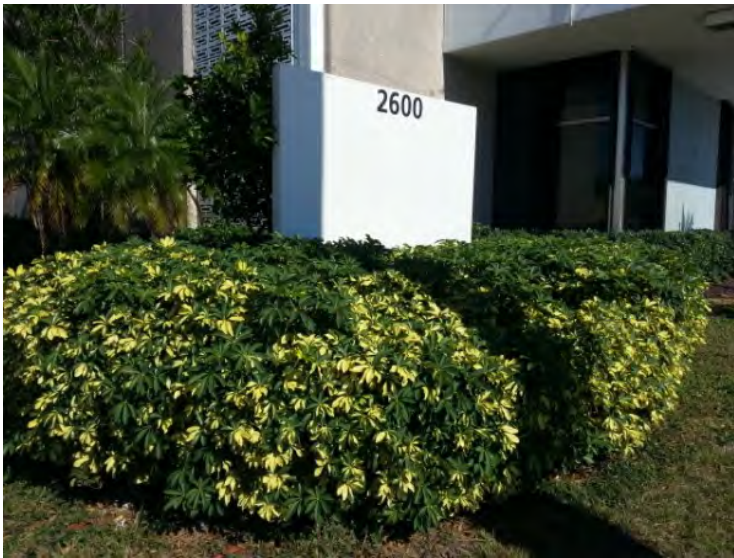
1. View of the monument signage noted at the southwest corner of the site.

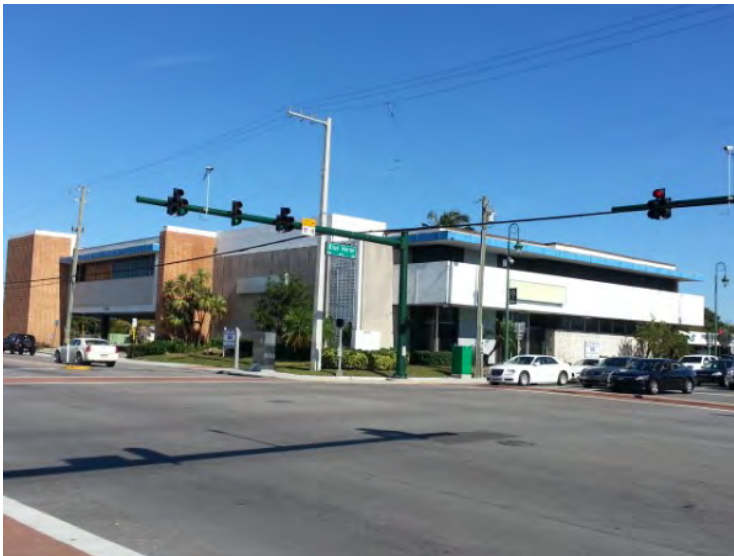
2. View looking northeast at the building from the intersection of Broadway and Blue Heron Boulevard.

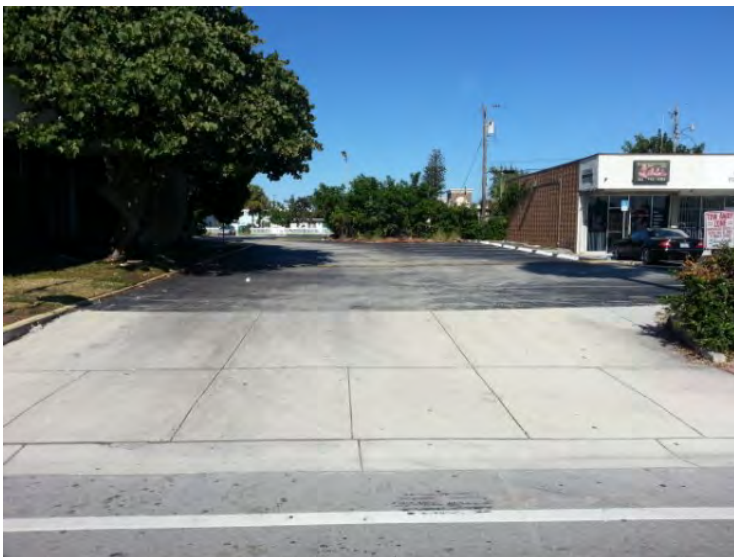
- 6. View looking north at the southern portion of the driveway and parking lot noting the condition of the concrete apron at the access apron on Blue Heron Boulevard.

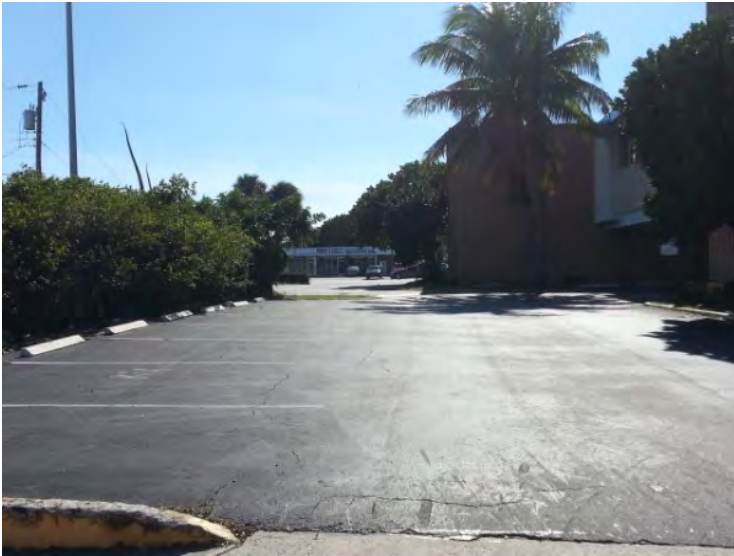
- 7. View looking south at the southern portion of the driveway and parking lot.

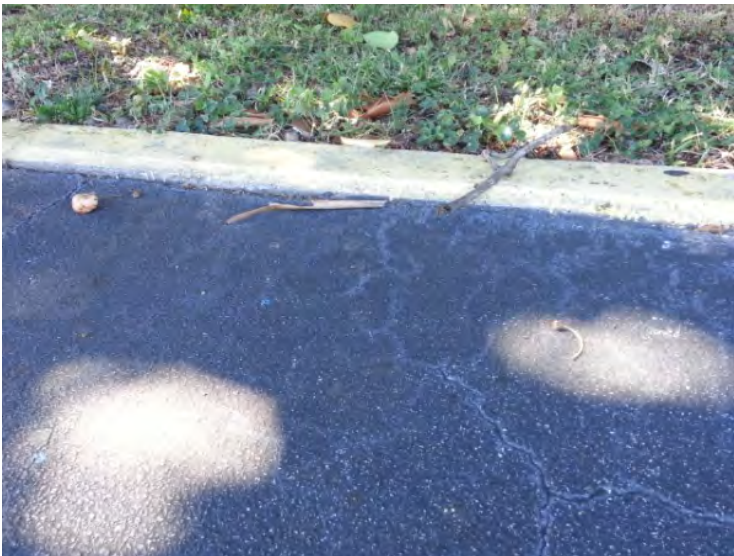
- 8. View of typical diminished height of the concrete curb noted at the edges of the paved areas. Note the condition of the pavement.

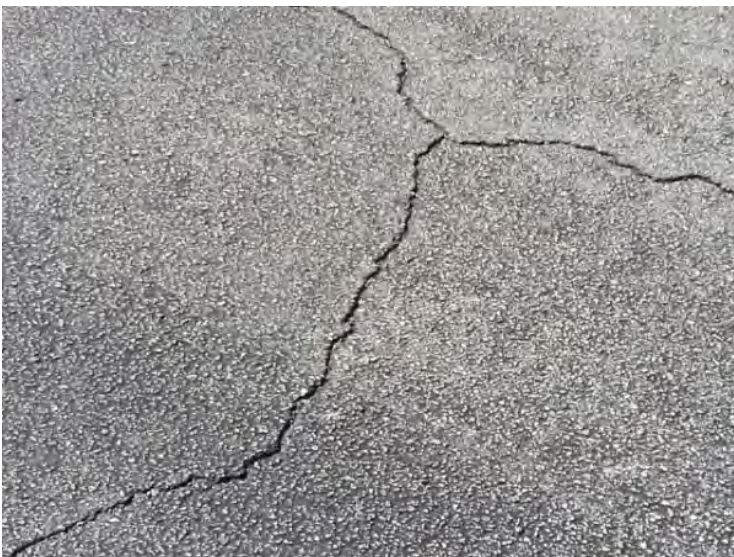
- 9. View of typical cracking and exposed aggregate noted at the parking areas.

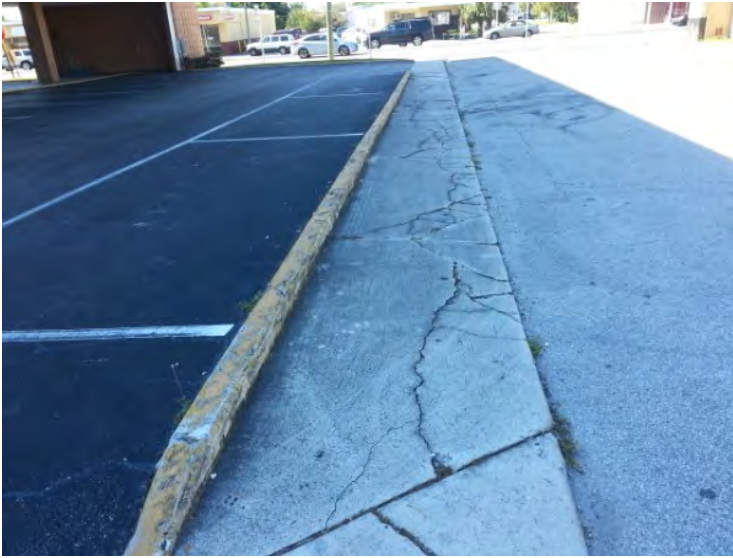
10. View looking west at the north side of the site noting the damaged concrete sidewalk and parallel parking spaces.

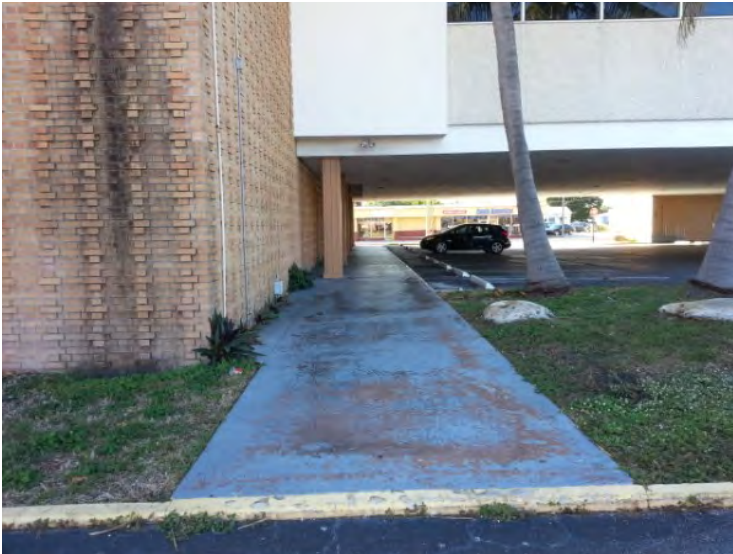
11. View of the sidewalk provided along the north side of the building noting peeling coating.

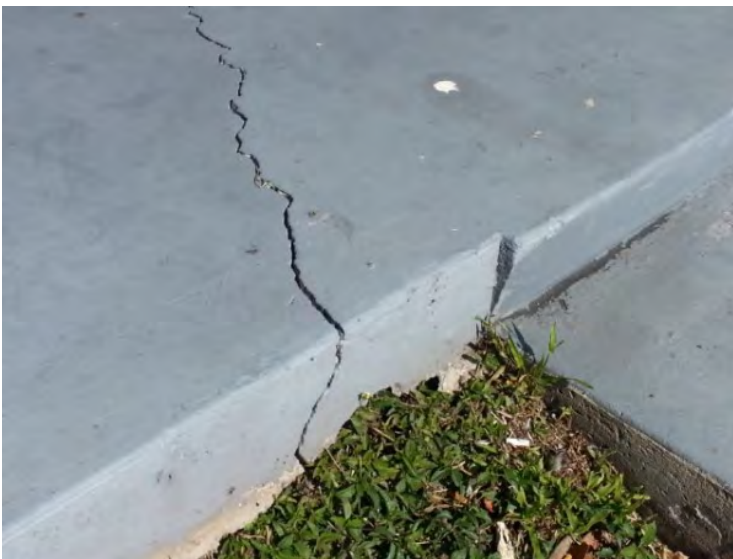
12. View of cracked concrete stoop noted at the south entrance to the building.

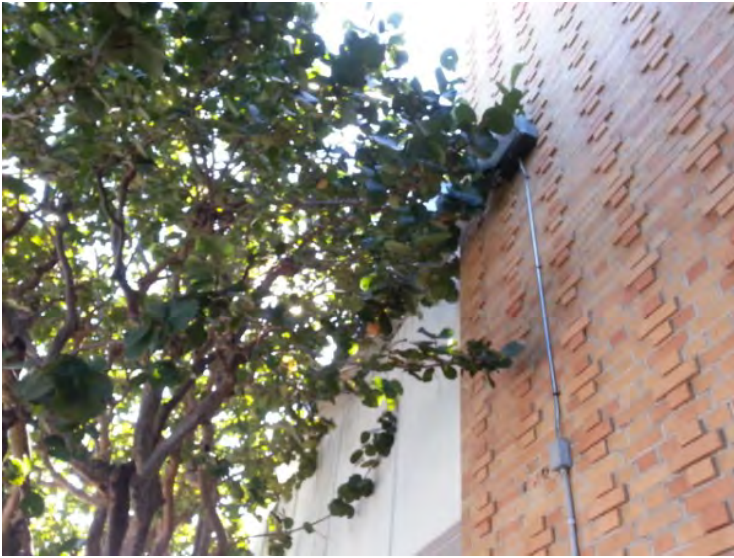
13. View of tree contact with the building noted on the east side.

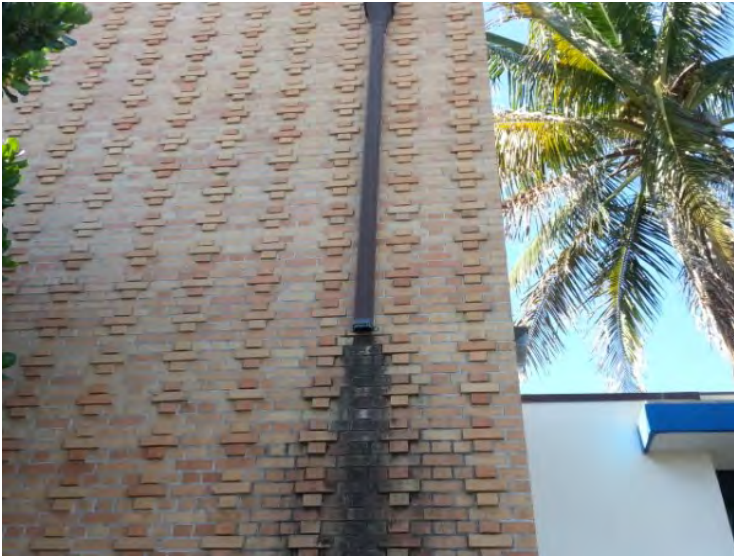
14. View of missing downspout noted on the east side of the building.

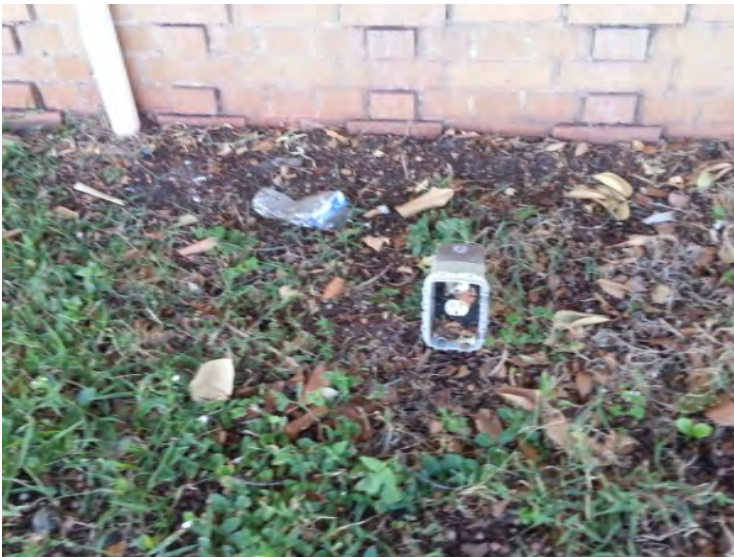
15. View of missing cover noted on an electric power receptacle at the east side of the building.

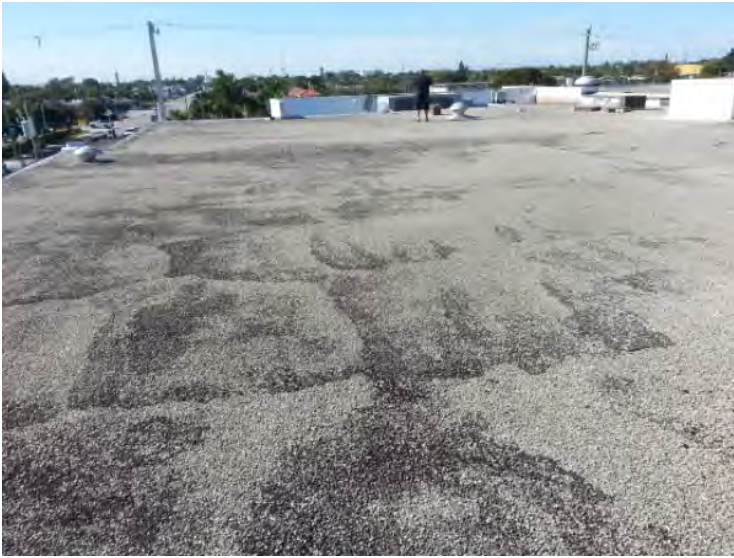
16. View looking west at the south roof of the building noting the condition.

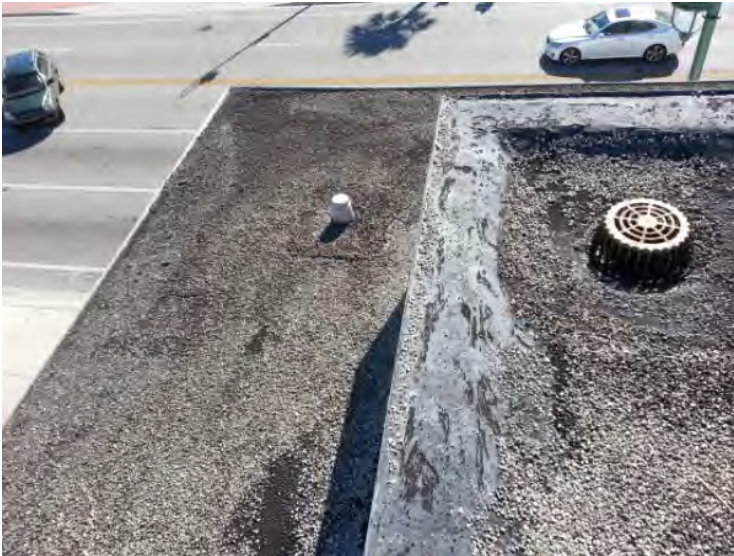
17. View at the southeast corner of the south roof noting the lower roof over the balcony and the interior drain on the main roof level.

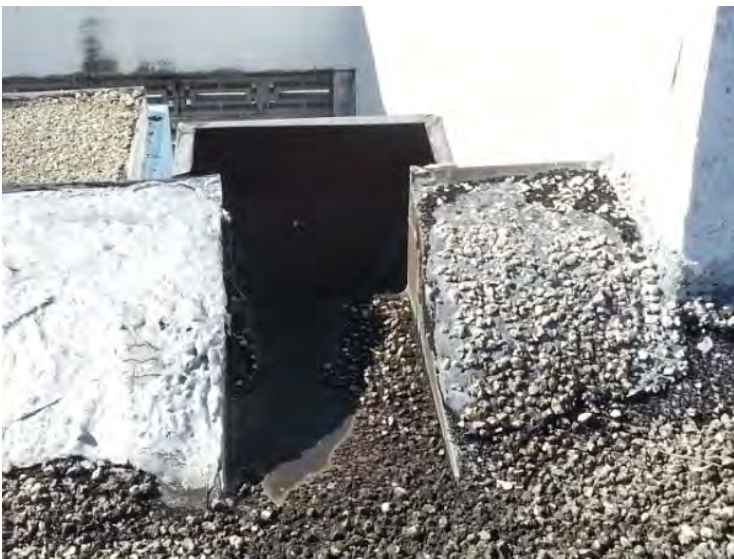
18. View of a roof drainage scupper noted at the west side of the south roof.

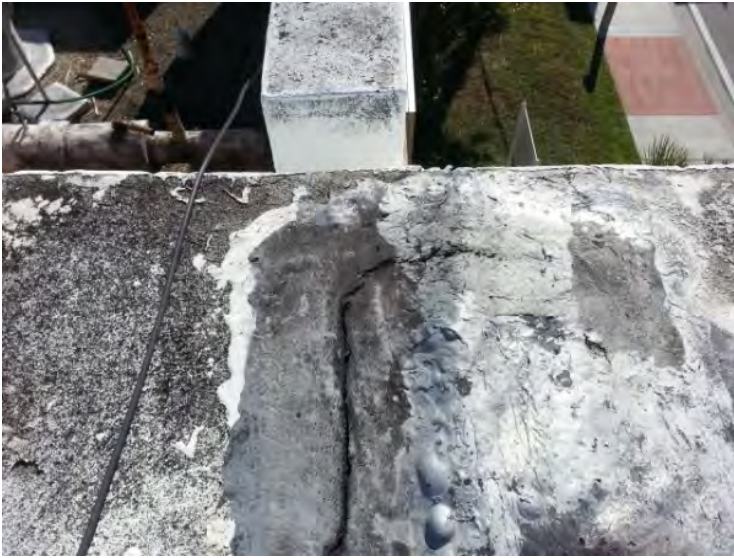
19. View of an open crack noted on the roof coping near the south packaged chiller area.

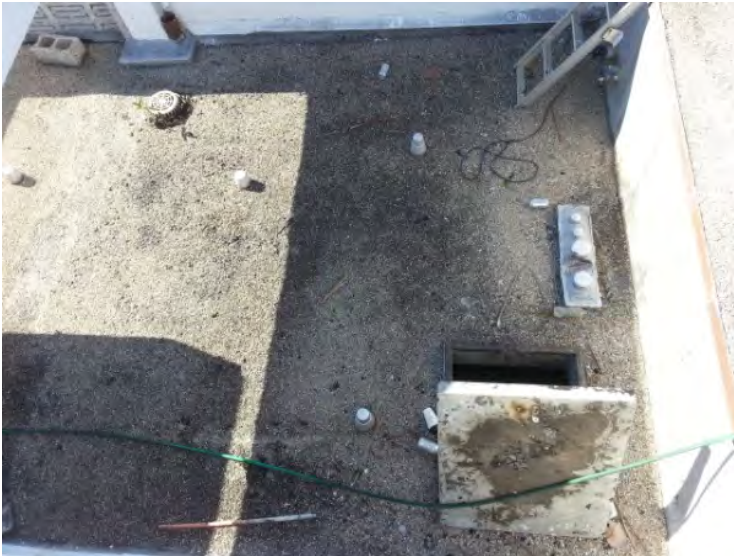
20. View of the roof access located over the lower roof of the mechanical room. Note the corrosion on the roof hatch.

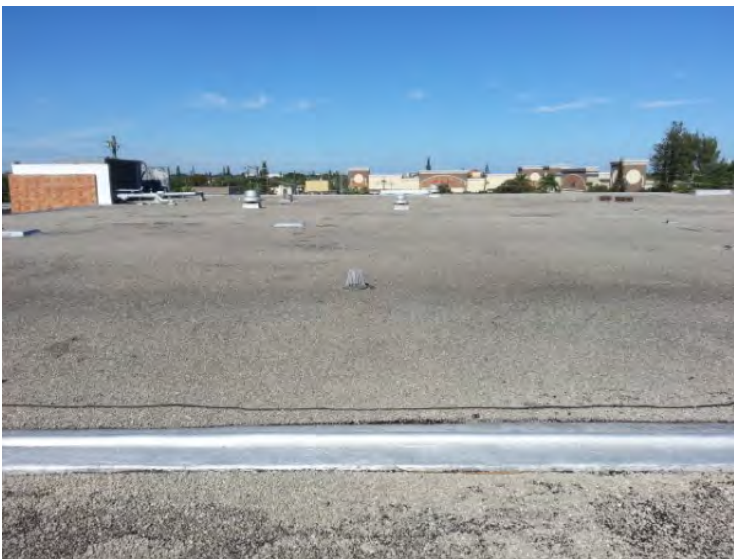
21. View looking north at the north roof area noting the membrane flashing over the expansion in the foreground.

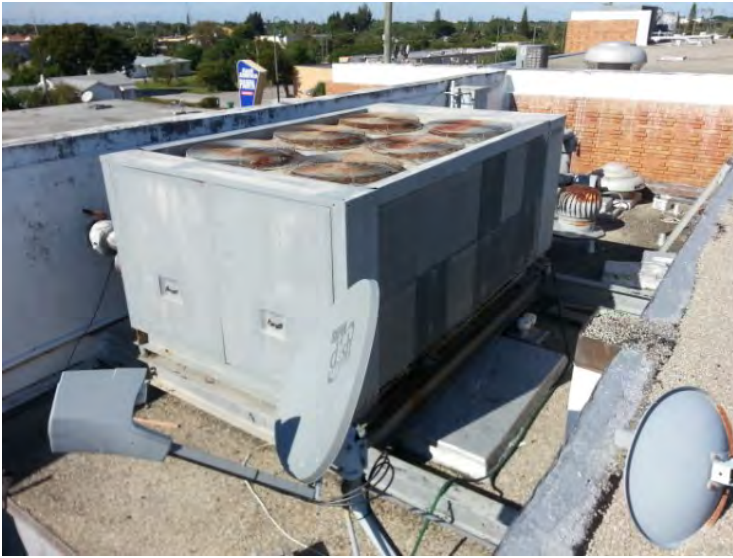
22. View of the packaged chiller unit noted on the lower roof area over the mechanical room.

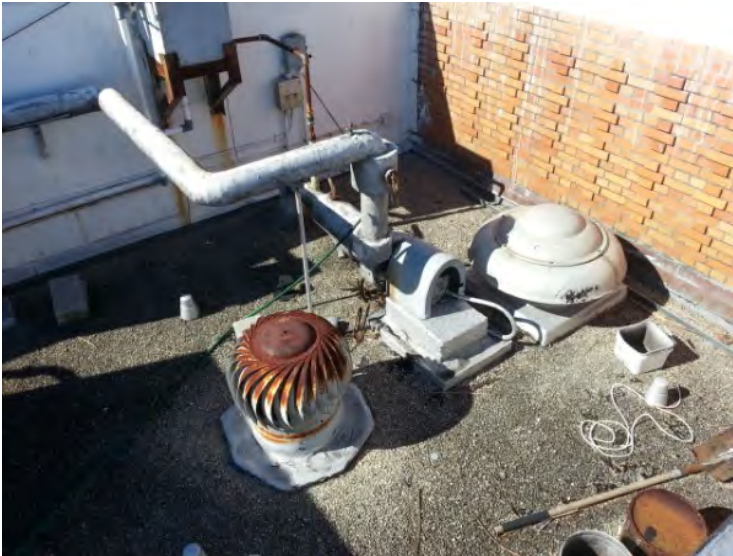
23. View of corroding exhaust fans and mechanical room turbine vent noted on the roof of the mechanical room in the west portion of the building.

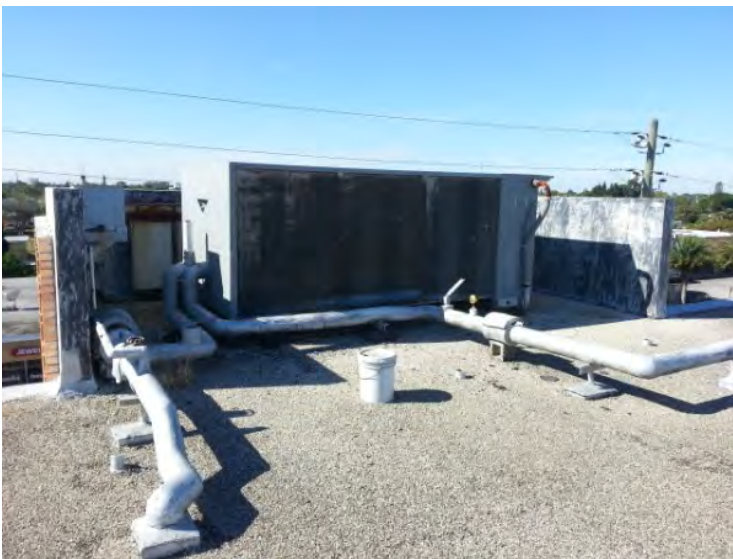
24. View of the 2nd packaged chiller unit noted in the west portion of the north roof.

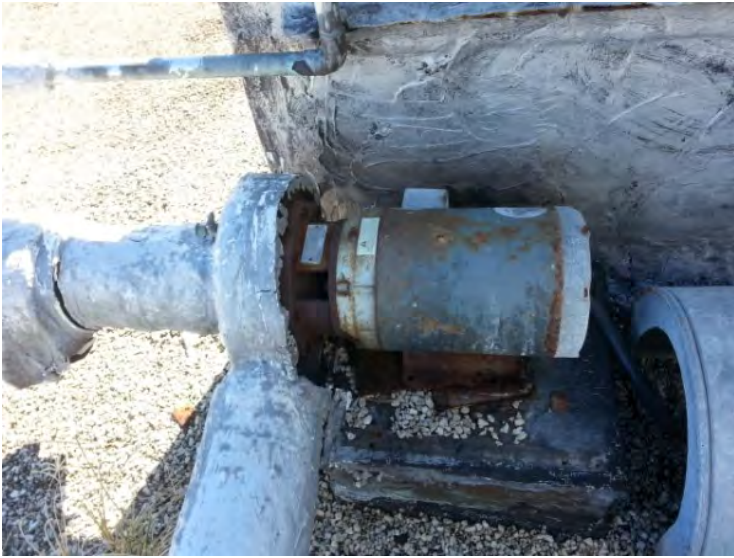
25. View of the chilled water pump noted near the 2nd chiller unit.

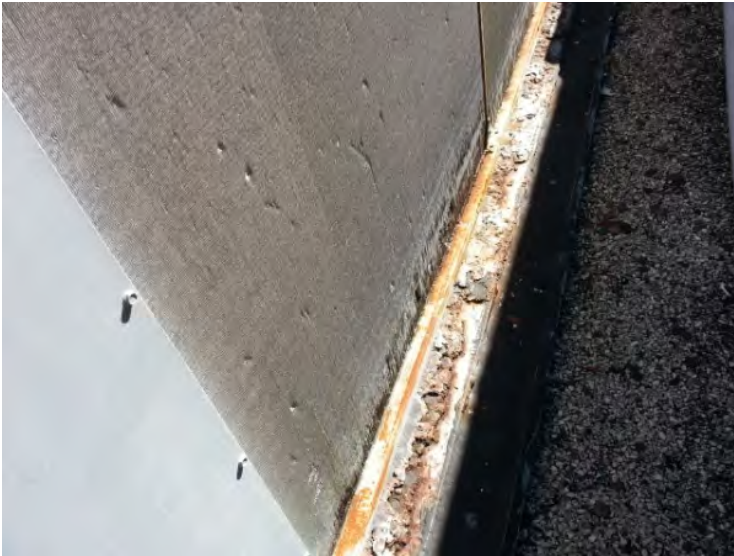
26. View of corroding metal noted on the skid level of the packaged chiller unit.

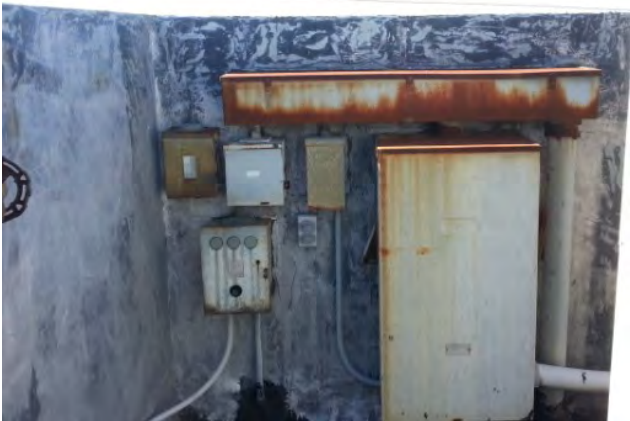
27. View of corroding metal surfaces noted on the electrical equipment near the north packaged chiller unit.

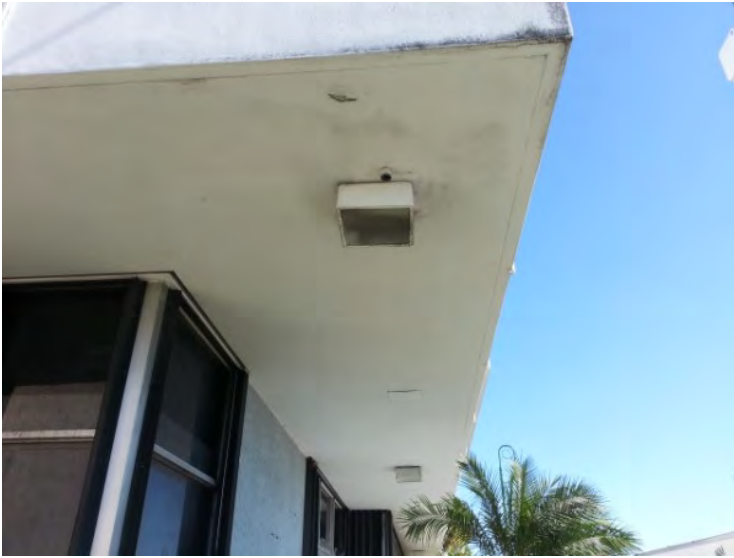
28. View of the 2nd floor balcony overhang at the south side of the building noting typical soffit-mounted lighting fixture.

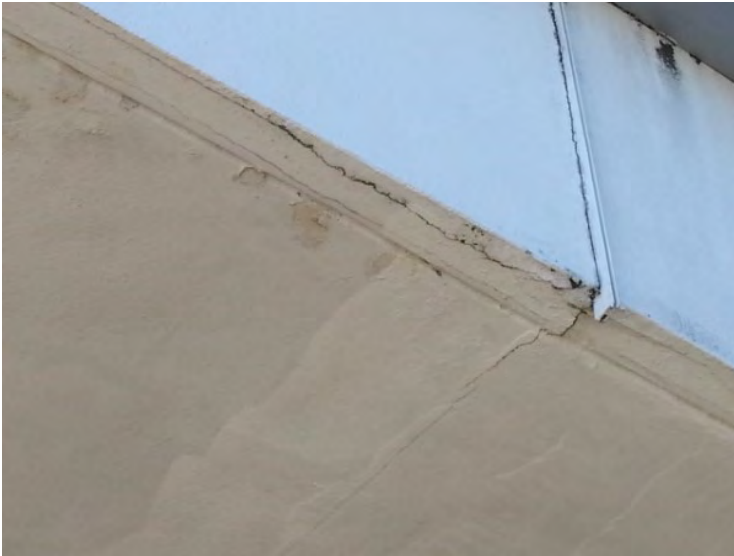
29. View of cracked concrete soffit noted at the east side balcony.

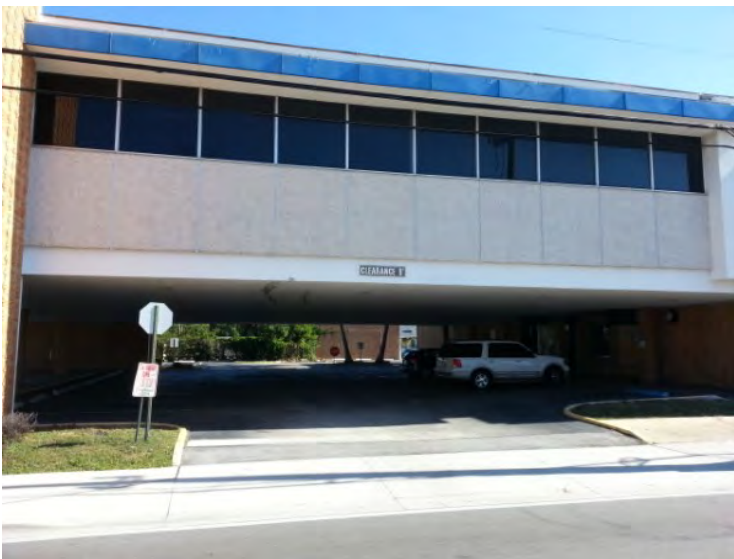
30. View of the access drive to the carport parking spaces below the north portion of the building from the west side of the site. Peeling paint on the blue fascia band was noted.

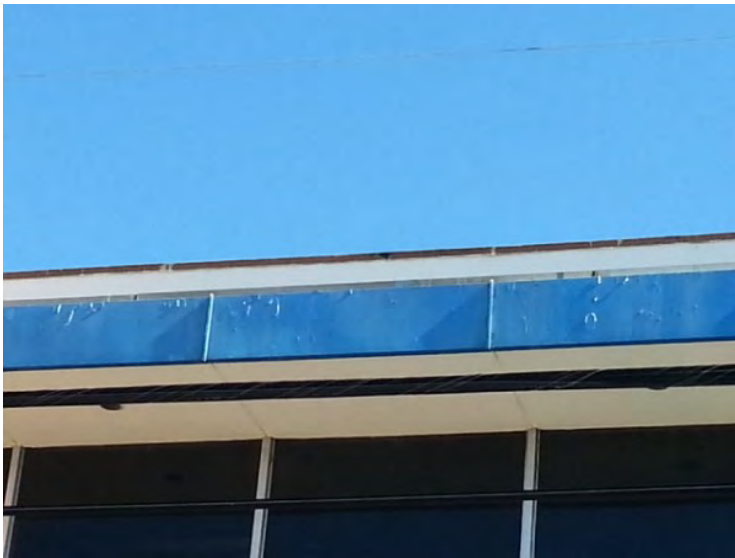
31. View of peeling paint noted on the metal fascia on the west side of the building. Similar conditions were noted elsewhere.

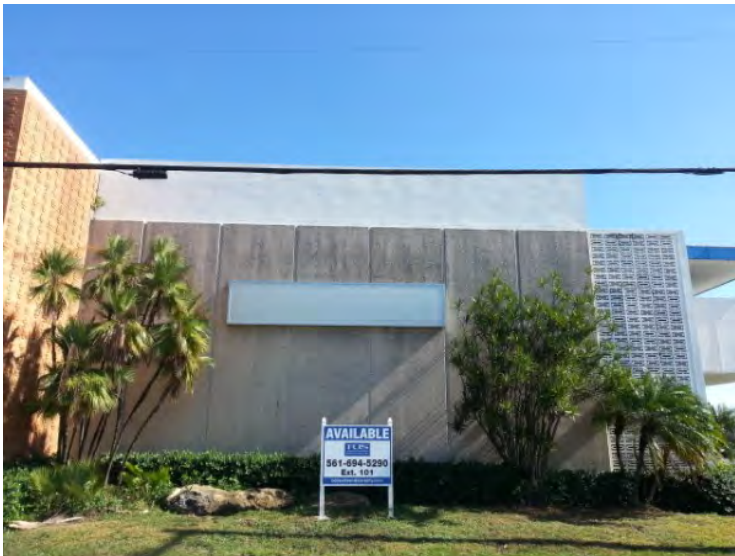
32. View of illuminated signage noted on the west side of the building.

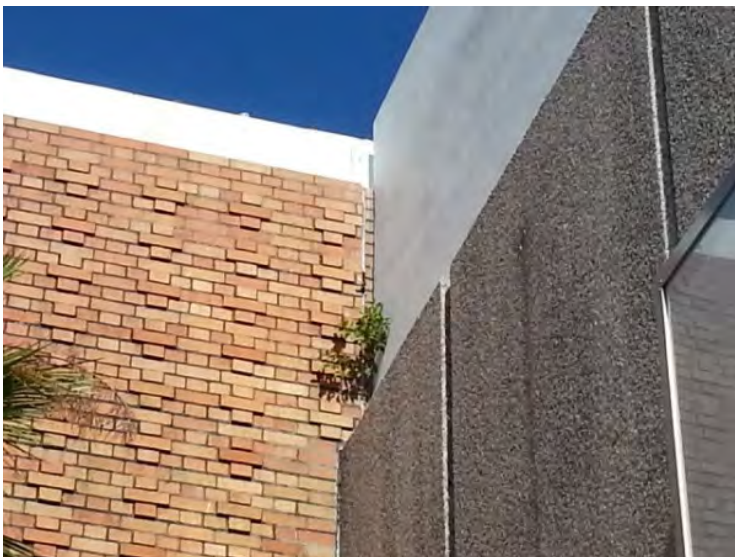
33. View of vegetation growth noted on the west side of the building.

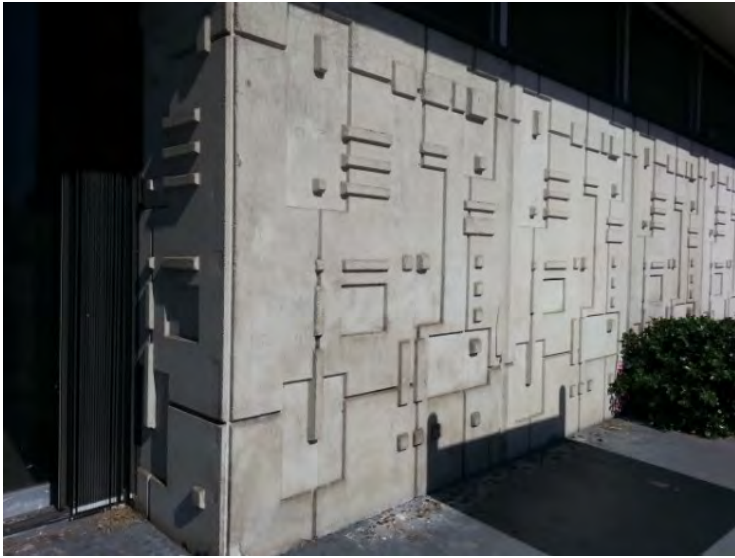
34. View of patterned precast concrete wall noted on the south side of the building.

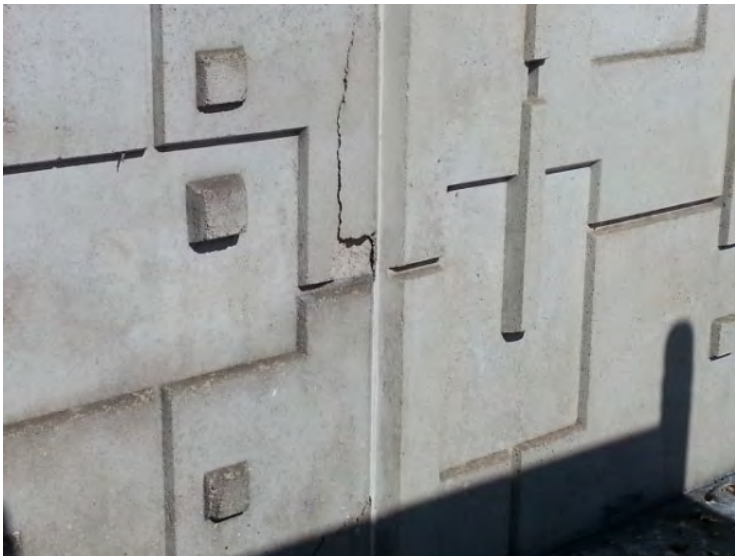
35. View of cracking noted on the patterned precast concrete wall at the south side of the building.

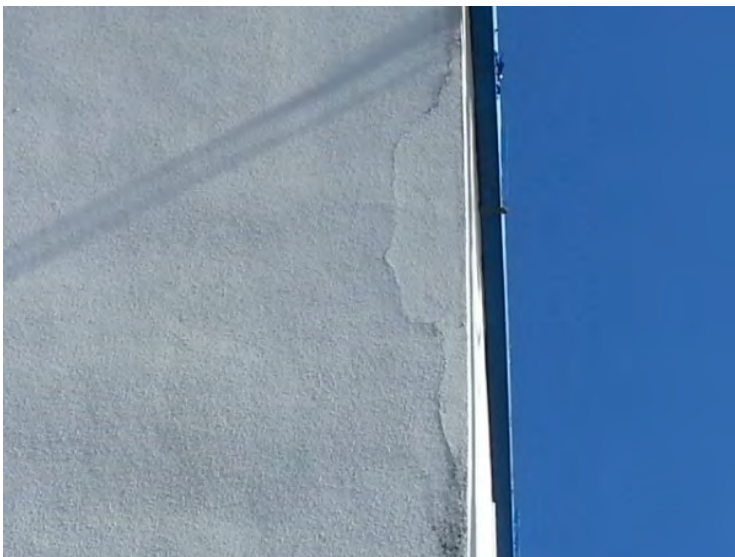
36. View of exterior concrete wall cracking noted at the southwest corner of the 2nd floor balcony.

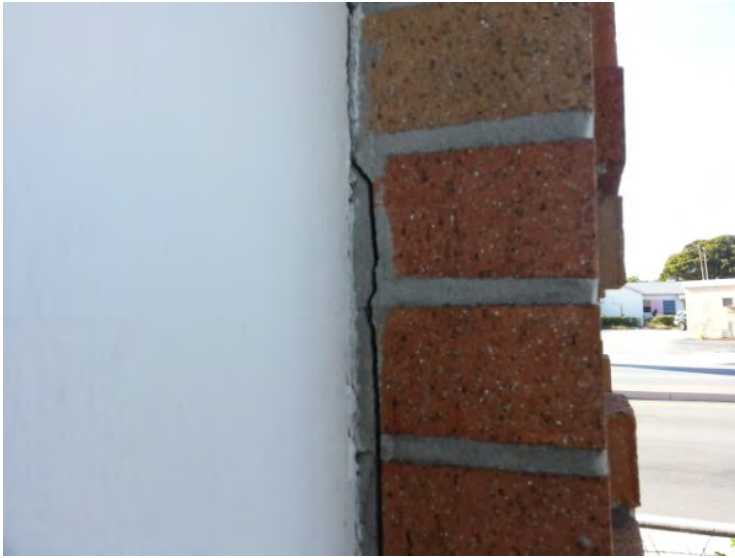
37. View of cracked joint noted between the brick and concrete walls at the northeast corner of the northwest stairway.

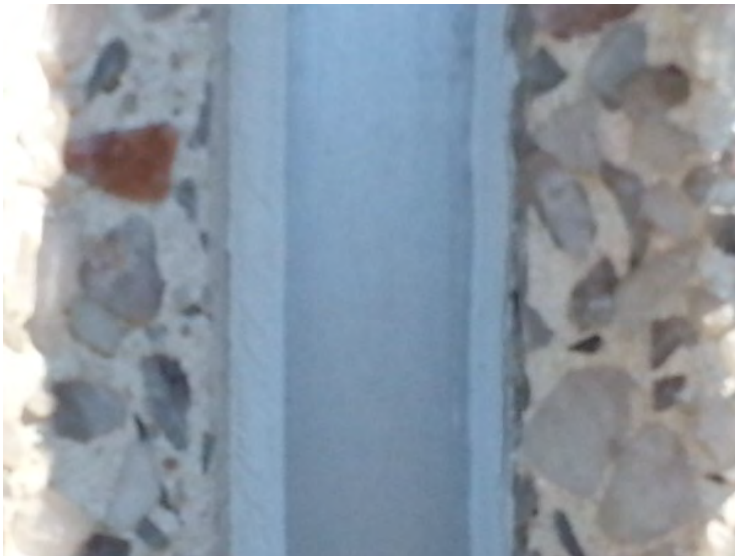
38. View of precast concrete wall joint detail noted on the west side of the building.

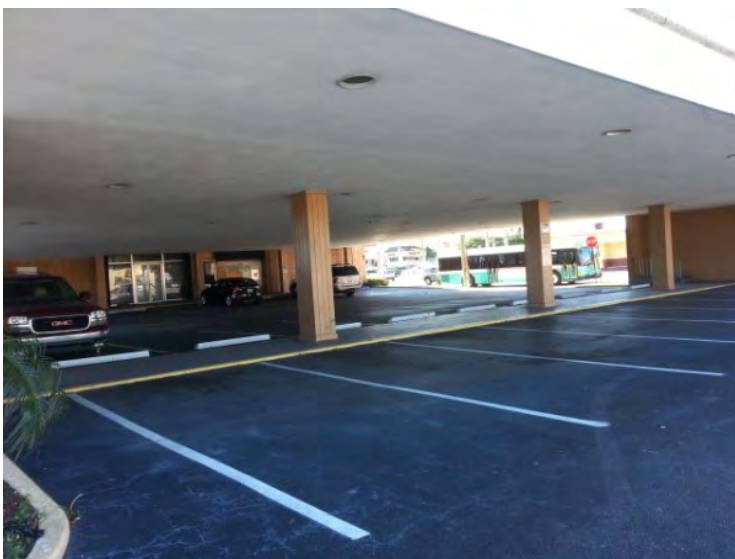
39. View of the parking spaces provided at the underside of the north portion of the building.

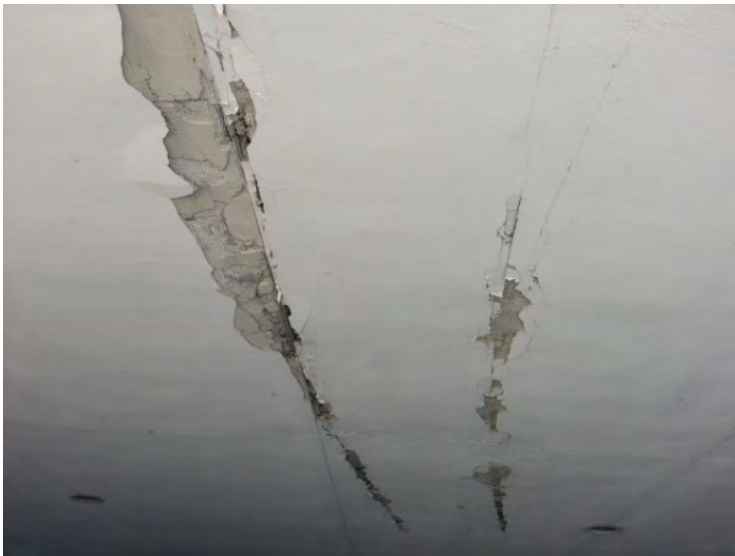
41. View of damaged soffit noted on the west-end portion of the carport.

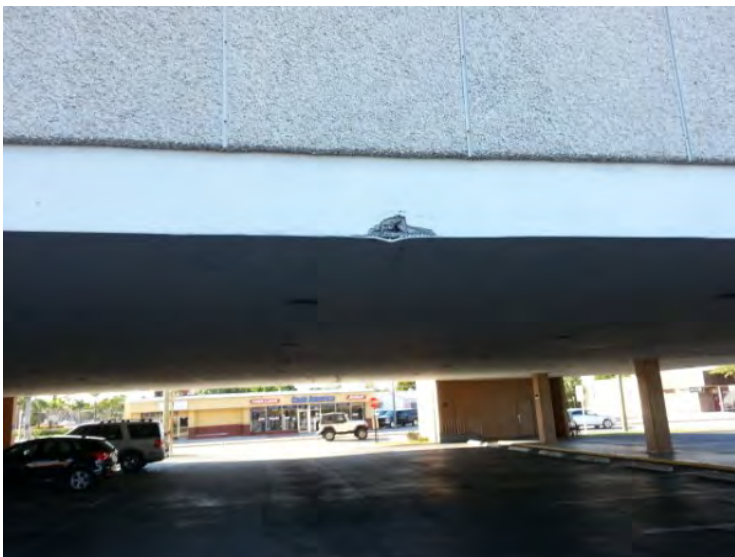
42. View of damaged soffit noted at the entrance header at the east side access to the covered parking spaces.

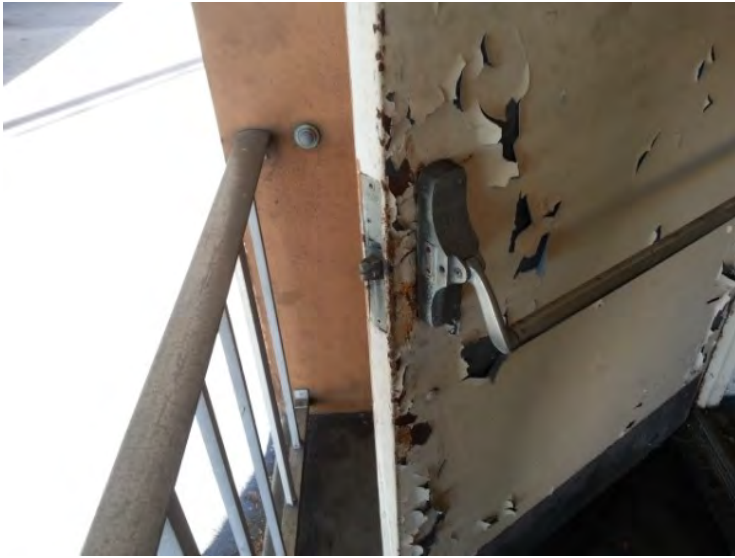
43. View of peeling paint and corroding metal surfaces noted on the exit door from the northwest stairway.

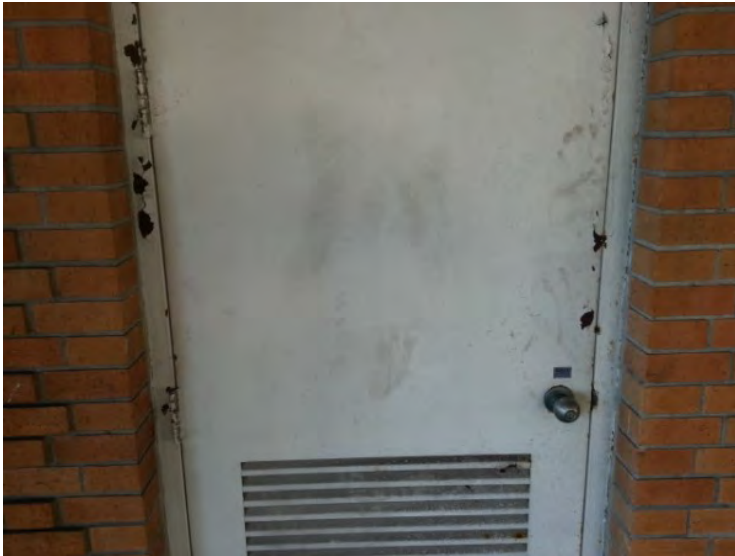
44. View of corroding metal door noted at the south side of the building.

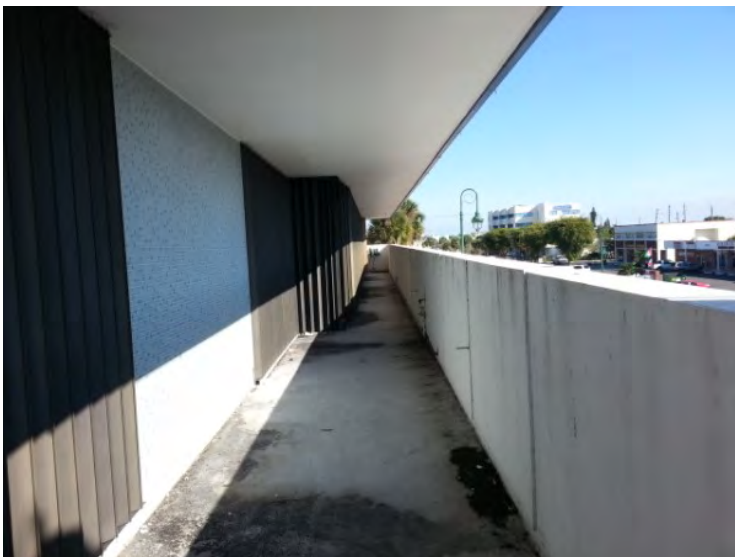
45. View looking east at the 2nd floor balcony on the south side of the building.

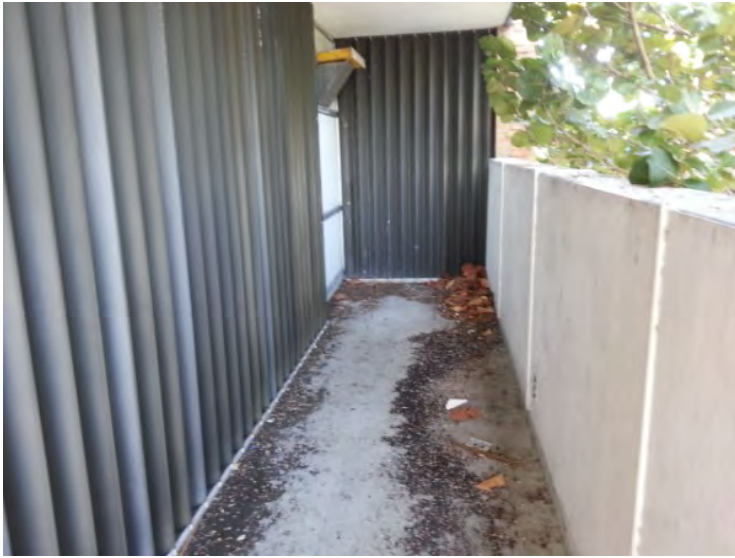
46. View of debris accumulation noted at the east side balcony on the 2nd floor.

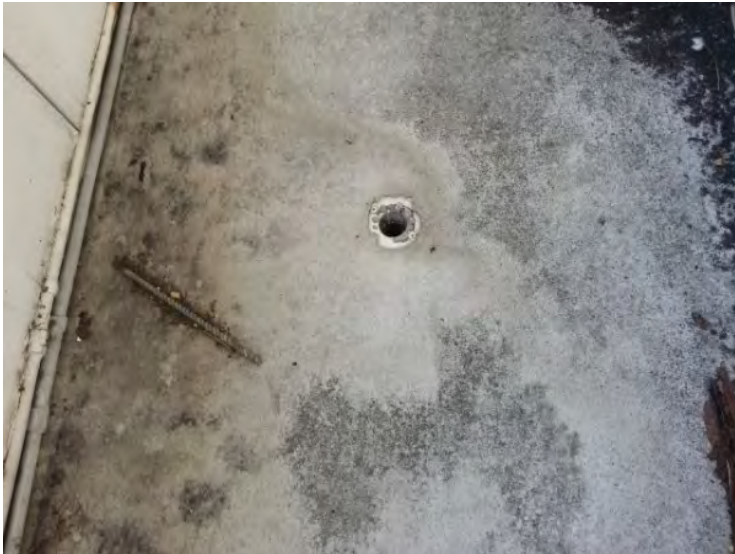
47. View of typical balcony floor drain with missing strainer cover noted at the south side of the building. Note the staining of the balcony floor.

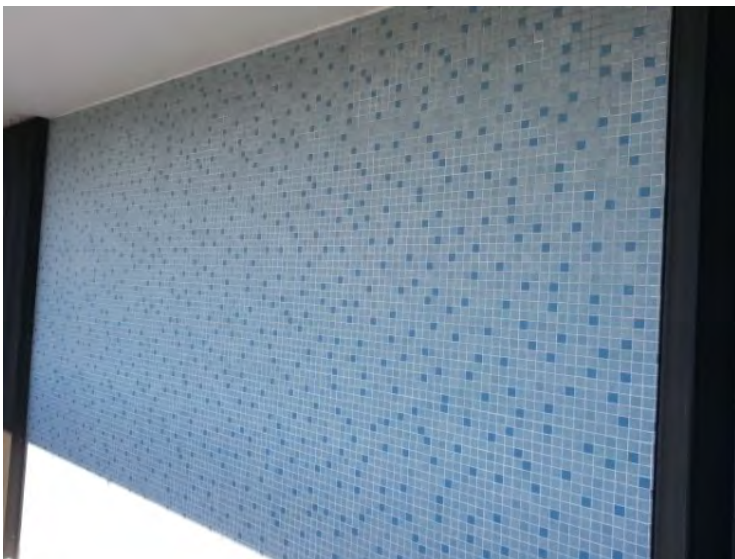
48. View of mosaic tile wall finish noted on the south side of the building.

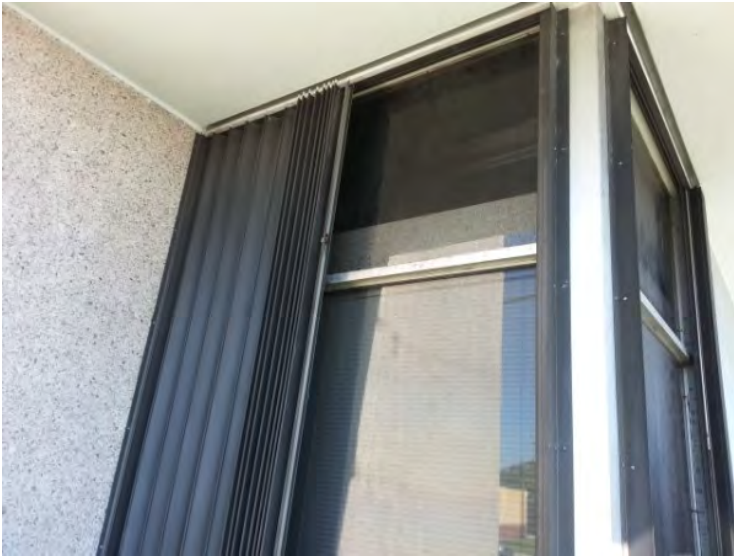
49. View of typical storefront assembly with hurricane shield noted on the building.

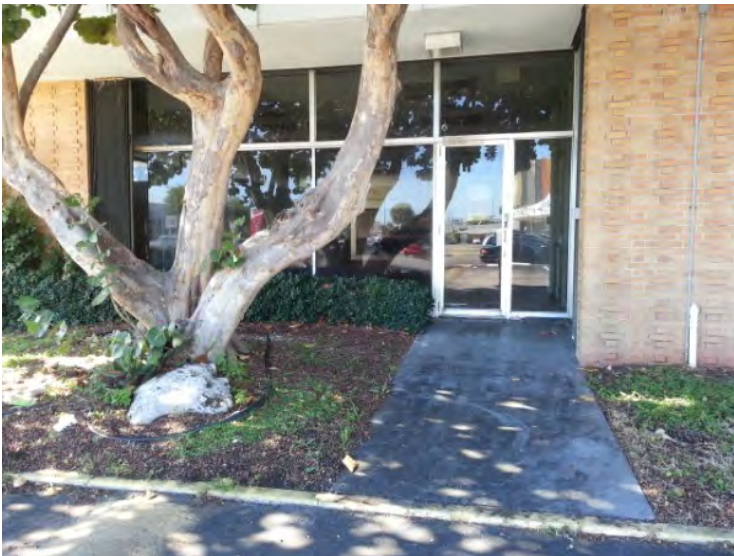
50. View of the east entry door to the building.

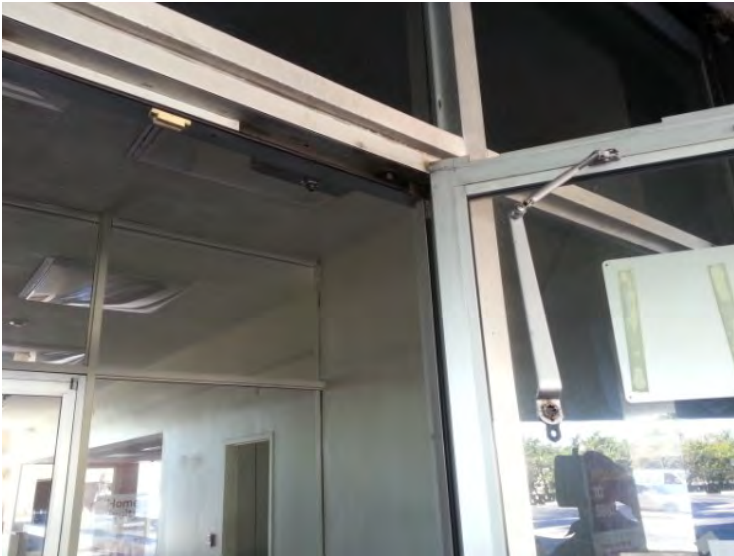
53. View of loose overhead closer noted on the north entry door.
