LEAD TESTING CONSULTANTS

October 16, 2018

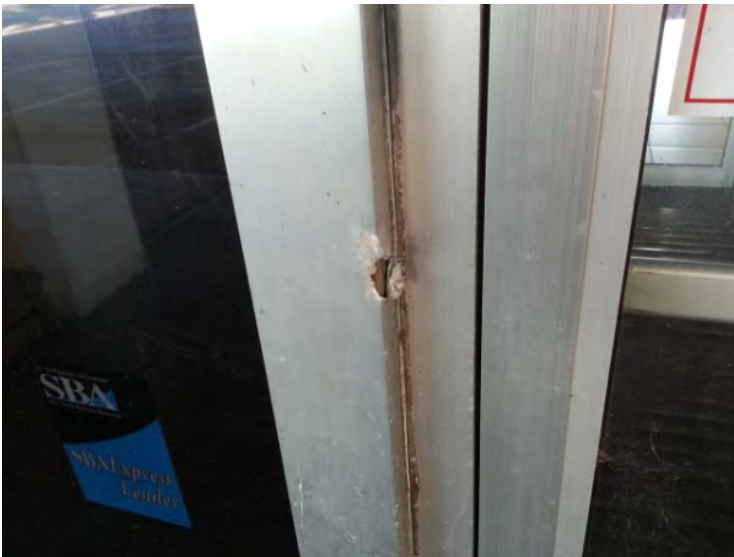
54. View of damaged storefront frame noted at the north entrance to the building.

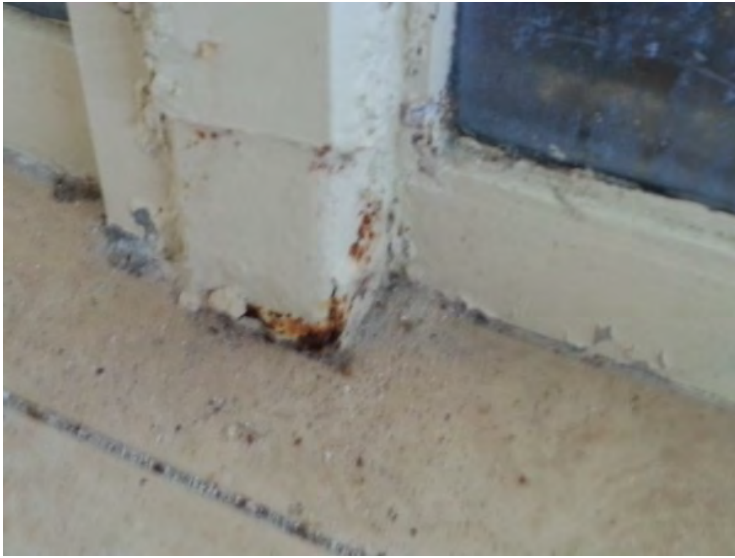
55. View of corroding storefront metal frame noted in the building at the east storefront assembly.

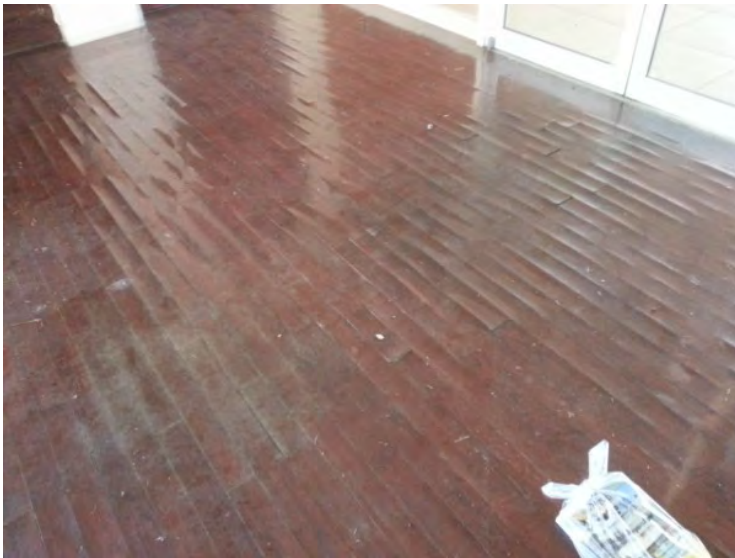
56. View of damaged wood flooring noted at the north entrance vestibule.

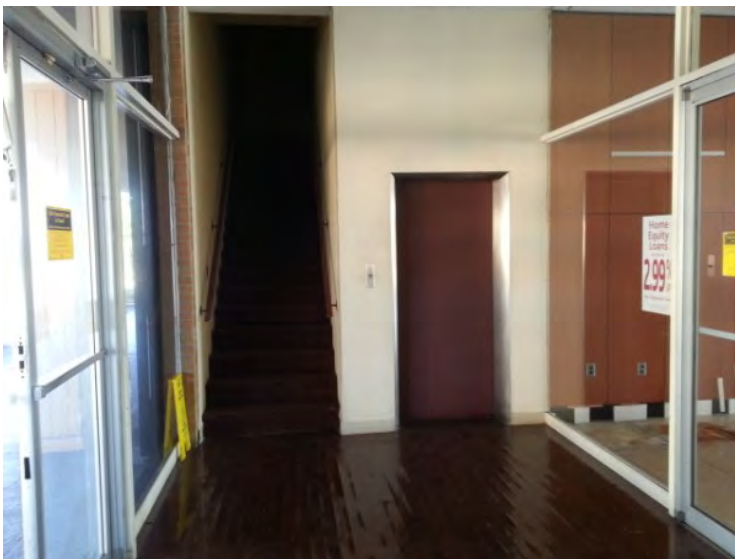
57. View in the vestibule noting the elevator.

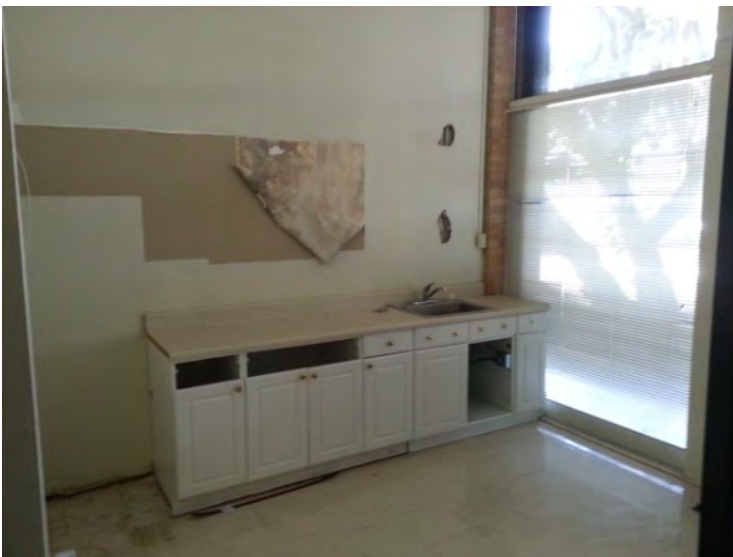
66. View in the break room noted in the north portion of the 1st floor.

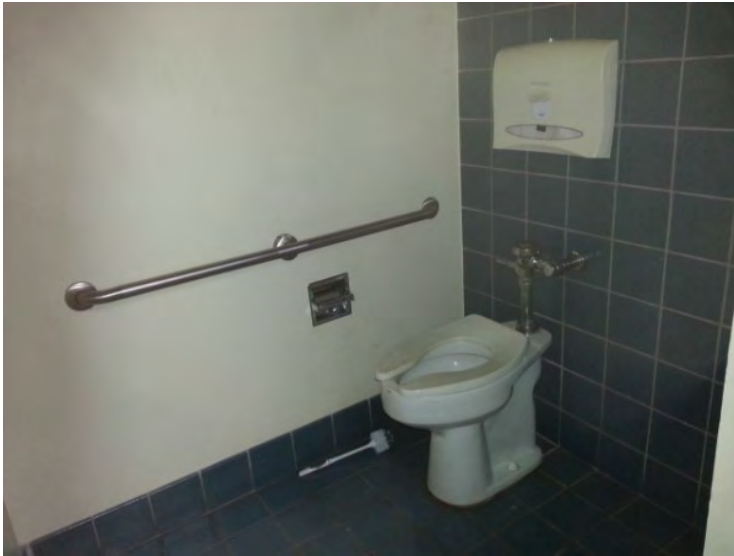
67. View in the 1st floor men's toilet room noting the handicapped accessible water closet stall.

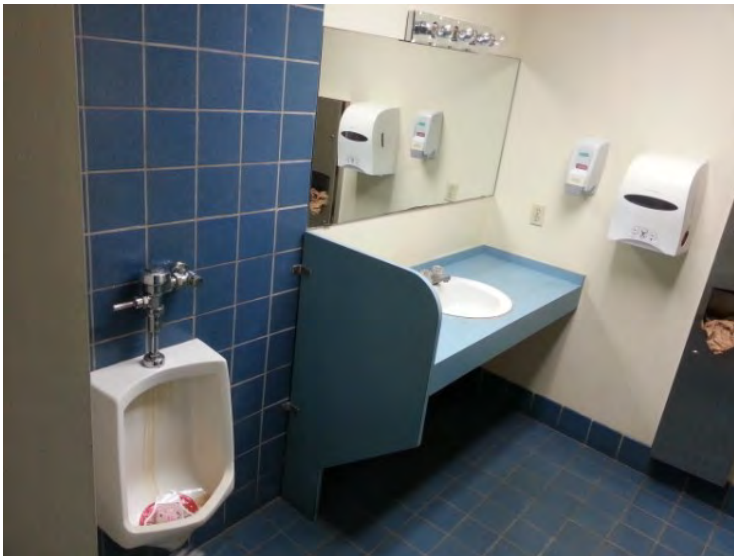
68. View of the urinal and lavatory noted in the 1st floor men's toilet room.

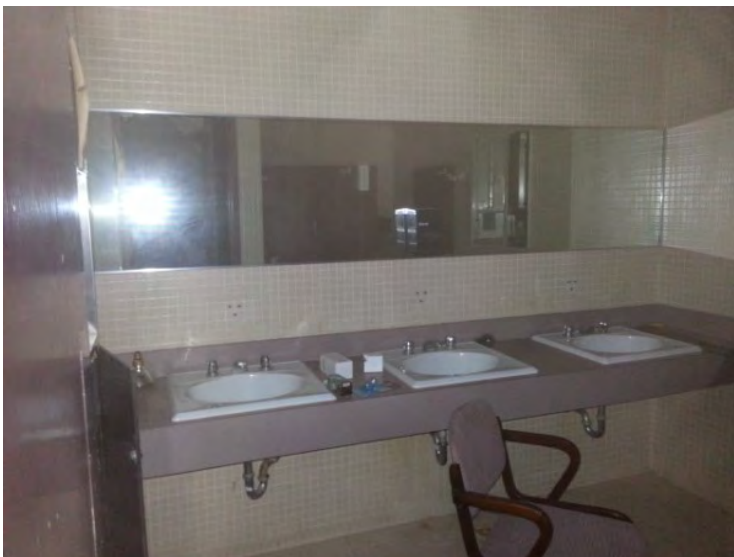
69. View of the lavatory in the women's toilet room located in the west portion of the 2nd floor.

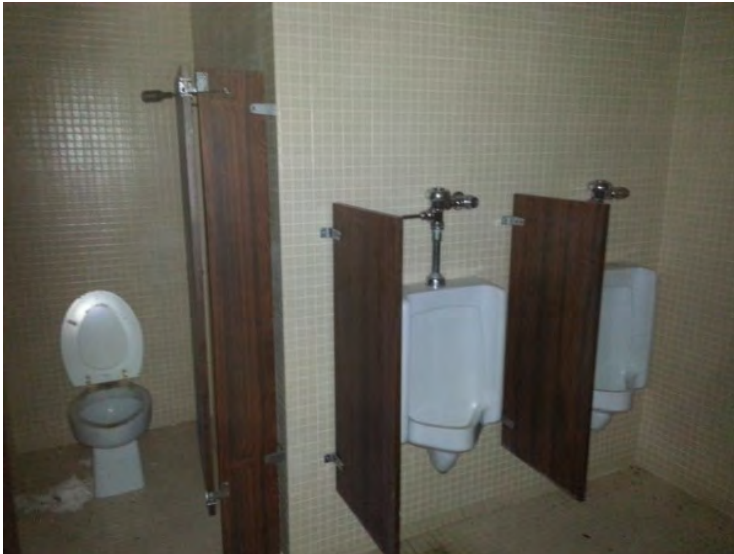
71. View of urinals and water closet noted in the men's toilet room in the west portion of the 2nd floor.

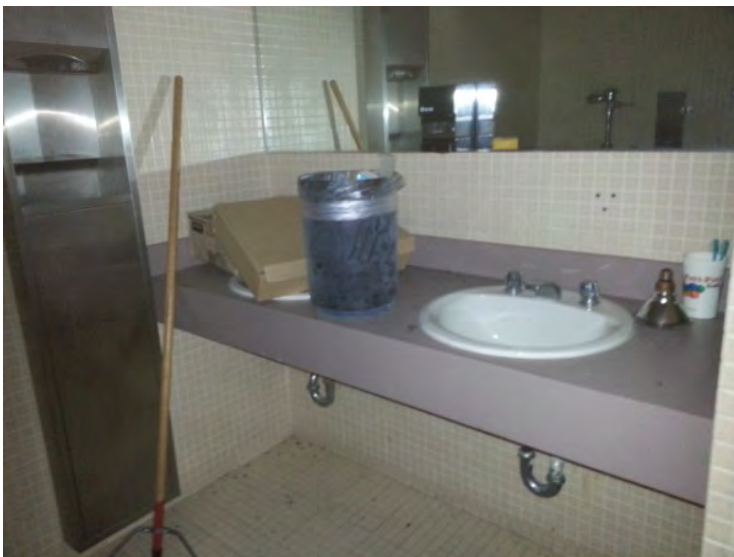
72. View of the lavatory in the men's toilet room located in the west portion of the 2nd floor.

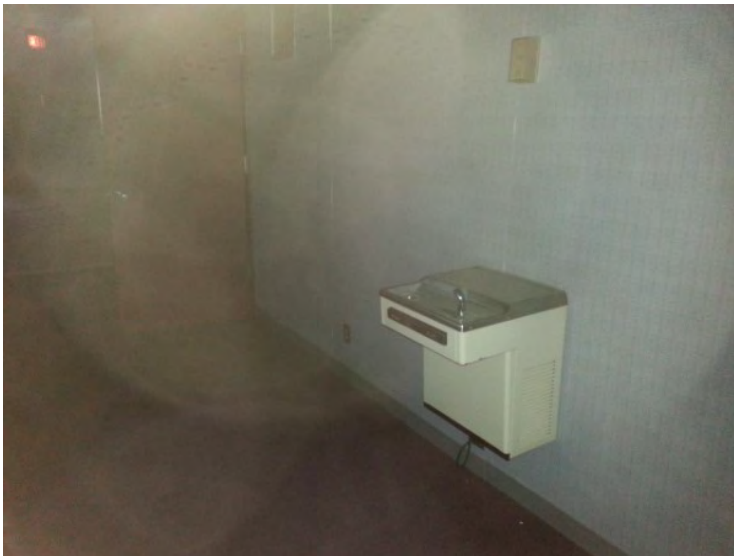
74. View of a drinking fountain noted in the northwest portion of the 2nd floor.

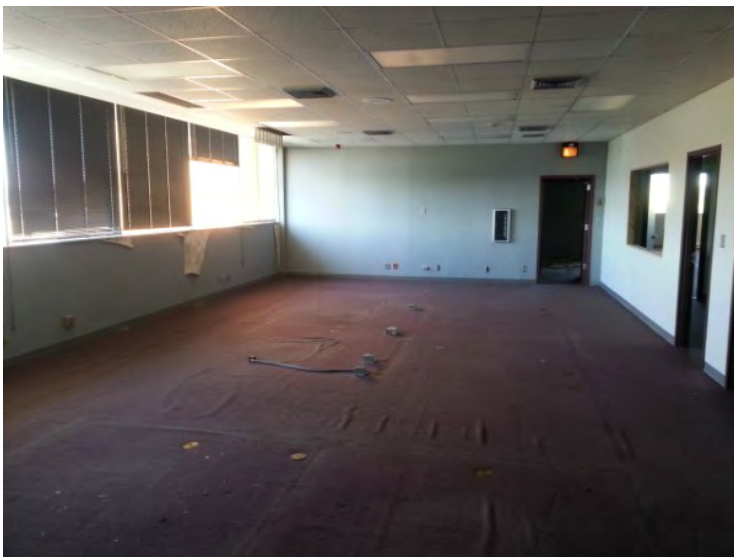
75. General view in the 2nd floor office area. Note the condition of the vinyl wall covering and the flooring.

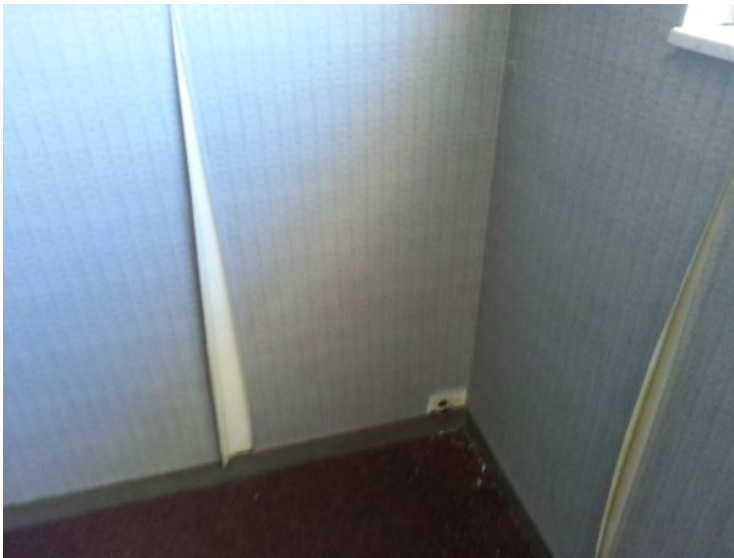
76. View of peeling vinyl wall covering noted on the 2nd floor.

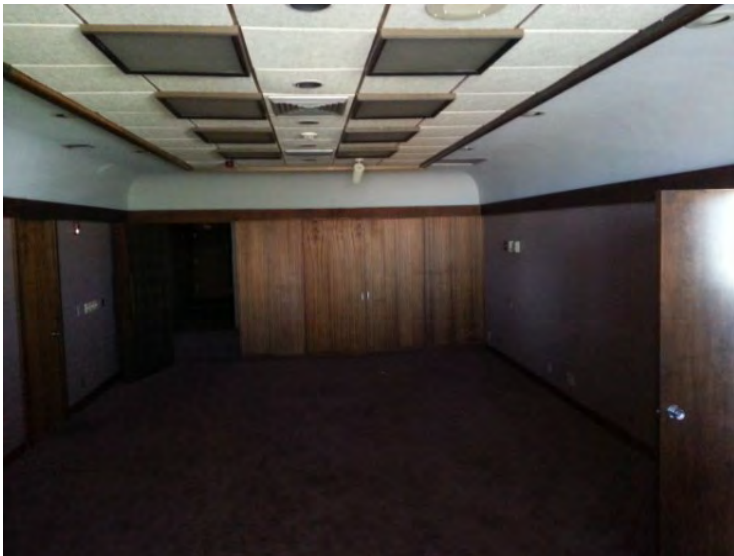
77. View in the former board room.

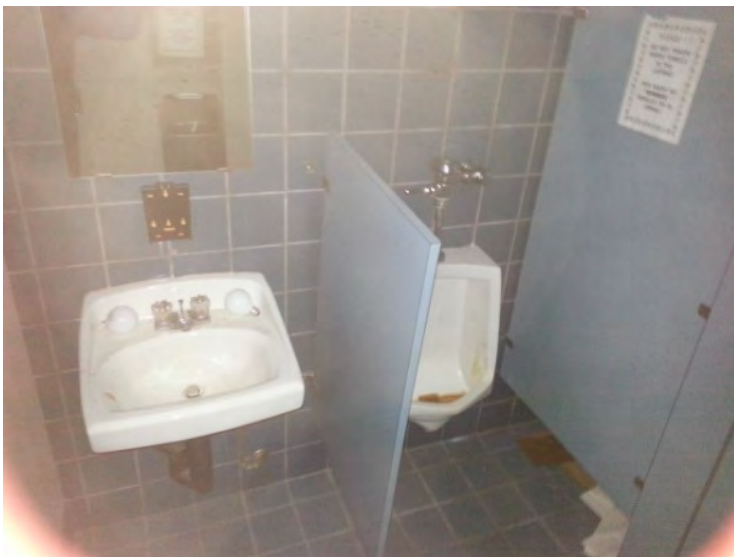
78. View of wall-mounted wash sink noted in the men's toilet room in the east portion of the 1st floor.

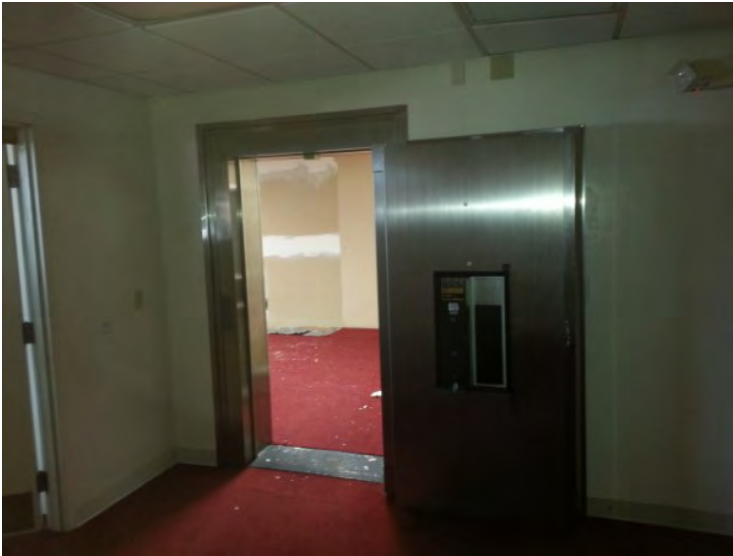
79. View in the entry door into the bank vault noted in the southwest portion of the 1st floor.

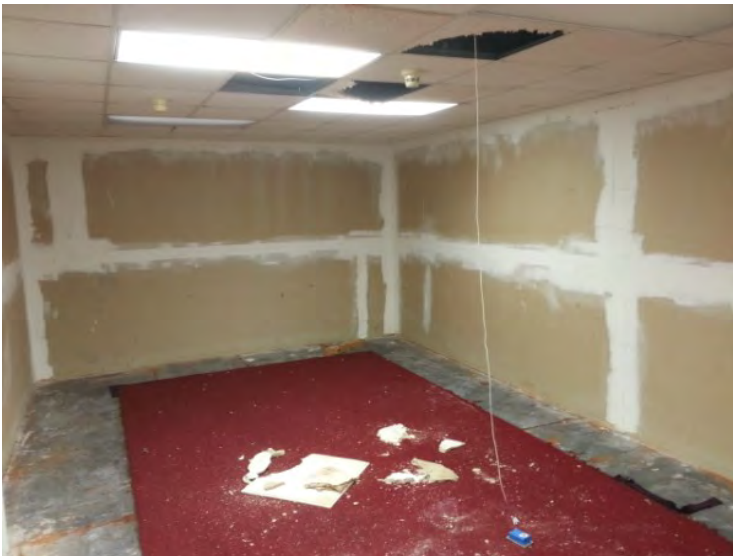
80. View in the bank vault noted in the southwest portion of the 1st floor.

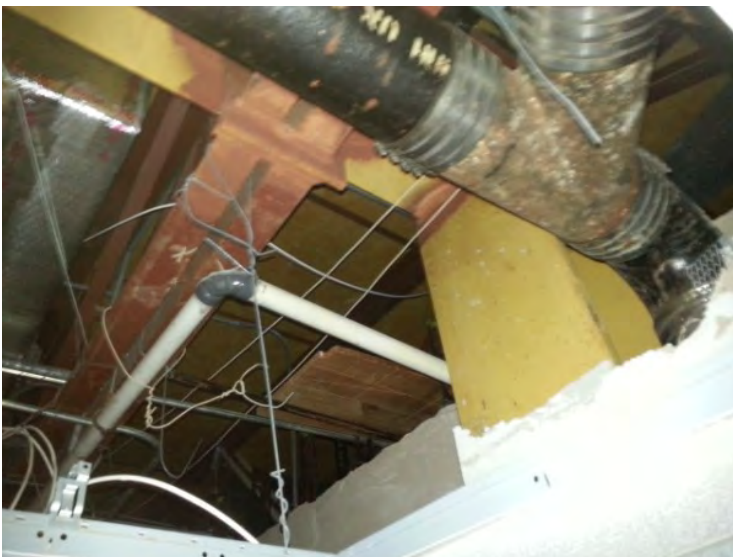
81. View of the structural steel framing of the building noted on the 2nd floor.

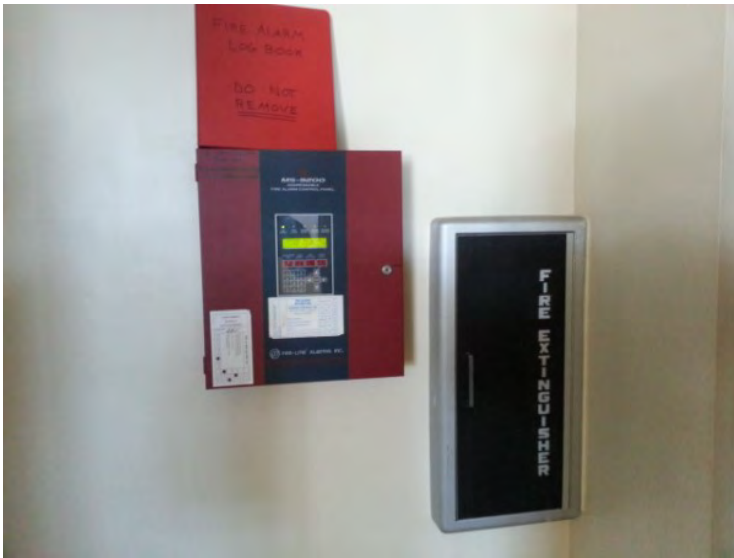
82. View of the fire alarm control panel noted in the north portion of the 1st floor. Note the typical fire extinguisher.

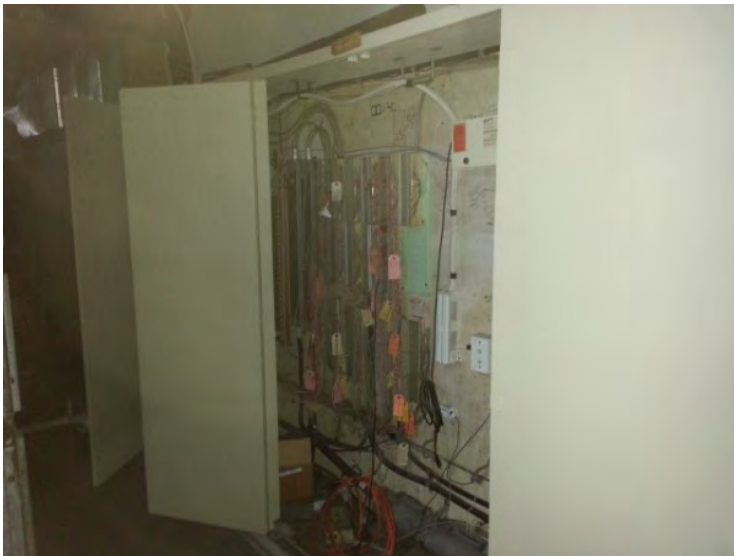
83. View of the telecom cabinet noted in the mechanical room in the west portion of the building.

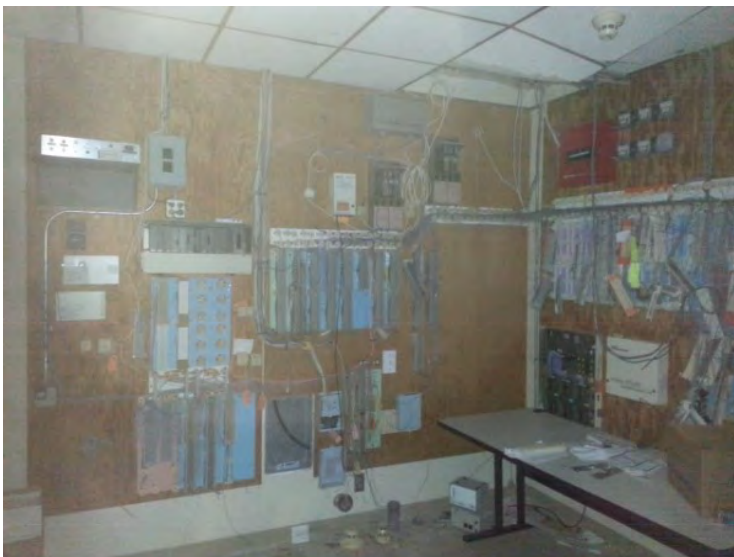
84. View in the telecom and computer room located on the 2nd floor of the building.

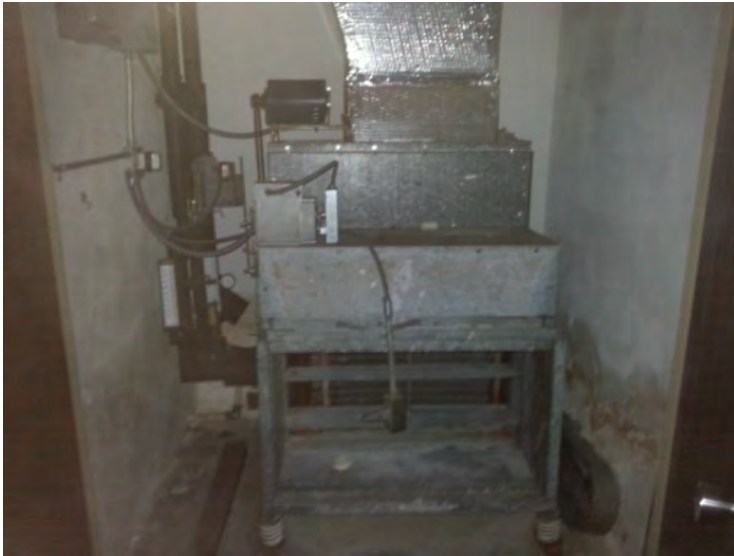
85. View of an HVAC equipment noted in the east portion of the 2nd floor.

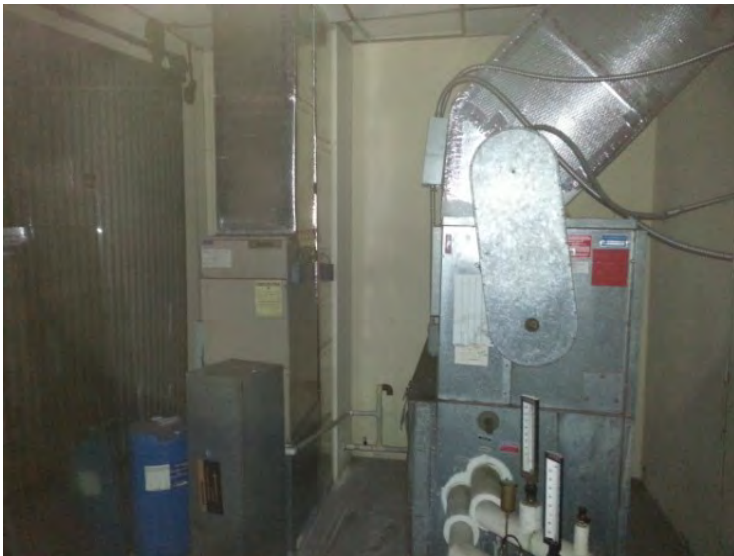
86. View of HVAC equipment noted in the north portion of the mechanical room.

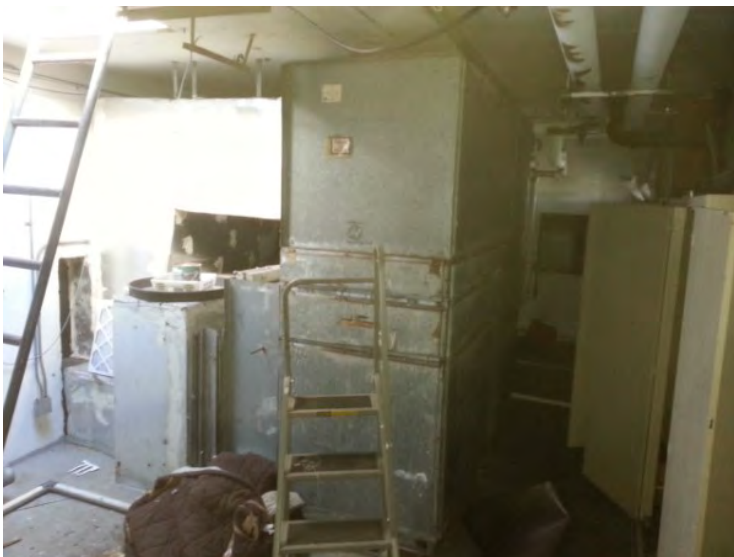
87. View of one of the two built-up air-handling unit noted in the mechanical room in the west portion of the building.

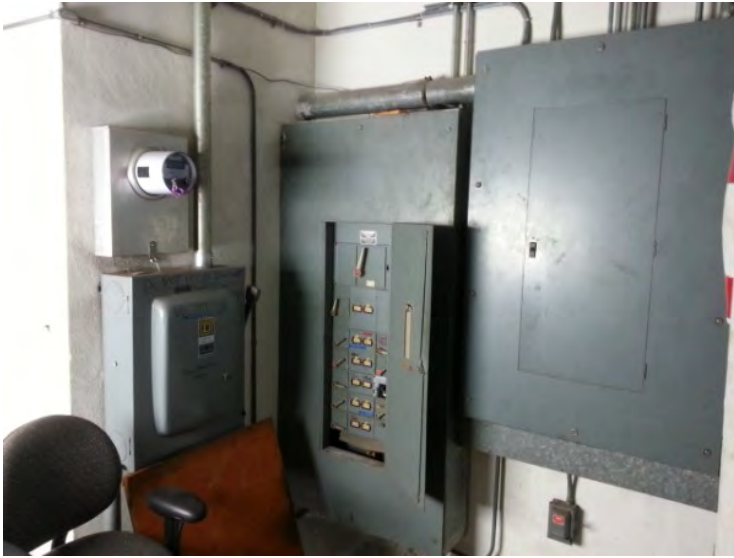
88. View of electrical main panel noted in the mechanical room in the west portion of the building.

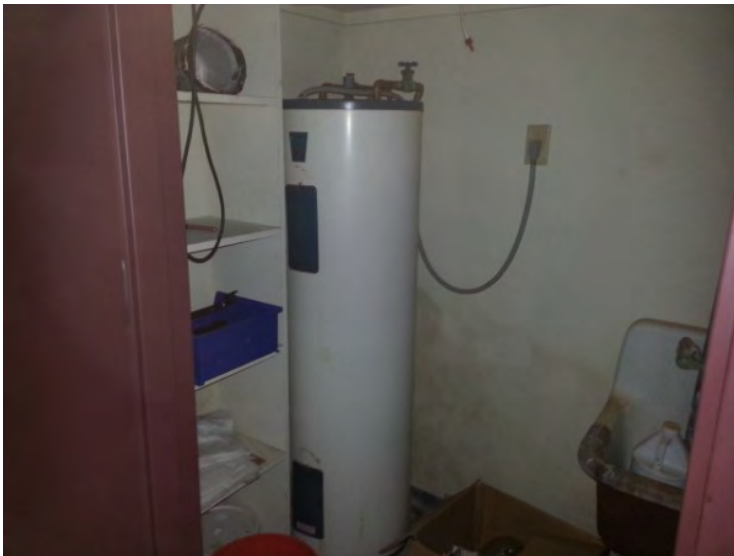
89. View of an electric water heater noted in the west portion of the 2nd floor.

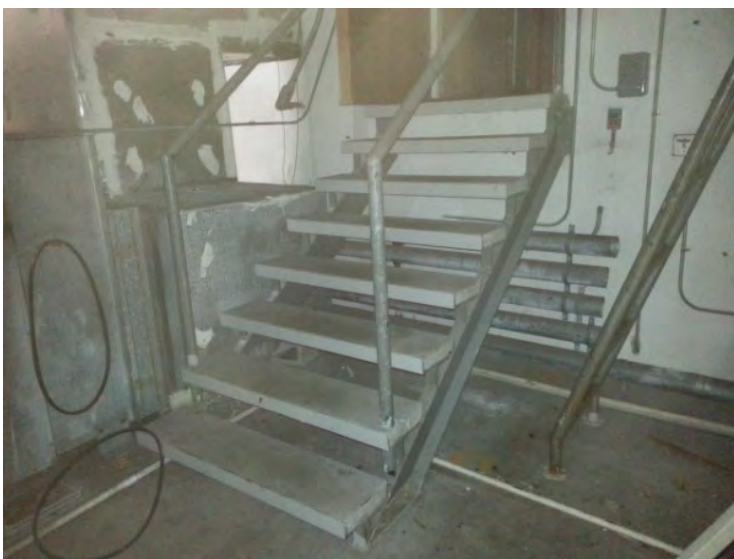
90. View of the access stair noted in the mechanical room in the west portion of the building.
