INSPECTION REPORT

PREPARED FOR: Riviera Beach Utilities Special District (RBUUSD)

DATE: December 29, 2020

SUBJECT: High Service Pump Inspection, Testing & Recommendations

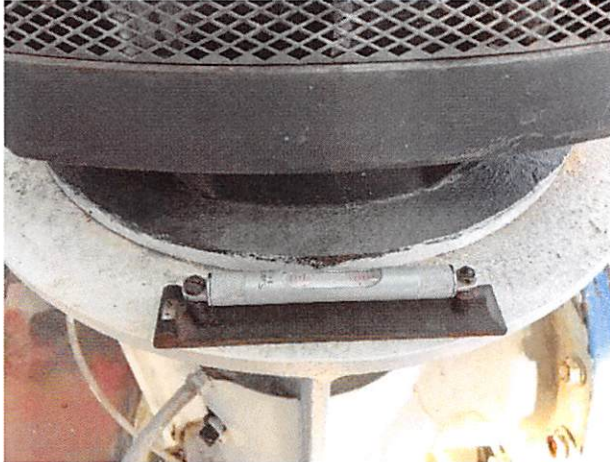
- Checked several of the installed pumps for level (including a new one) with a machinist's level. The pumps are not level and are off between 1/16 inch to 1/8 inch in 8-inch (0.0625 – 0.0078) machinist level (**Figure 2**). This exceeds the manufacturer's installation instructions of 0.000083-0.000417.

Figure 2. Uneven level of an installed pump

3. All new installed pumps need to be removed and installed correctly. Proper installation of the pumps will require chipping out the existing concrete pedestal several inches further, then setting the pump with the sole plate, leveling and grouting. New uninstalled pumps will also have to be installed following the same procedure. Sole plates are recommended to be installed for the pumps that were installed removing the sole plates. Installing sole plates will make level installation easier, allows for better grouting under the pump, allows for easier removal of the pump for maintenance later and it spreads out the stresses placed on the anchors farther from the slab penetration for the column.

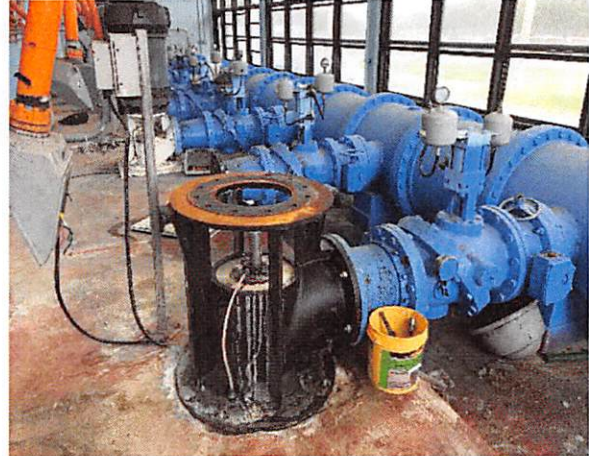
- Some of the pumps were installed with no visible grout (**Figure 3**). HSP 6 has caulk under the sole plate instead of grout (**Figure 4**). Some of the pumps that are grouted exhibit grout cracking.

Figure 3. No visible grout on HSP No. 1

4. All pumps need to be grouted in securely both for proper operation of the pump and to prevent any debris from entering the clearwell through gaps.
5. We recommend using epoxy anchors for installation of pumps, particularly when the anchors are close to the hole edge as in the case here where the pumps were installed without the sole plates.

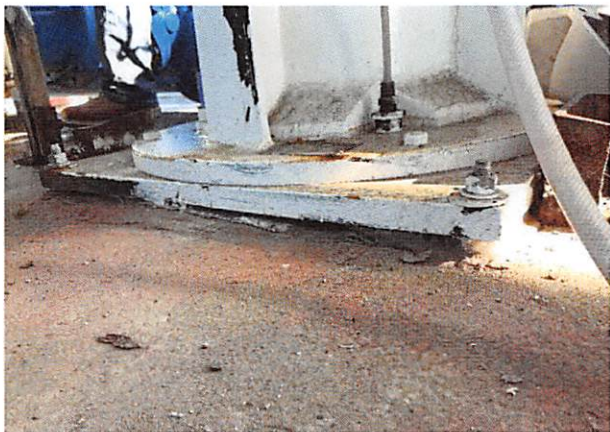
Figure 4. Caulk under sole plate of HSP No. 6

15. Piping should not be supported by the pump flange. We recommend installing adjustable pipe supports on each pump discharge piping.
16. Existing caulk under HSP 5 should be removed and non-shrink grout should be installed under the base plate.

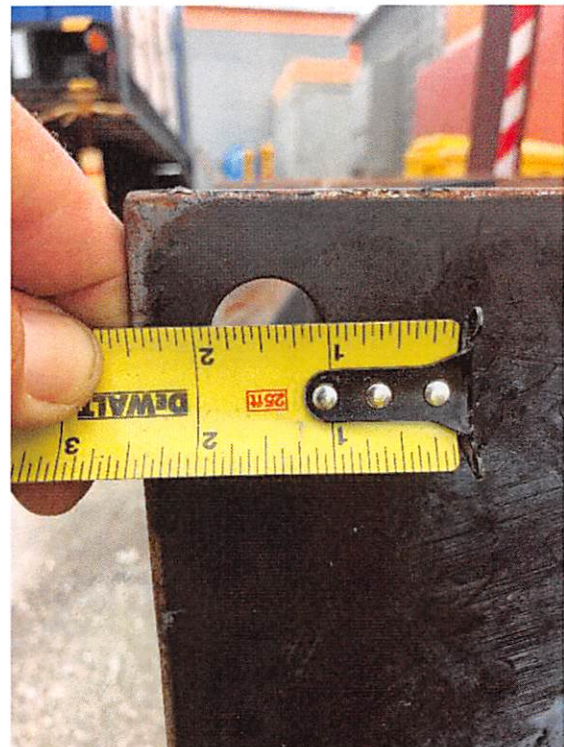
- The newly installed pumps are anchored using 5/8-inch galvanized wedge anchors. The depth is unknown. The bolt holes on the new pumps measure 7/8-inch (**Figure 5**), normally the anchor bolt diameters are 1/8-inch smaller than the hole, which would result in a 3/4-inch anchor. More importantly, the anchors are galvanized steel, and the pump base is carbon steel. These metals are about 0.35 volts apart in the galvanic series. In coastal or humid areas, galvanic pairs should be limited to 0.15 volts to minimize corrosion. The galvanized steel is the anode in this pair and will lose metal to the carbon steel pump. This could result in the anchor bolts being compromised and potentially a dangerous situation if the pumps were no longer secured to the floor.

Figure 5. Sole plate bolt holes of uninstalled pumps

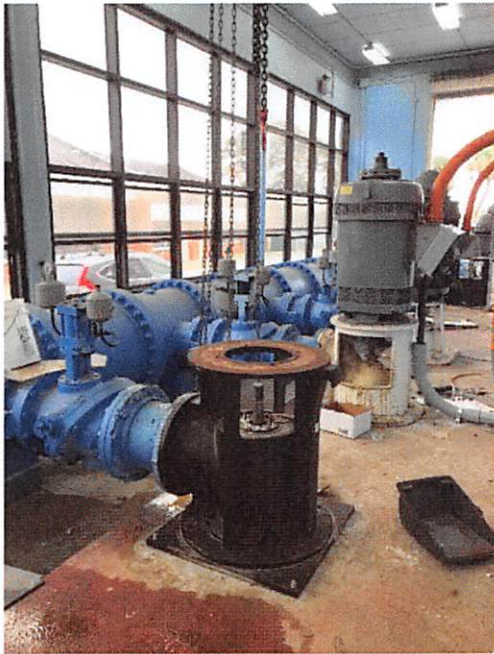
- There were no shaft guards on any of the installed pumps (**Figure 6**).
 - HSP 7 was in operation and is missing two of the anchor bolts (**Figure 8**). Some missing bolts were found on some pump flanges (**Figure 9**). Some of the flange bolts on the new pumps are smaller diameter.

Figure 6. No shaft guards on any pump

8. Install shaft guards on all the pumps.
9. We recommend stored motors be connected to strip heaters as soon as possible until they are installed. The uninstalled motors do not need to be sent in for baking at this time. If they continue to be stored outside without heaters, then they should be meggered again to confirm they do not have moisture in the windings.

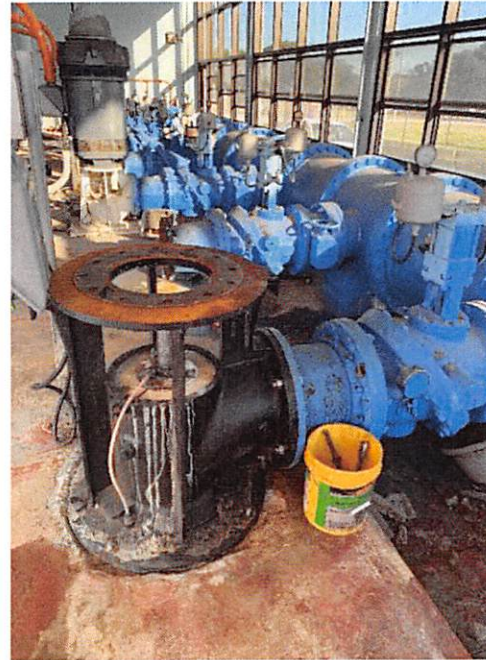
- The new pumps appear to be taller than the previous pumps and the existing concrete pedestals had to be chipped out for installation. Two of the sole plates of new pumps were also removed to reduce the installed pump height (**Figure 7**). This results in an uneven mounting surface for the pumps and places the anchor bolts very close to the pump penetration in the slab.

Figure 7. No sole plate on newly installed pump

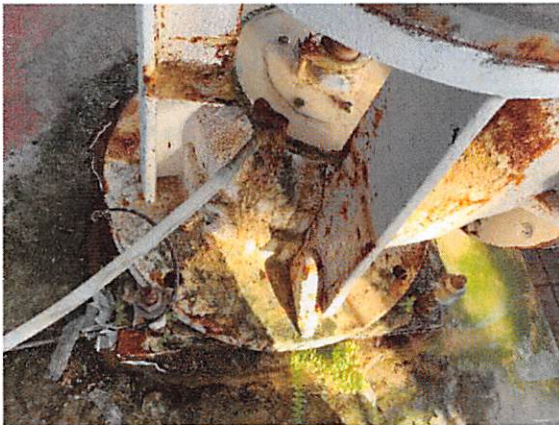
- Observed a large constant water flow coming from the HSP packing (**Figure 8**). The design drip rate for pump packing is normally given in drips per minute. Excessive drip rates can reduce the pump performance and prematurely wear the packing. Vendor can provide the actual design drip rate during their certification of proper installation inspection.

Figure 8. Missing bolts and constant seal water flow at HSP No. 7

1. Install the missing bolts on HSP 6 as soon as possible.
2. The Pump 1 body should not be used to secure piping that is not properly restrained. Separation of the pipe at this location could result in loss of all the high service pumps as well as damage to the watermain, high service pump building, filter structure and electrical room. Restraining rods should be connected through ductile iron spool with the slipping restraint immediately. We would also recommend that the isolation valve be replaced, and a new restraint be installed on the ductile iron spool at that time.

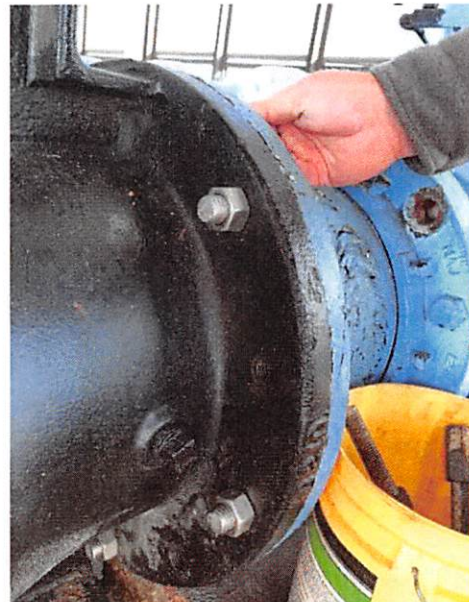
Figure 9. Missing bolts on pump flange

12. Every bolt hole must be bolted up.
13. Bolt down a competent steel plate and provide caulk around the edges at the exposed floor penetration at HSP 2.

17. Flange bolts should all be sized correctly for the bolt holes. We recommend installing bolts 1/8-inch smaller than bolt holes.

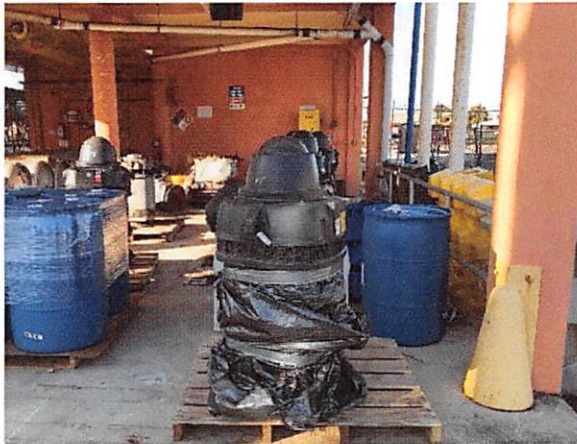
2. New Uninstalled Pumps
- The new uninstalled pumps motors are being stored outside in the base of the North Lime Building without heaters attached (**Figure 10**). The motors were meggered and they tested satisfactory at that time.

Figure 10. New uninstalled HSP motors

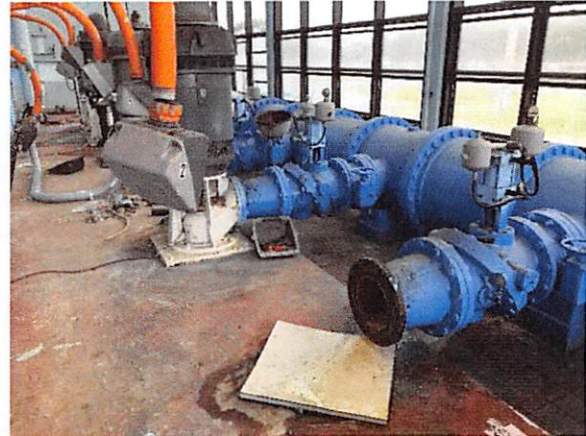
- Exposed floor penetration at HSP 2 was not properly secured after pump was removed. Pressed wood piece (**Figure 11**) was placed loosely over the penetration and is falling apart. The wooden piece may collapse if stepped on. This arrangement is dangerous and unsanitary.

Figure 11. Exposed floor penetration not secured properly for HSP No. 2

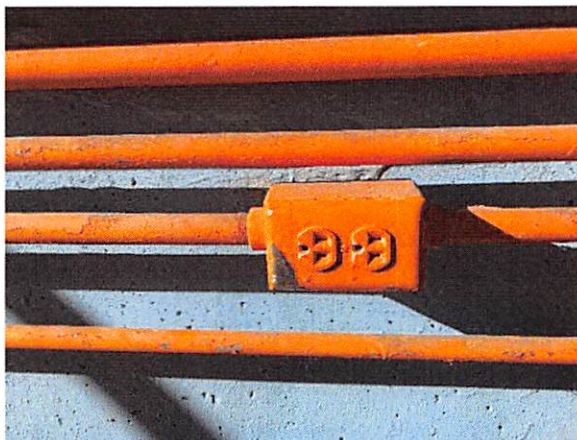
- No covers on electrical outlet observed and they do not appear to be ground fault protected (**Figure 12**). Electrical conduits do not fully cover wiring and are not properly terminated (**Figure 13**).

Figure 12. Open electrical outlet

14. The HSP room is a potentially wet room. Exposed electrical wires at several HSPs should be properly terminated and all electrical outlets should have a cover and be ground fault protected.

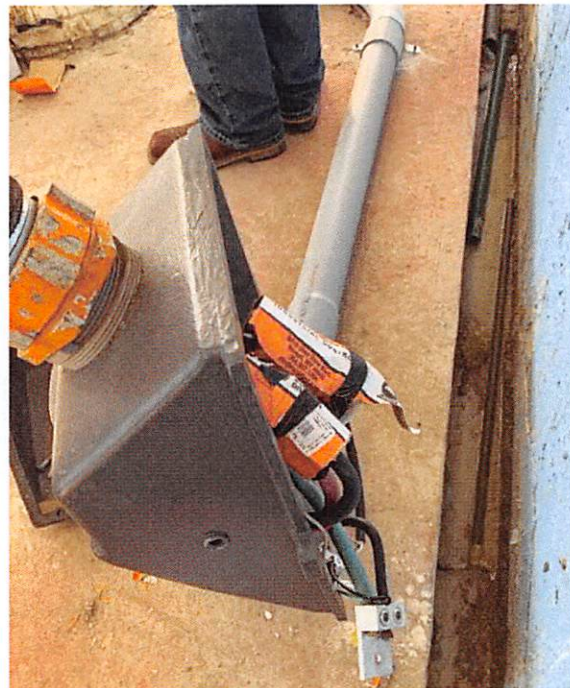
Figure 13. Exposed electric wires

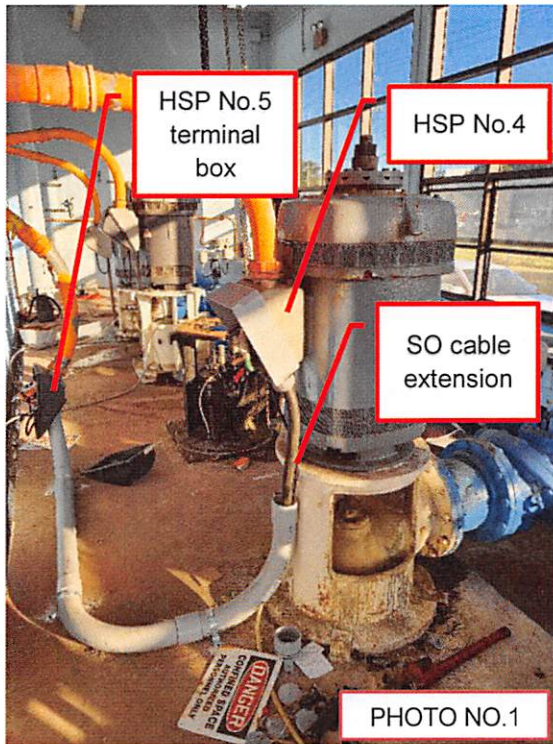
- Feeder and Soft-Starter No.5 are being temporarily used to run the motor for HSP-4 via SO cable extension, there is no motor installed for HSP-5. See Photo No.1

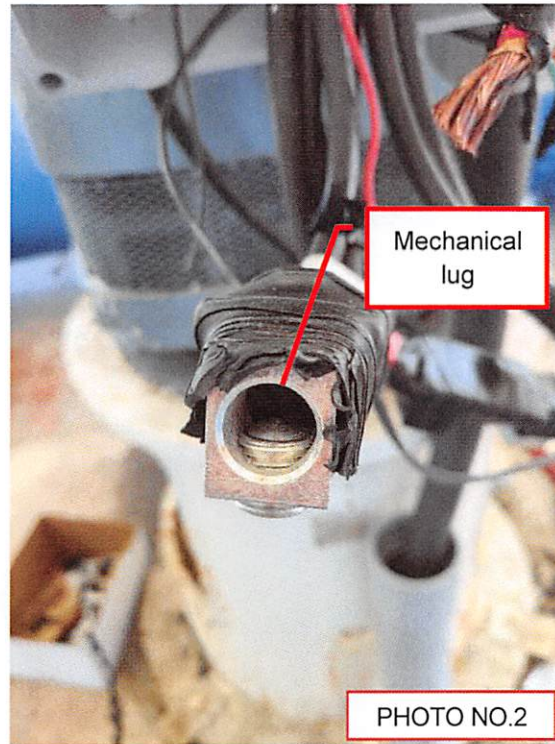
- a. Electrical connections at motor for HSP-4 and inside of old terminal box for HSP-5 are made via mechanical set-screw lugs. Mechanical set-screw lugs are not recommended for motor connections as vibration and heat may cause cables to become loose at lugs. High-pressure terminal connectors or split bolts are preferred. See Photo No.2

- Recommend replacing the mechanical set-screw lugs for HSP-4 with high-pressure lug connectors.
- Currently HSP-4 auto transformer has an internal failure and HSP-5 is operational. HSP-4 and HSP5 auto transformer starters are old technology and beyond their reliable lifespan. Recommend replacing the existing auto transformers of HSP-4 and HSP-5 with new reduced voltage solid state straters due to lack of readily available replacement parts.

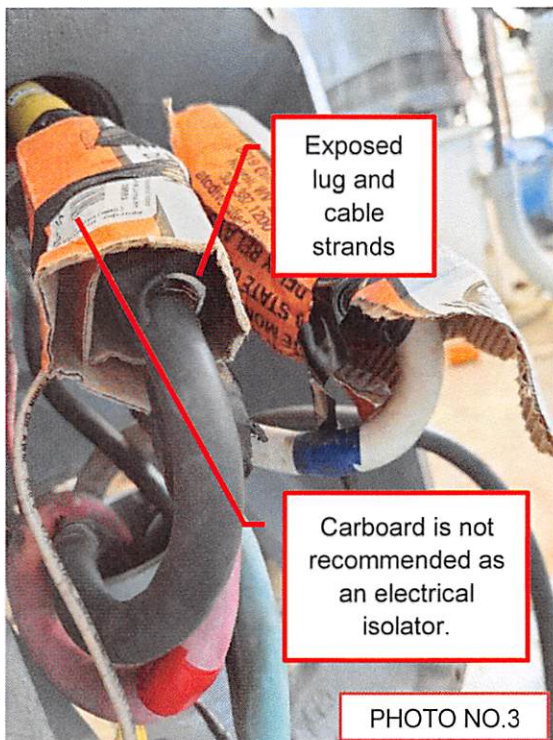
- b. Terminations at terminal box for Motor-5 have exposed metal, which may cause electrical shock to personnel or short-out if in contact with another conductive object. See Photo No.3

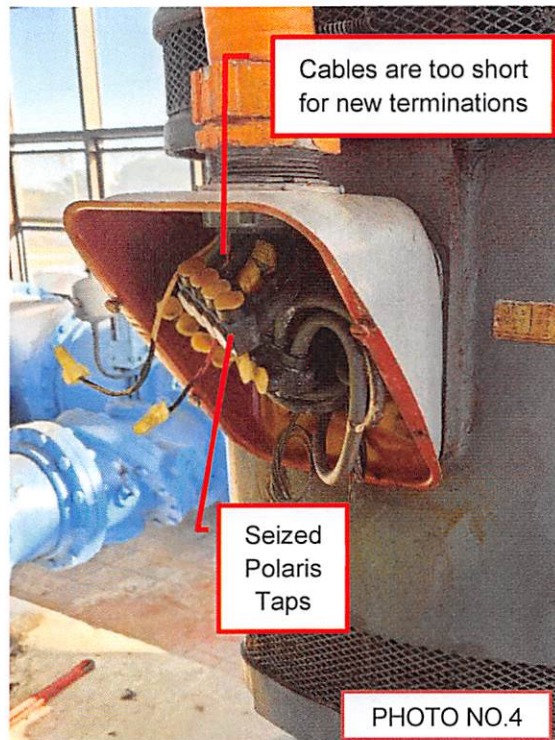
- Electrical connections at motor for HSP-3 are made via Mechanical lugs (Polaris taps). Mechanical set-screw lugs are not recommended for motor connections as vibration and heat may cause cables to become loose at lugs. High-pressure terminal connectors or split bolts are preferred. See Photo No.4

- a. Energy Efficient Electric (EEE) was not able to test the feeders for HSP-3 independent of motor windings due to existing lugs being seized and not enough slack in the cables to cut and make new terminations. Terminations were left as found. See Photo No.4

- The starter contactors for HSP-2 were tested and found to be functional.
- Although HSP-3 wires show acceptable resistance reading, the lugs are seized and cannot be disconnected from the motor. Since there is not enough slack in the existing cables to make new connections, it is recommended to replace the cables and connectors.

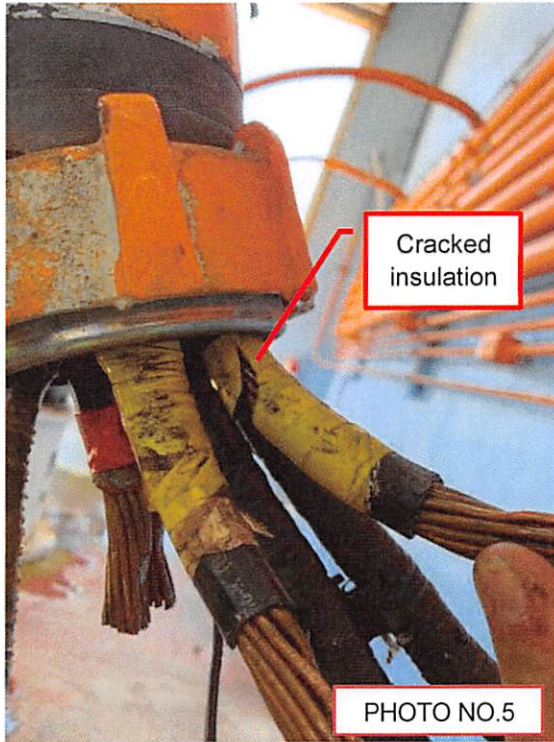
- Feeder cable insulation (C phase) for HSP-1 is cracked to the point that copper is visible. Crack is at the motor-end of cable, partially inside the flexible conduit. Recommend replacing cable. See Photo No.5

- The wires for HSP-1 thru HSP-5 tested with acceptable resistance reading under dry condition.
- Cables for HSP-1 have exposed copper due to cracked insulation. Replace cables for HSP-1 for personnel safety if HSP1 motor and pump will be installed in the future.

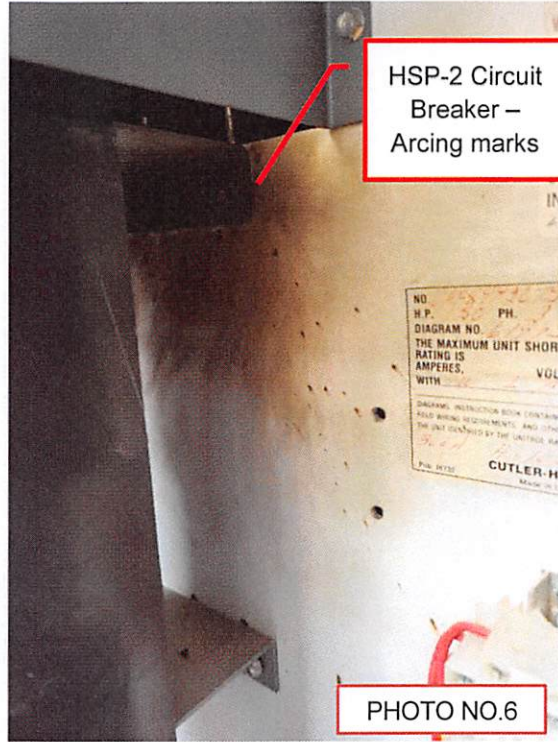
- Circuit Breaker inside Starter Bucket for HSP-2 has arcing marks where mounting bracket attaches to backplate. Recommend isolating breaker and testing prior to energizing. See Photo No.6

- Due to the arc flash marks on the breaker for HSP-2, it is recommended to obtain the service of MCC manufacturer to isolate the breaker from MCC for testing. Depending on the test results, breaker may need to be replaced.
