## CITY OF RIVIERA BEACH – MEMORANDUM

**SUBJECT:** EMERGENCY JUSTIFICATION FOR HIGH SERVICE AND TRANSFER PUMPS

## INSPECTION REPORT

SUBJECT: High Service Pump Inspection, Testing & Recommendations

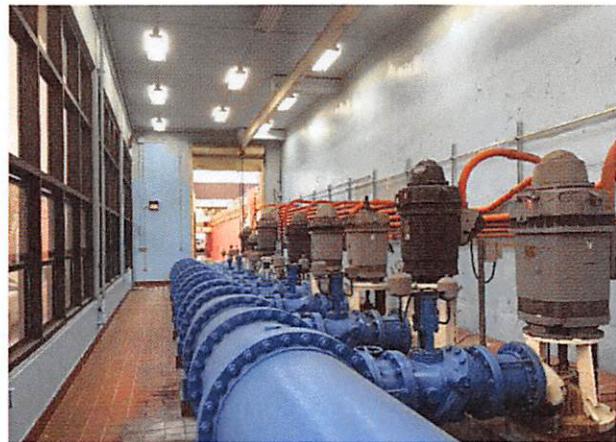
Figure 1. Existing High Service Pumps

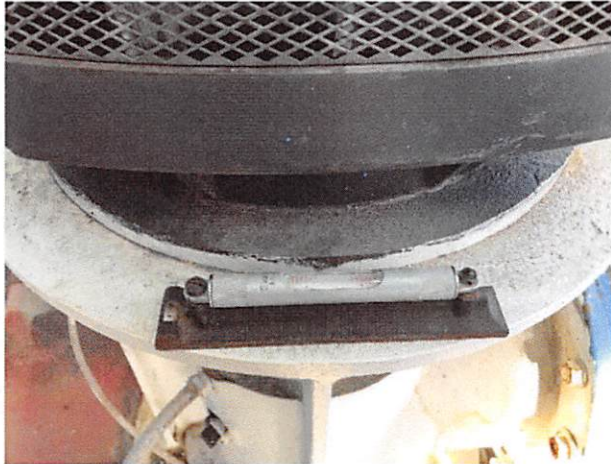
- Checked several of the installed pumps for level (including a new one) with a machinist's level. The pumps are not level and are off between 1/16 inch to 1/8 inch in 8-inch (0.0625 – 0.0078) machinist level (**Figure 2**). This exceeds the manufacturer's installation instructions of 0.000083-0.000417.

Figure 2. Uneven level of an installed pump

3. All new installed pumps need to be removed and installed correctly. Proper installation of the pumps will require chipping out the existing concrete pedestal several inches further, then setting the pump with the sole plate, leveling and grouting. New uninstalled pumps will also have to be installed following the same procedure. Sole plates are recommended to be installed for the pumps that were installed removing the sole plates. Installing sole plates will make level installation easier, allows for better grouting under the pump, allows for easier removal of the pump for maintenance later and it spreads out the stresses placed on the anchors farther from the slab penetration for the column.

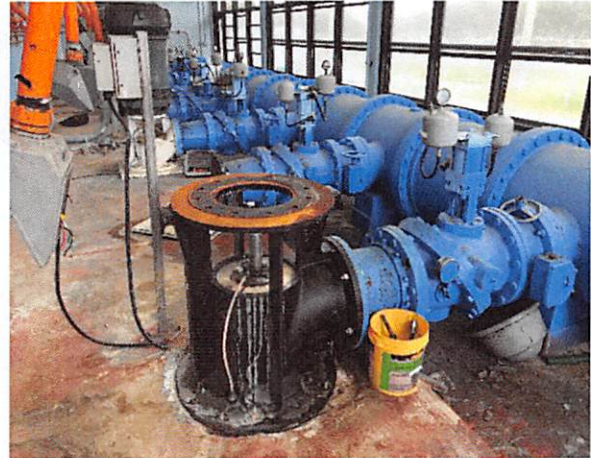
- Some of the pumps were installed with no visible grout (**Figure 3**). HSP 6 has caulk under the sole plate instead of grout (**Figure 4**). Some of the pumps that are grouted exhibit grout cracking.

Figure 3. No visible grout on HSP No. 1

4. All pumps need to be grouted in securely both for proper operation of the pump and to prevent any debris from entering the clearwell through gaps.
5. We recommend using epoxy anchors for installation of pumps, particularly when the anchors are close to the hole edge as in the case here where the pumps were installed without the sole plates.

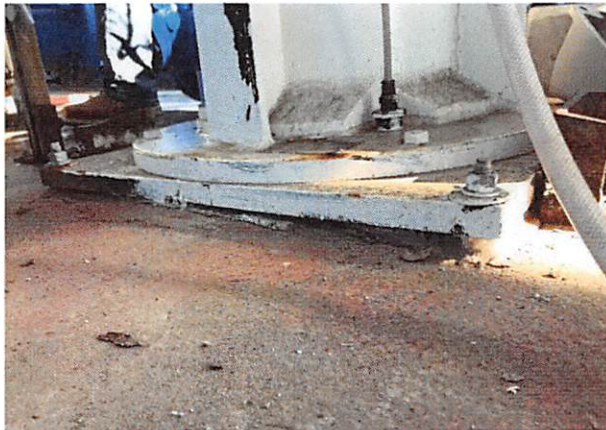
Figure 4. Caulk under sole plate of HSP No. 6

15. Piping should not be supported by the pump flange. We recommend installing adjustable pipe supports on each pump discharge piping.
16. Existing caulk under HSP 5 should be removed and non-shrink grout should be installed under the base plate.

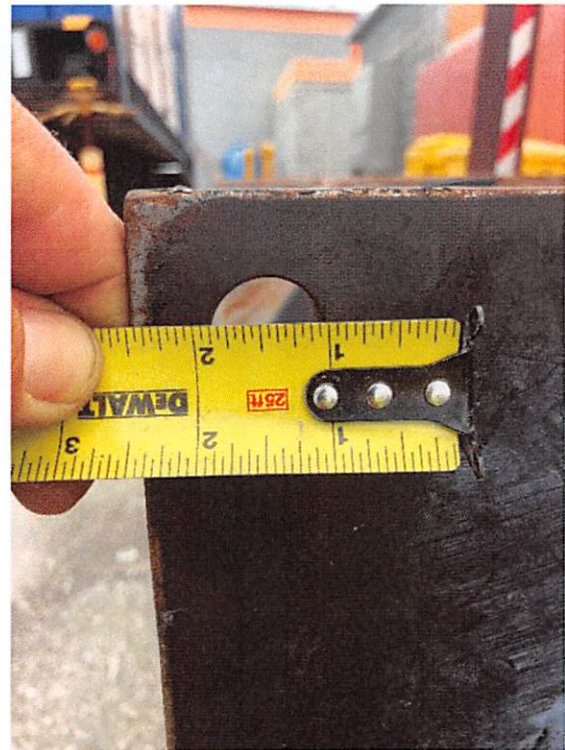
- The newly installed pumps are anchored using 5/8-inch galvanized wedge anchors. The depth is unknown. The bolt holes on the new pumps measure 7/8-inch (**Figure 5**), normally the anchor bolt diameters are 1/8-inch smaller than the hole, which would result in a 3/4-inch anchor. More importantly, the anchors are galvanized steel, and the pump base is carbon steel. These metals are about 0.35 volts apart in the galvanic series. In coastal or humid areas, galvanic pairs should be limited to 0.15 volts to minimize corrosion. The galvanized steel is the anode in this pair and will lose metal to the carbon steel pump. This could result in the anchor bolts being compromised and potentially a dangerous situation if the pumps were no longer secured to the floor.

Figure 5. Sole plate bolt holes of uninstalled pumps

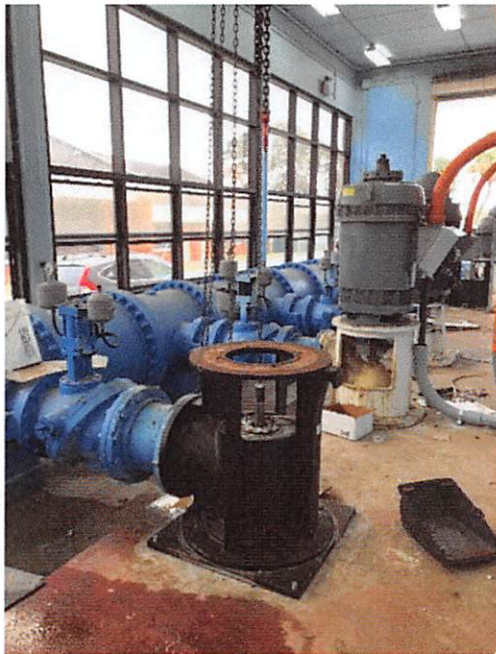
- There were no shaft guards on any of the installed pumps (**Figure 6**).
  - HSP 7 was in operation and is missing two of the anchor bolts (**Figure 8**). Some missing bolts were found on some pump flanges (**Figure 9**). Some of the flange bolts on the new pumps are smaller diameter.

Figure 6. No shaft guards on any pump

8. Install shaft guards on all the pumps.
9. We recommend stored motors be connected to strip heaters as soon as possible until they are installed. The uninstalled motors do not need to be sent in for baking at this time. If they continue to be stored outside without heaters, then they should be meggered again to confirm they do not have moisture in the windings.

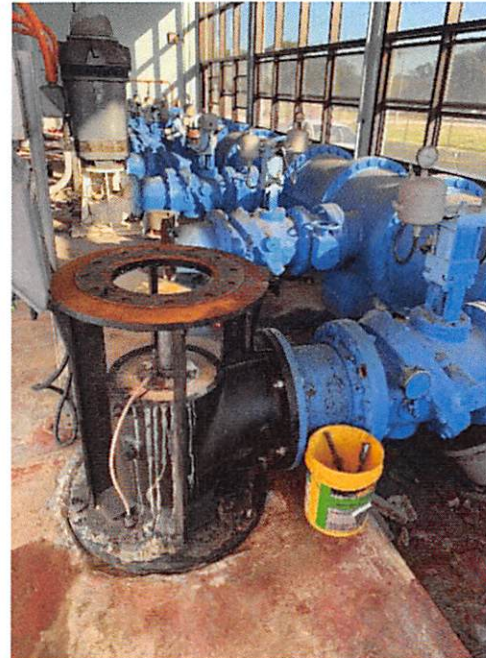
Figure 7. No sole plate on newly installed pump

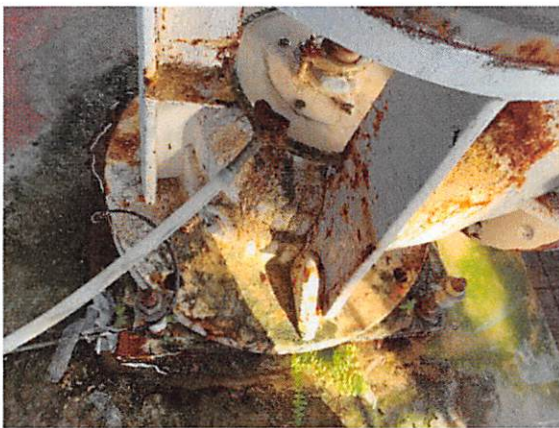
- Observed a large constant water flow coming from the HSP packing (**Figure 8**). The design drip rate for pump packing is normally given in drips per minute. Excessive drip rates can reduce the pump performance and prematurely wear the packing. Vendor can provide the actual design drip rate during their certification of proper installation inspection.

Figure 8. Missing bolts and constant seal water flow at HSP No. 7

12. Every bolt hole must be bolted up.
13. Bolt down a competent steel plate and provide caulk around the edges at the exposed floor penetration at HSP 2.

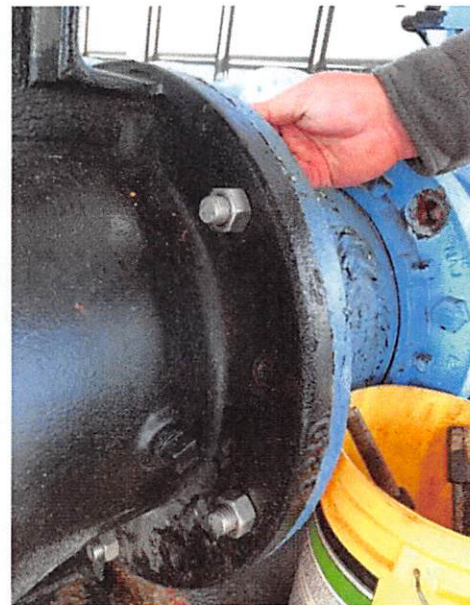
Figure 9. Missing bolts on pump flange

17. Flange bolts should all be sized correctly for the bolt holes. We recommend installing bolts 1/8-inch smaller than bolt holes.

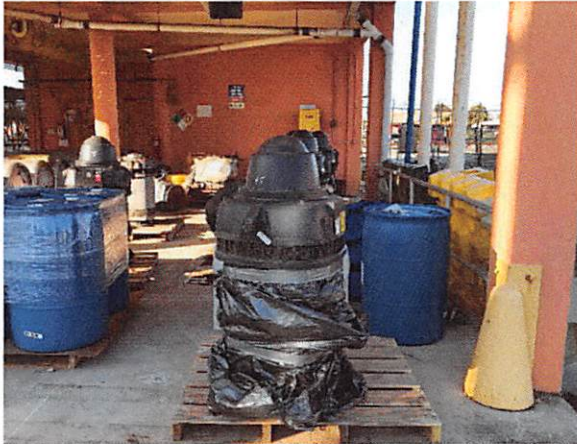
2. New Uninstalled Pumps
- The new uninstalled pumps motors are being stored outside in the base of the North Lime Building without heaters attached (**Figure 10**). The motors were meggered and they tested satisfactory at that time.

Figure 10. New uninstalled HSP motors

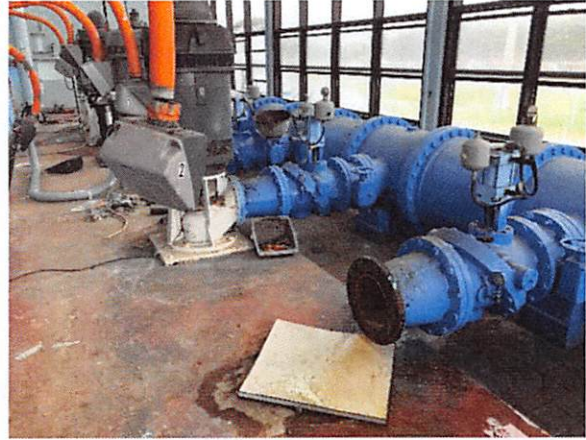
- Exposed floor penetration at HSP 2 was not properly secured after pump was removed. Pressed wood piece (**Figure 11**) was placed loosely over the penetration and is falling apart. The wooden piece may collapse if stepped on. This arrangement is dangerous and unsanitary.

Figure 11. Exposed floor penetration not secured properly for HSP No. 2

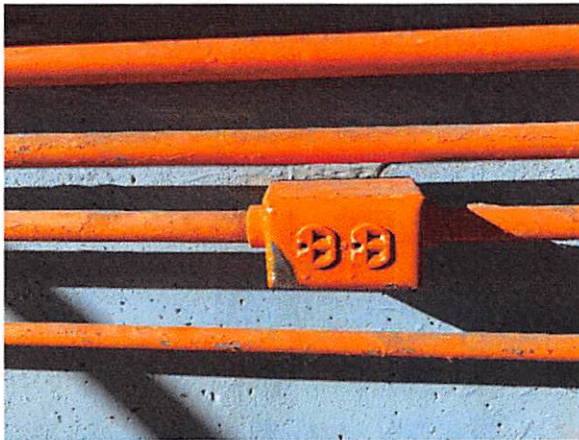
- No covers on electrical outlet observed and they do not appear to be ground fault protected (**Figure 12**). Electrical conduits do not fully cover wiring and are not properly terminated (**Figure 13**).

Figure 12. Open electrical outlet

14. The HSP room is a potentially wet room. Exposed electrical wires at several HSPs should be properly terminated and all electrical outlets should have a cover and be ground fault protected.

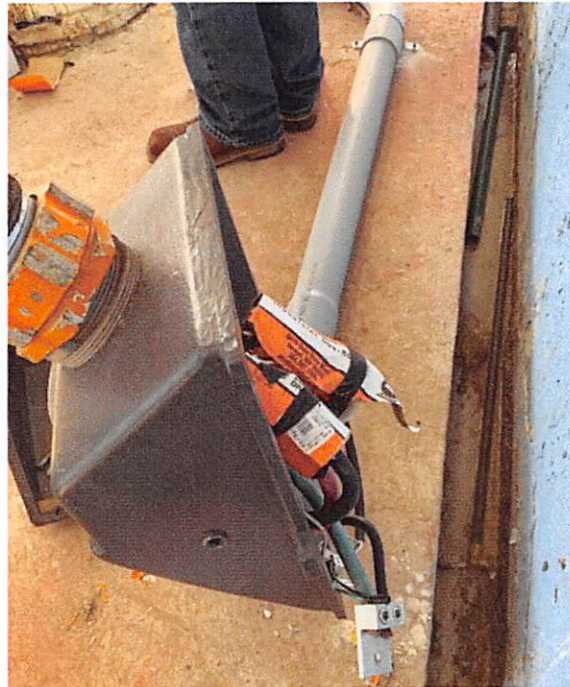
Figure 13. Exposed electric wires

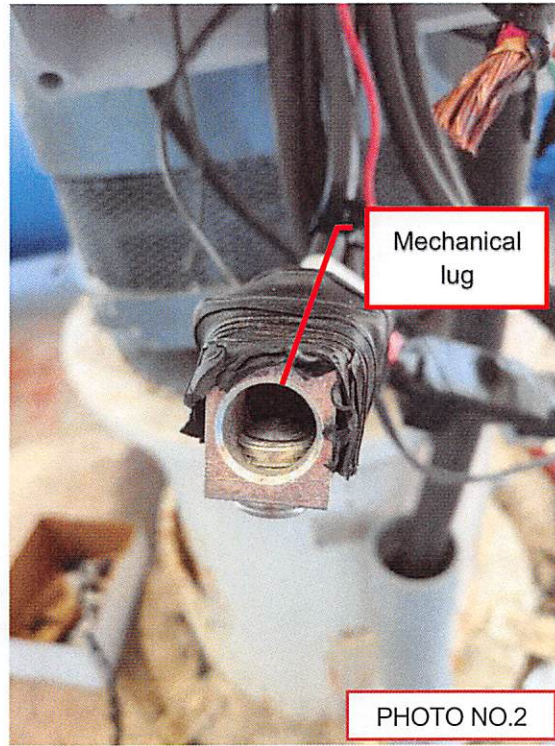
- a. Electrical connections at motor for HSP-4 and inside of old terminal box for HSP-5 are made via mechanical set-screw lugs. Mechanical set-screw lugs are not recommended for motor connections as vibration and heat may cause cables to become loose at lugs. High-pressure terminal connectors or split bolts are preferred. See Photo No.2

- Recommend replacing the mechanical set-screw lugs for HSP-4 with high-pressure lug connectors.
- Currently HSP-4 auto transformer has an internal failure and HSP-5 is operational. HSP-4 and HSP5 auto transformer starters are old technology and beyond their reliable lifespan. Recommend replacing the existing auto transformers of HSP-4 and HSP-5 with new reduced voltage solid state starters due to lack of readily available replacement parts.

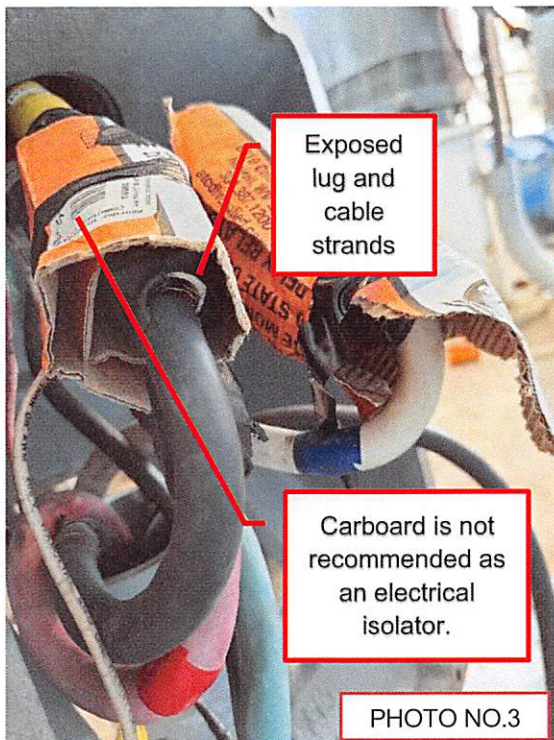
- b. Terminations at terminal box for Motor-5 have exposed metal, which may cause electrical shock to personnel or short-out if in contact with another conductive object. See Photo No.3

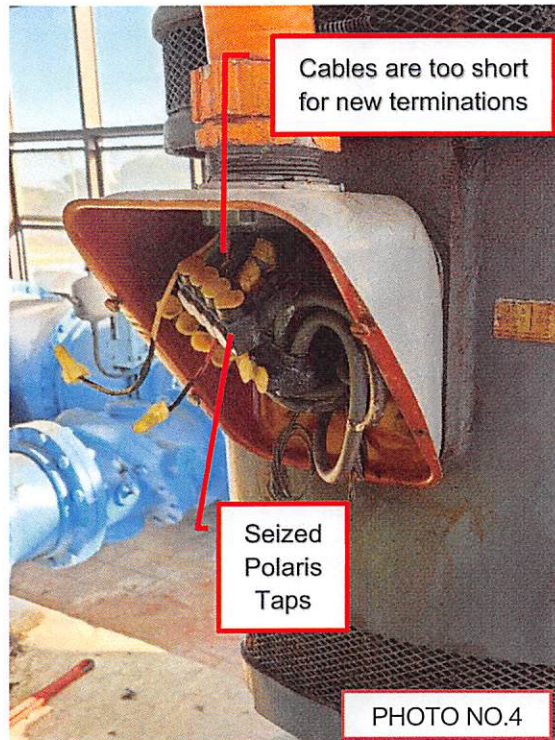
- Electrical connections at motor for HSP-3 are made via Mechanical lugs (Polaris taps). Mechanical set-screw lugs are not recommended for motor connections as vibration and heat may cause cables to become loose at lugs. High-pressure terminal connectors or split bolts are preferred. See Photo No.4

- a. Energy Efficient Electric (EEE) was not able to test the feeders for HSP-3 independent of motor windings due to existing lugs being seized and not enough slack in the cables to cut and make new terminations. Terminations were left as found. See Photo No.4

- The starter contactors for HSP-2 were tested and found to be functional.
- Although HSP-3 wires show acceptable resistance reading, the lugs are seized and cannot be disconnected from the motor. Since there is not enough slack in the existing cables to make new connections, it is recommended to replace the cables and connectors.

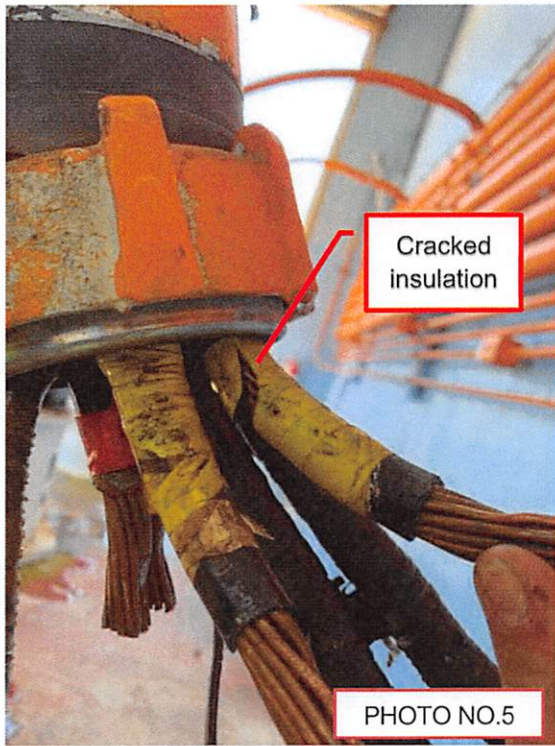
- Feeder cable insulation (C phase) for HSP-1 is cracked to the point that copper is visible. Crack is at the motor-end of cable, partially inside the flexible conduit. Recommend replacing cable. See Photo No.5

- The wires for HSP-1 thru HSP-5 tested with acceptable resistance reading under dry condition.
- Cables for HSP-1 have exposed copper due to cracked insulation. Replace cables for HSP-1 for personnel safety if HSP1 motor and pump will be installed in the future.

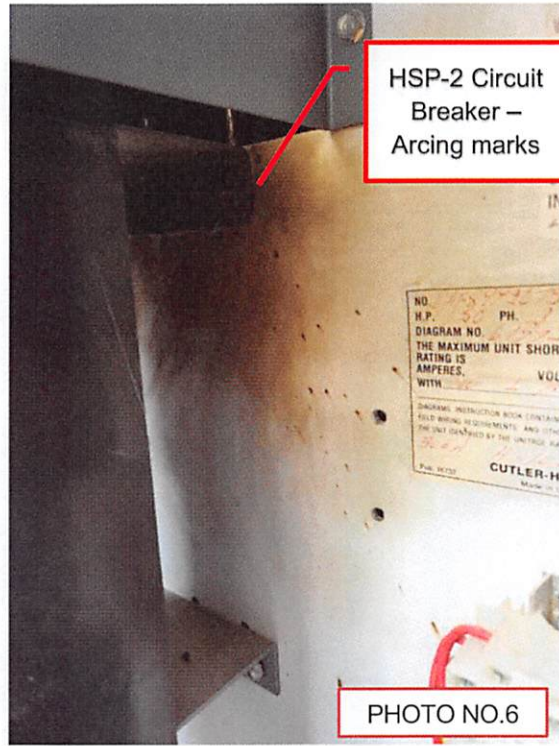
- Circuit Breaker inside Starter Bucket for HSP-2 has arcing marks where mounting bracket attaches to backplate. Recommend isolating breaker and testing prior to energizing. See Photo No.6

- Due to the arc flash marks on the breaker for HSP-2, it is recommended to obtain the service of MCC manufacturer to isolate the breaker from MCC for testing. Depending on the test results, breaker may need to be replaced.
