Technical Memorandum

Project Title: Independent Consulting Implementation Water Treatment Plant Improvements

Technical Memorandum 3 (Final)

Subject: Task 4 – Filtration Assessment

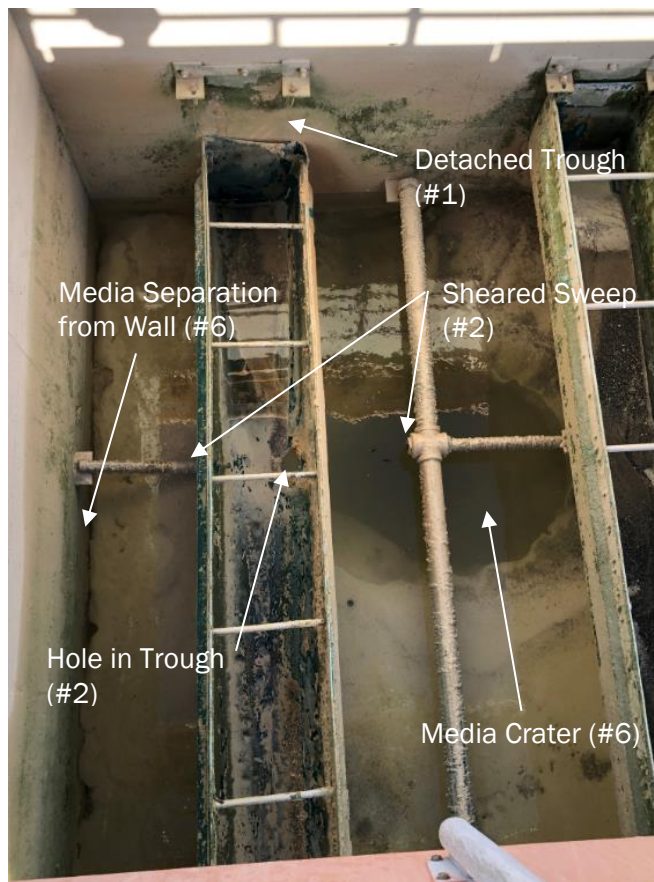
Figure 4-1 highlights several typical deficiencies observed in the filter cells. The noted deficiencies are indexed to the descriptions noted in Table 4-1.

Figure 4-1. Typical Deficiencies Observed (Filter #12) - Sheared Sweep, Detached Trough and Media Crater

Various deficiencies were observed in the wash troughs that included inconsistent levels (evidenced by non-uniform water flow over the troughs), and troughs partially detached from supports. In some cases, troughs collapsed and are on top of the media surface on one end while being partially supported on at the opposite end. In these cases, this has resulted in severe maldistribution of influent settled water and the backwash supply resulting in significant disturbance of the filter media. In impacted areas, significant displacement of

filter media was observed that is anticipated to result in short circuiting and impaired filtration. Refer to Figure 4-1 and Figure 4-2.

5. Washwater Troughs – replace all washwater troughs (including supports and appurtenances) in the filters that are currently out of service and assume that approximately 50% of troughs in remaining filters will require replacement (subject to filter specific inspection).

- d. Conduct field repairs of existing troughs, reattach/replace supports to achieve level configuration
 - e. Replace surface wash piping and reposition or cap existing sweeps (note – all sweeps will be replaced as part of Phase 2 work)

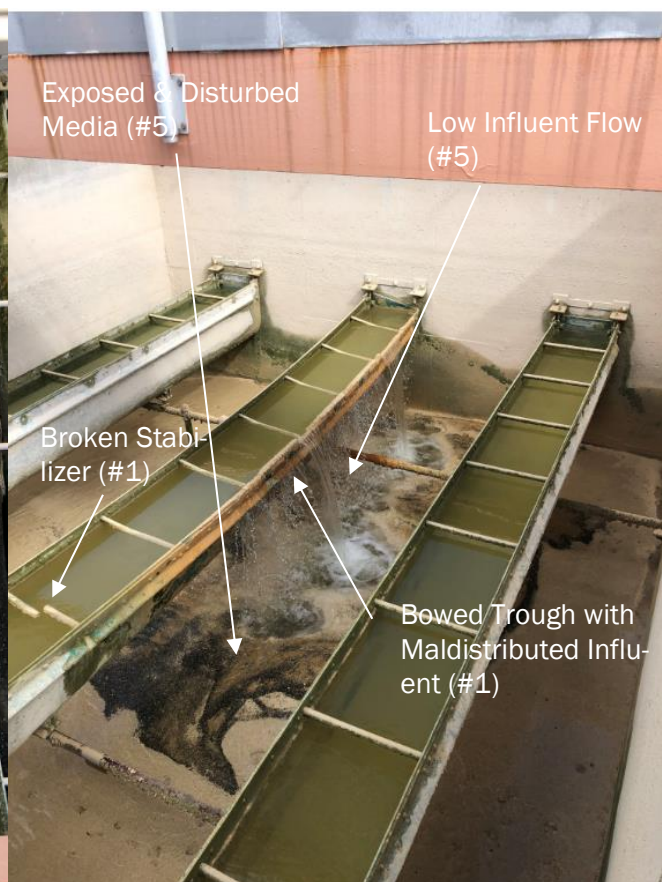
Figure 4-2. Typical Bowed Trough, Mal-distributed Influent, Media Disturbance and Lack of Water Level Control (Filter #10)

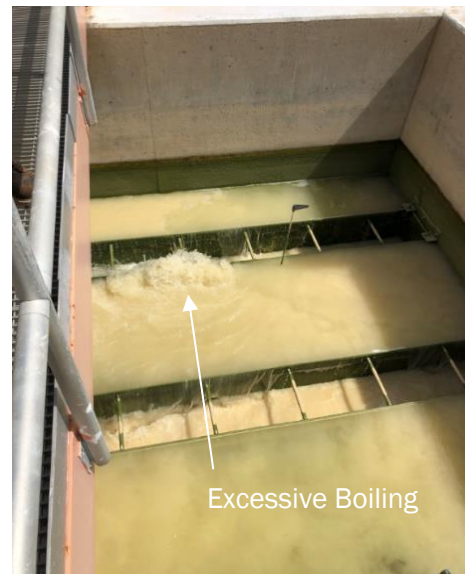
Filters 9 to 16 utilize a surface wash system. The sweeps and associated piping system for surface wash is compromised typically with holes in the piping and in one case, sheared piping. With these conditions, upon activation of the high-pressure water supply to the sweeps, significant jetting action would cause the scouring of media increase the formation of craters and in some cases, damage to impacted troughs. Note that no rotation of the sweeps was observed during visits (operators confirmed that the sweeps are generally inoperable). Besides the detrimental impact of compromised sweeps on media/trough condition, the widespread inoperability also impairs the ability to break up accumulated mudballs for subsequent removal during the rapid rinse phase of backwashing. Consequently, the inoperability of the surface sweep system contributes to an impairment of the ability to adequately clean the filter beds. Refer to Figure 4-3 for an indication of coarse localized agitation during backwashing that results from a failed sweep.

Figure 4-3. Nonuniform Backwash flow Observed (Filter #14)

3. Surface Wash (North Train Filters) – replace all surface wash sweeps, piping grid, supports and associated system elements.
4. Air Scour System – subject to recommendations to be developed (refer to Section 5.3.1.1)

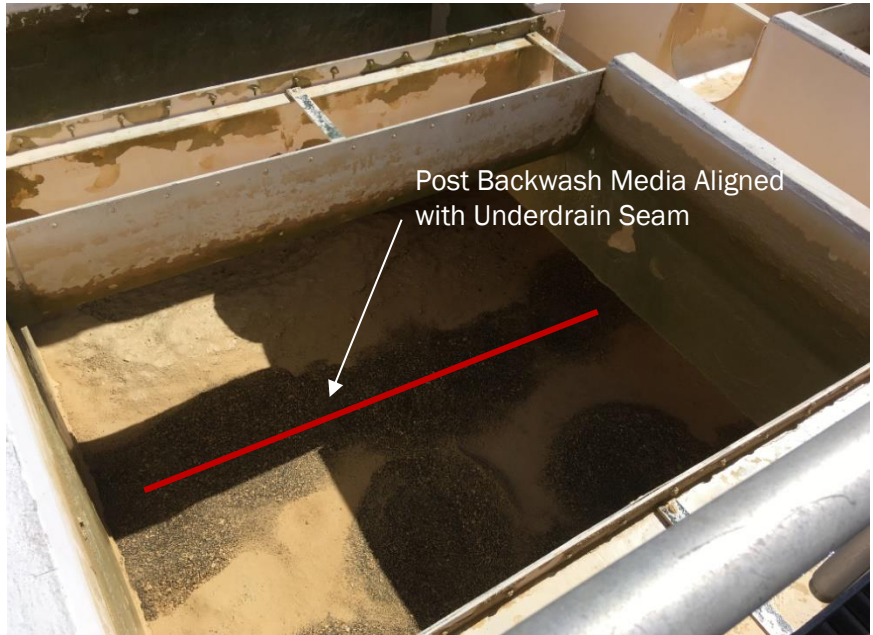
Filters 1 to 8 (South Train) have a Leopold Type S underdrain system that is equipped with an IMS cap for media retention. This was confirmed during a visual inspection of a failed underdrain (in Filter No. 5) that emerged from the media. Filters 9 to 16 reportedly have Leopold clay tiles with a gravel bed for media retention. The actual underdrains used in this train was not confirmed in the field; however, media probing efforts indicated the presence of a supporting gravel layer.

Of the three filters (1, 3 and 5), Filter No. 5 has been in a known failed condition for years (unspecified) and with the dislocated underdrain emerging from the media bed (refer to Figure 4-4). The apparent failure in the other two underdrains was evident from excessive coarse air bubbling in a line that is aligned with a known failed underdrain seam in in Filter No. 5 and/or cleaner than typical media also aligned with a seam

of the underdrain block. The high incidence of failure is indicative of a vulnerability and associated risk for all the filters in this train.

Figure 4-4. Failed Underdrain Emerged Through Media Surface

6. Filter Underdrains (South Train) – replace existing Leopold Type S underdrains selected for rehabilitation.
7. Filter Underdrains (North Train) – prioritize field repairs with contingent requirement to replace in select filters where field examination indicates a need.

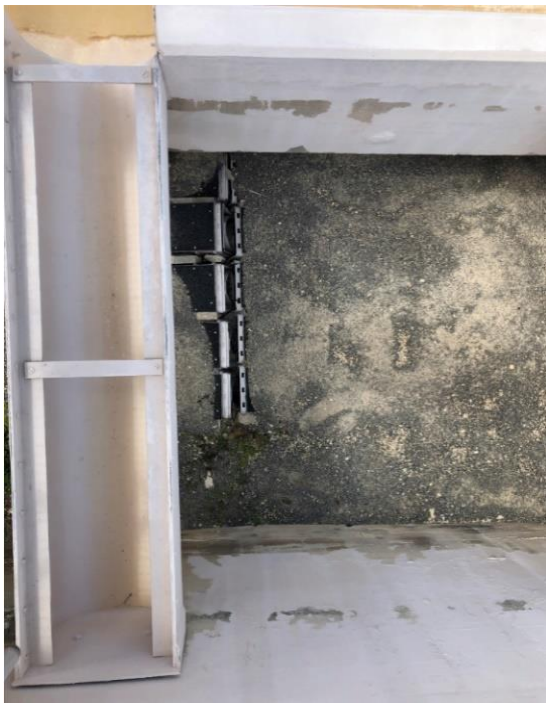
Figure 4-5. Potential Indicator of Underdrain Failure (Filter No 5)

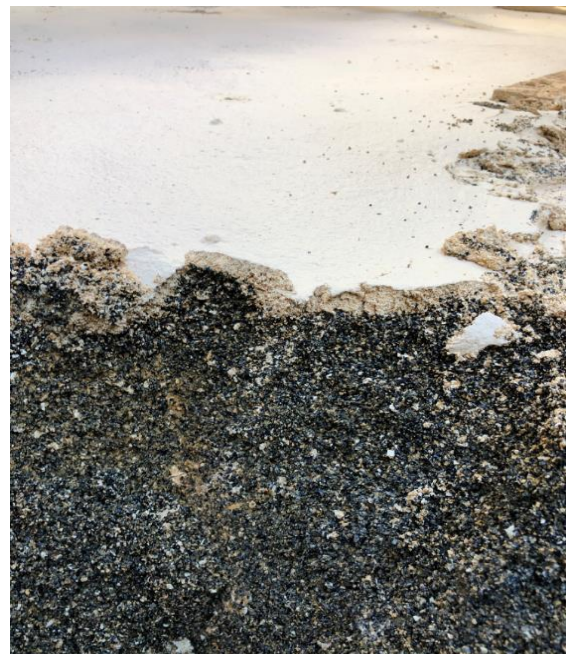
The observed condition of the media is very poor. Close inspection of the media indicated no discernable stratification (or separation) of anthracite and sand layers, extensive sludge retention/mudballs, and indicators of loss. Several contributing factors have been identified that impact the observed condition of the media particularly inadequate backwash rate and application of auxiliary washes (air scour and surface wash).

Figure 4-6 shows the remnant of a thick sludge cap remaining on the filter media following a complete backwash cycle. Close examination of the washed bed was the presence of mudballs throughout the areas of the bed probed. As shown in the photo, there media was with no delineation of stratified anthracite and sand layers. According to plant operations staff, the inability of the diversion valve (that diverts flow from the GST to the filters for backwashing) to achieve a tight seal is believed to contribute to the deficient backwash flow. Furthermore, reported flow inconsistencies indicated a need to conduct further investigation into the accuracy of backwash flow measurements.

Figure 4-6. Cross-section of Washed Filter Bed

2. Filter Media - replace in all filters selected to be rehabilitated inclusive of all eight filters in the North Train and selected filters in the South Train. The media design shall be developed by the EOR once the available backwash flow is established.

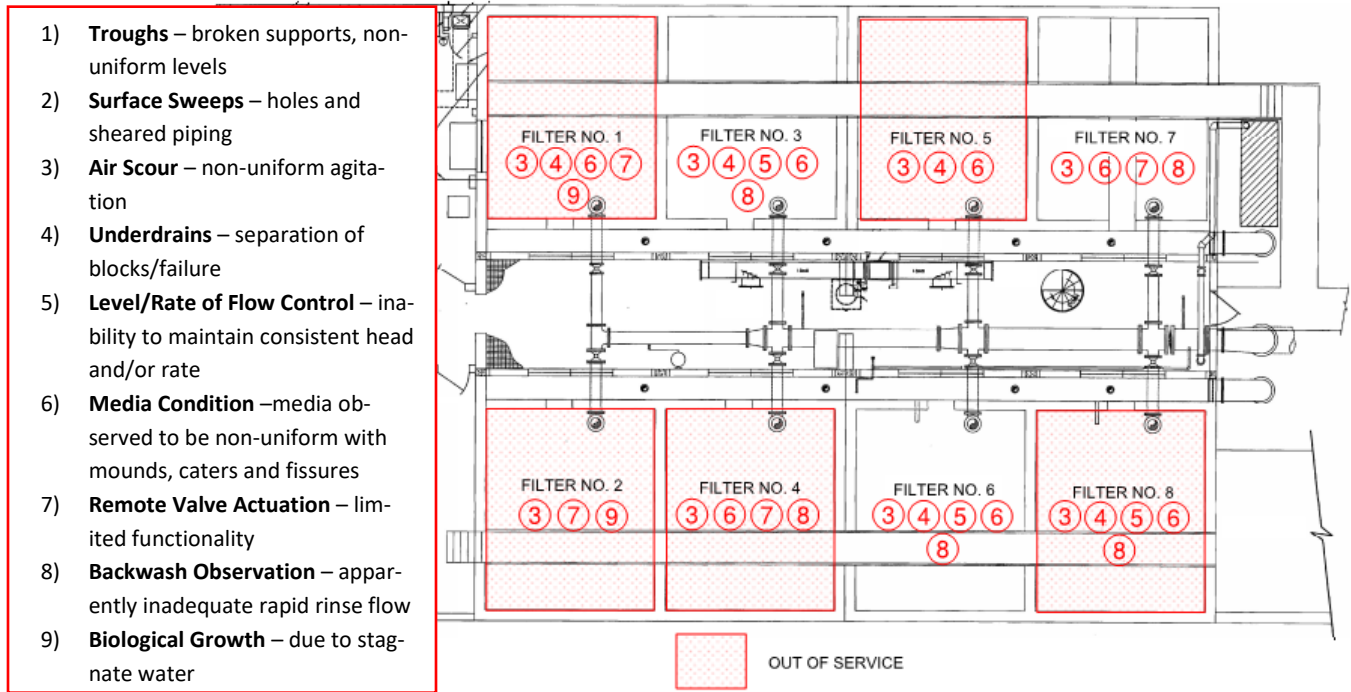
Figures 4-7 and 4-8 depict plan views of both filter trains. The numbers assigned to each filter correspond with the observed conditions listed in Table 4-1. Refer to Appendix B for more details regarding the configuration filters.

Figure 4-7. Filters 1-8 Inspection and Evaluation Results

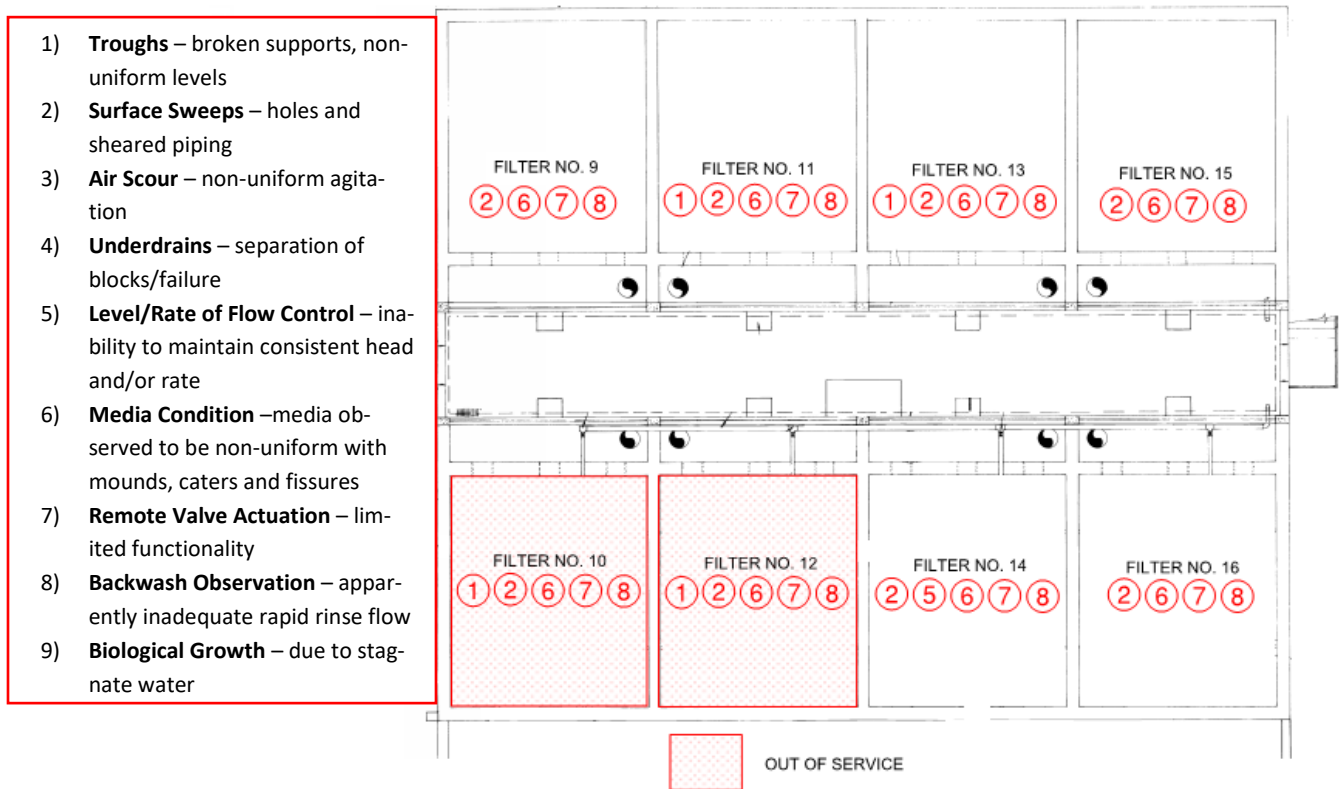
Figure 4-8. Filters 9-16 Inspection and Evaluation Results

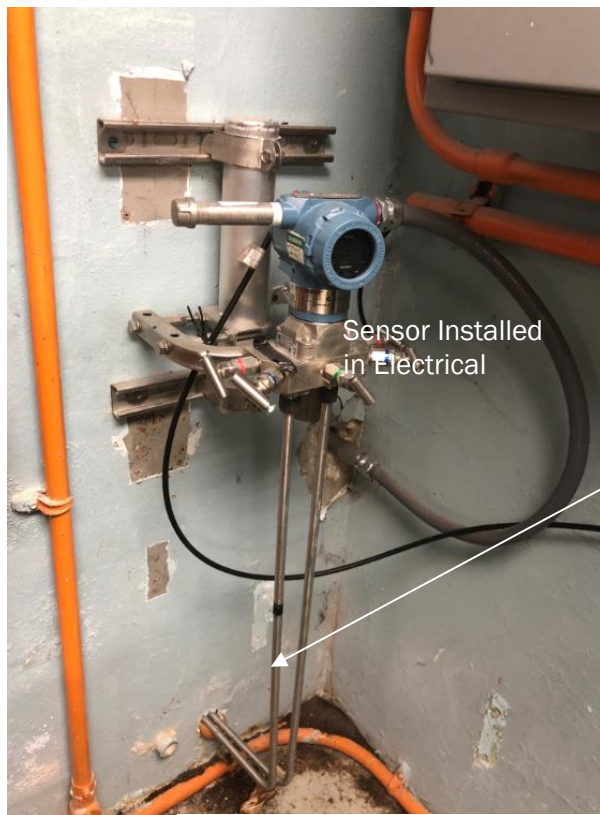
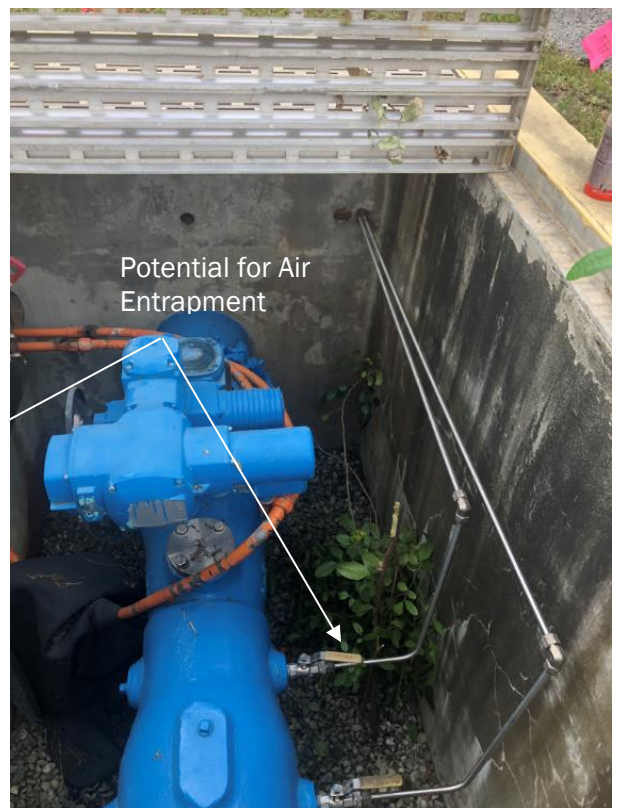
The visual inspection of the venturi meter and modulating valve arrangement use to control and report backwash flow indicated the unfavorable configuration and placement of the sensor lines and associated instruments that could be conducive to error and potential hazard. Specifically, the following was noted (refer to Figure 4-7 and Figure 4-8):

1. The high- and low-pressure sensor lines terminate at the differential pressure transmitter at a high point that increases the risk of air entrapment with no mechanism in place to purge accumulated gasses. Accumulated air in the sensor lines could introduce significant error in the flow measurements (Figure 4-7)
2. The differential pressure transmitter and associated pressurized terminations is located in the electrical room. This is not a suitable environment for locating equipment of this type due to the potential hazard that could be caused by a water leak inside the electrical room.

Figure 4-9 and Figure 4-10. Arrangement of Venturi Meter and Sensor Lines

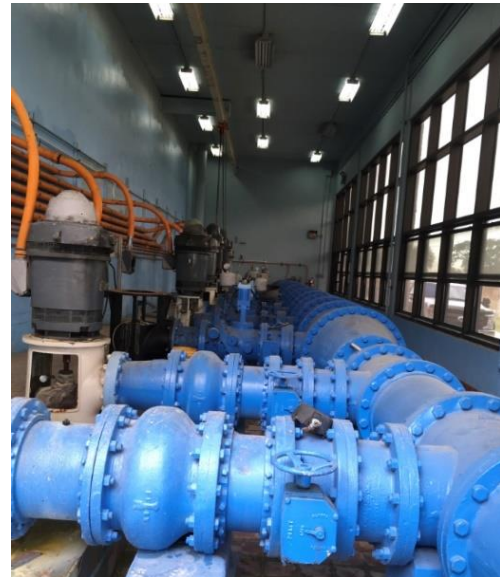
A visual inspection of the transfer pumps and visible piping system indicated the absence of air relief valves (ARVs) that would typically be located at the discharge of each pump and/or high points in the piping system. Without appropriate venting of the high points in a piping system, there is an increased risk of air accumulating in those locations that can progressively reduce the capacity of the system as air binding progresses. There were no functional pressure gages in the system that could be used to assess operating conditions within the piping system. High points in the piping system were observed in the discharge header for the transfer pumps as well as the backwash supply piping to the Filters 1 to 8. Refer to Figure 4-9. To the extent that air binding exists, that could contribute to the constraining of backwash flow. While unrelated to the filtration system, the high service pumping system was also noted to lack air relief valves and functional pressure gages.

Figure 4-11. Transfer Pumps and Piping Discharge Missing ARVs
