Singer Island Bridges Inspection Photographs April 7, 2020

Summary - Grand Bahama Lane Bridges

Summary – Island Drive Bridges

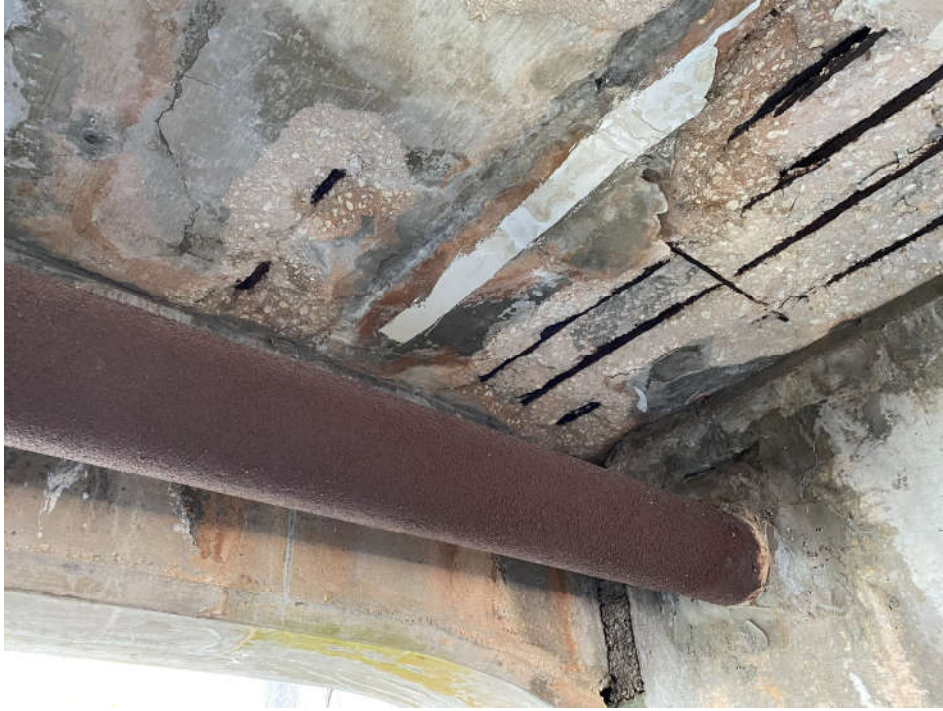
Photo 1: Grand Bahama Lane – East Bridge Underside of Deck

The photos for Grand Bahama Lane (1 to 8) show severe concrete spalling and reinforcing steel corrosion on the underside of the concrete deck slabs that span between the main longitudinal support beams. Photos 1, 2 and 5 to 8 show significant concrete spalls resulting from the corrosion of the lower reinforcing steel. This has resulted in the reinforcing steel being fully exposed, which furthers the corrosion and loss of steel section. Photos 3 and 4 show some concrete spalling and reinforcing corrosion with areas of concrete delaminating from the slabs, which will result in further spalling and steel corrosion.

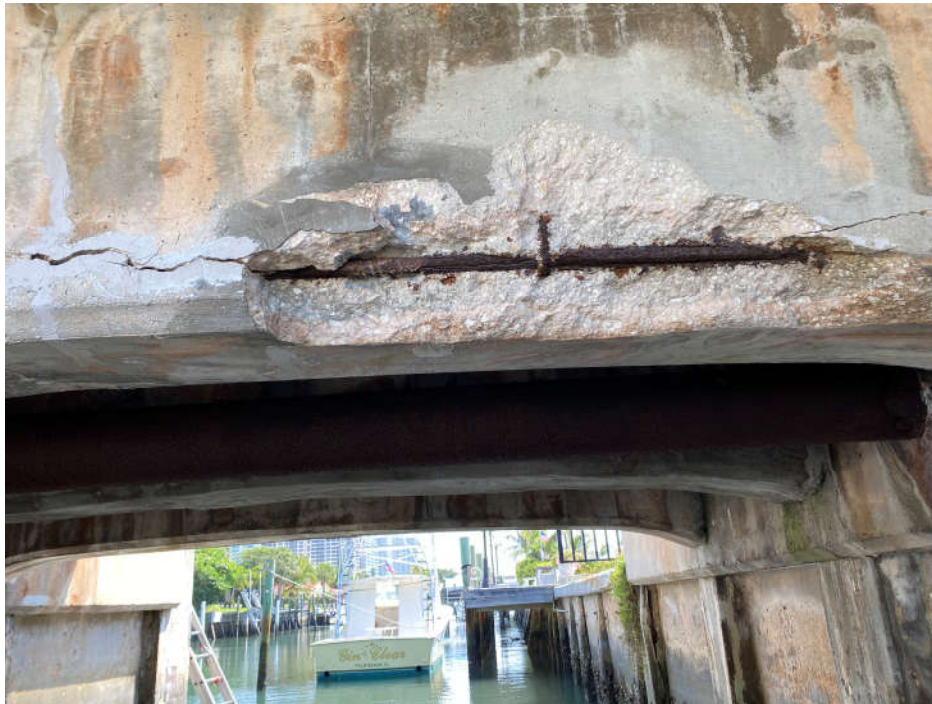
Photo 9: Island Drive – SW Bridge Outer Beam North Side

The photos for Island Drive (9 to 8) show longitudinal cracking, concrete spalling and reinforcing steel corrosion on the sides and bottom of the main longitudinal concrete support beams. Photos 9 to 13 and 15 and 16 show significant longitudinal cracking and concrete spalling resulting from corrosion of the steel reinforcing in the beams. The spalling has led to some of the reinforcing steel being fully exposed, which furthers the corrosion and loss of steel section. The longitudinal cracks will result in further concrete spalling as the steel reinforcing corrodes further, which will expose more steel and cause more steel corrosion. Photos 14 and 17 show significant longitudinal cracks resulting from corrosion of the reinforcing steel. This will result in future spalls and further steel corrosion.
