Palm Beach Isles, Singer Island  
Canal Crossing Structures Condition Report  
2nd Draft Report: November 25, 2015

**Palm Beach Isles, Singer Island Canal Crossing Structures Condition Report  
(2<sup>nd</sup> Draft)**

Simon A. Coleman, Ph.D., P.E.  
FL License No. 68929  
Alan Gerwig & Associates, Inc.  
12798, W Forest Hill Boulevard, Suite 201  
Wellington, FL 33414  
CA # 7969

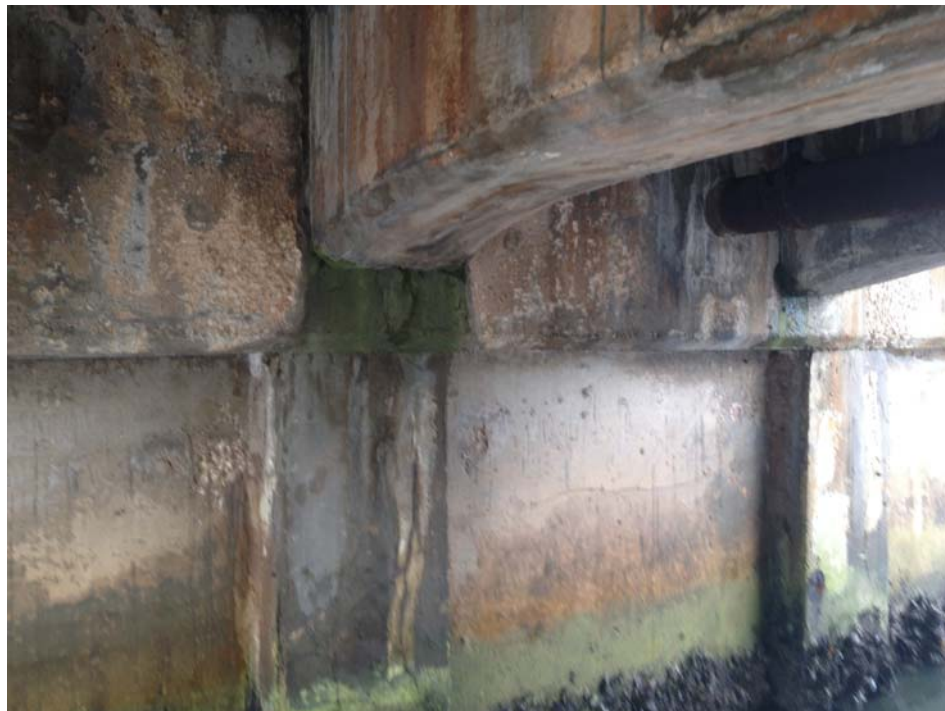
**Figure 11: Substructure Island Drive**

Figures 8 to 15 show representative photographs of the substructure and foundations of the structures at Island Drive. Generally, the piles, sheet panels and cap are in fairly reasonable condition given the age of the structures and the corrosive salt water environment that they are located in.

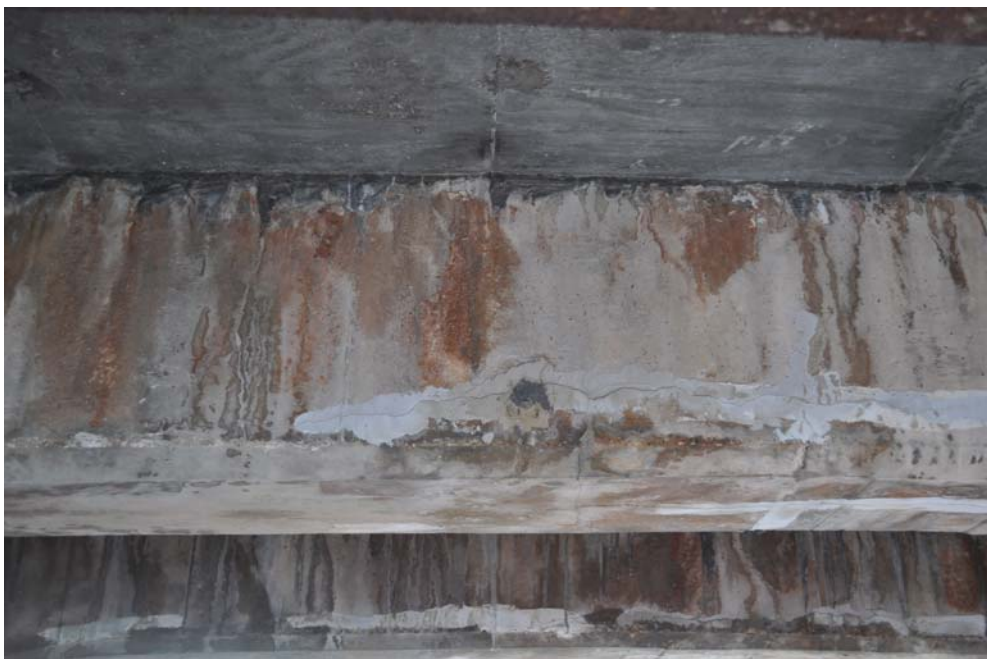
**Figure 17: Deck Slab & Beam Island Drive Structure**

The underside of the deck slabs of the four structures are in good condition as these elements were replaced in the late 1990s. Other than some surface defects at what appears to be a previous repair of the slab under one of the planters as shown in Figure 16, the deck slabs are in good condition. Representative photographs of the underside of the slabs are shown in Figures 17 and 18, which show the surface of the concrete in good condition with no signs of deterioration.
