## CITY OF RIVIERA BEACH – MEMORANDUM

**SUBJECT:** EMERGENCY JUSTIFICATION FOR HIGH SERVICE AND TRANSFER PUMPS

## INSPECTION REPORT

SUBJECT: High Service Pump Inspection, Testing & Recommendations

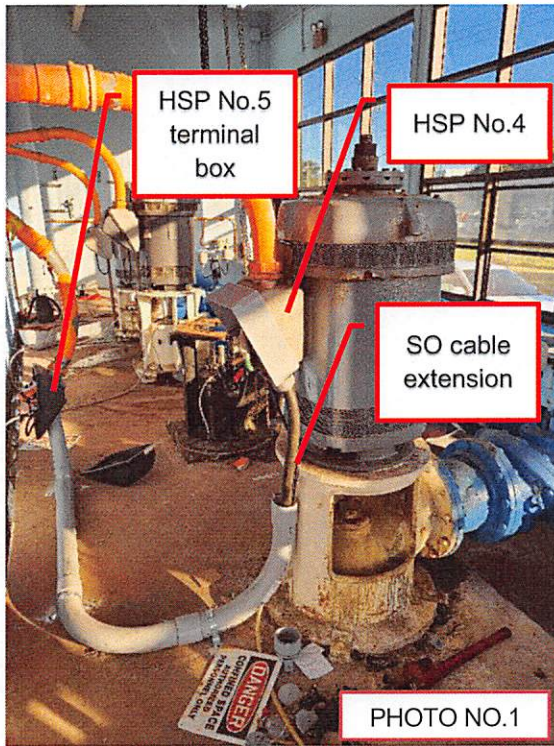
- The wires for HSP-1 thru HSP-5 tested with acceptable resistance reading under dry condition.
- Cables for HSP-1 have exposed copper due to cracked insulation. Replace cables for HSP-1 for personnel safety if HSP1 motor and pump will be installed in the future.

- VFD for HSP-1 is functional but the pump shaft is seized and both motor and pump need to be replaced. Additional work may be required in preparation to replace the pump, as the existing check valve and isolation valve are leaking, which will cause water to come out of the pump casing when trying to remove the pump.
